INFRARED
PREDICTIVE
SURVEYS
INCORPORATED

INFRARED ROOF INSPECTION

University of MD
School of Medicine

December 28, 2016

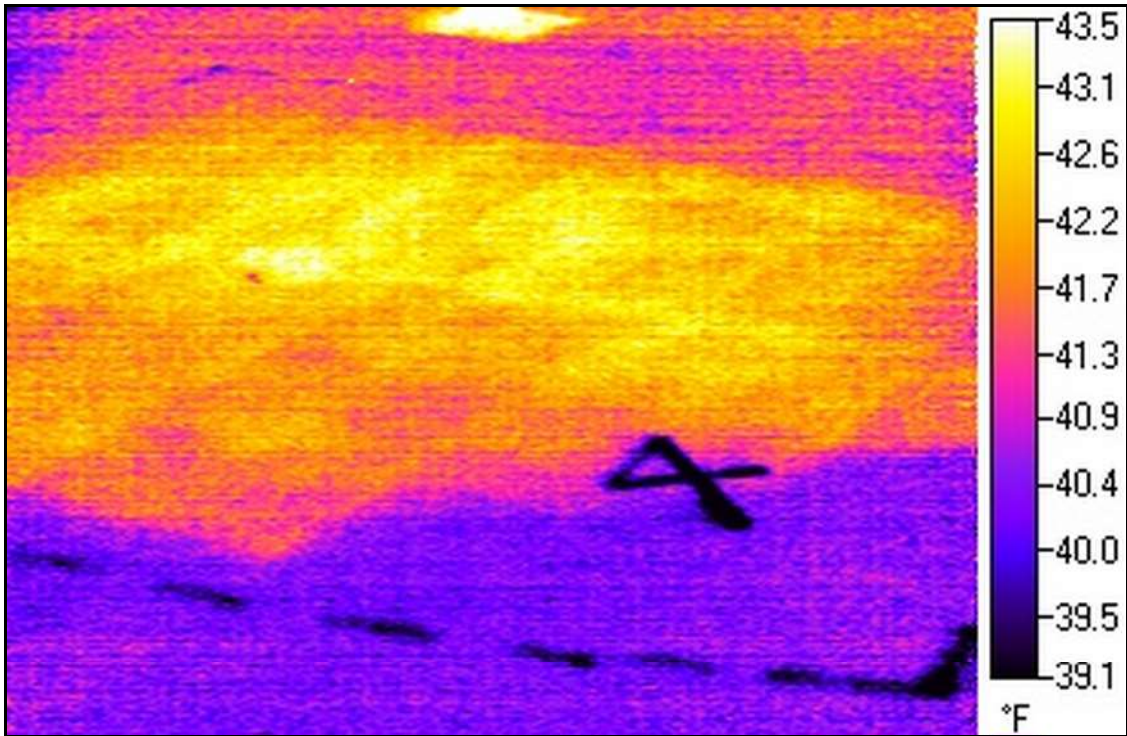
Roof A-Wet Area #4, looking South

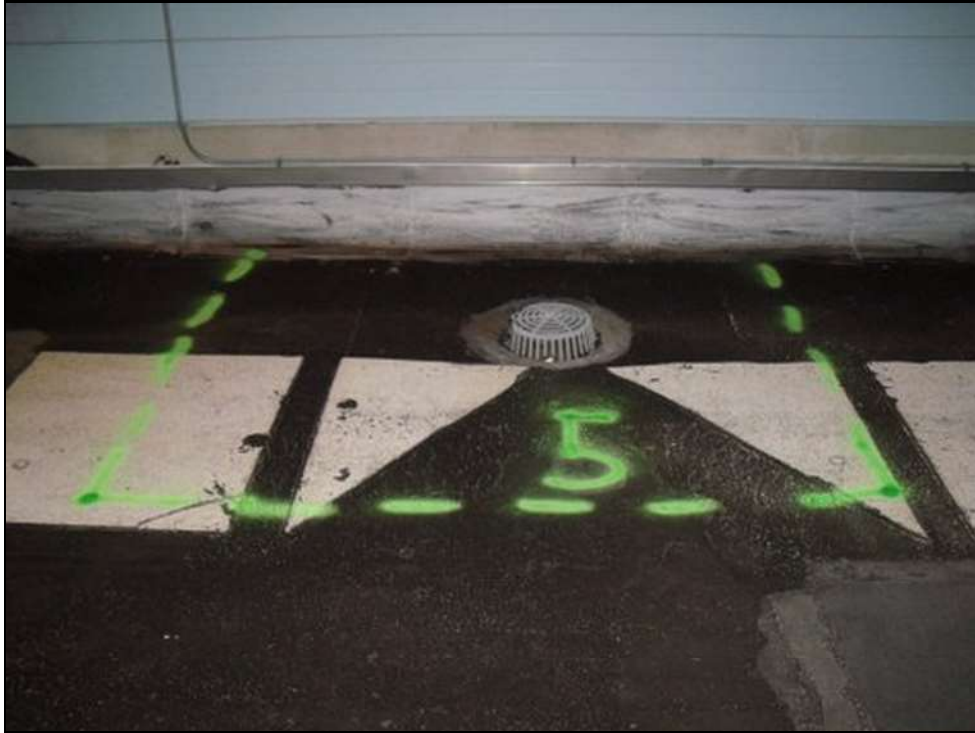
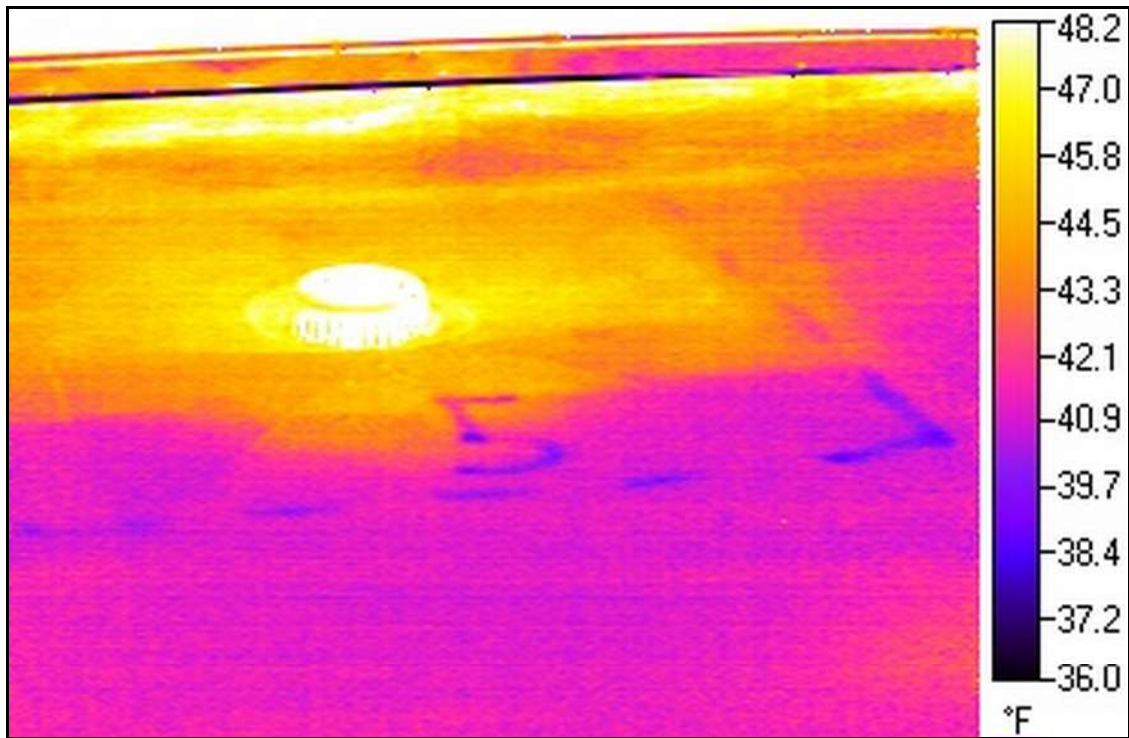
Roof A-Wet Area #5, looking East

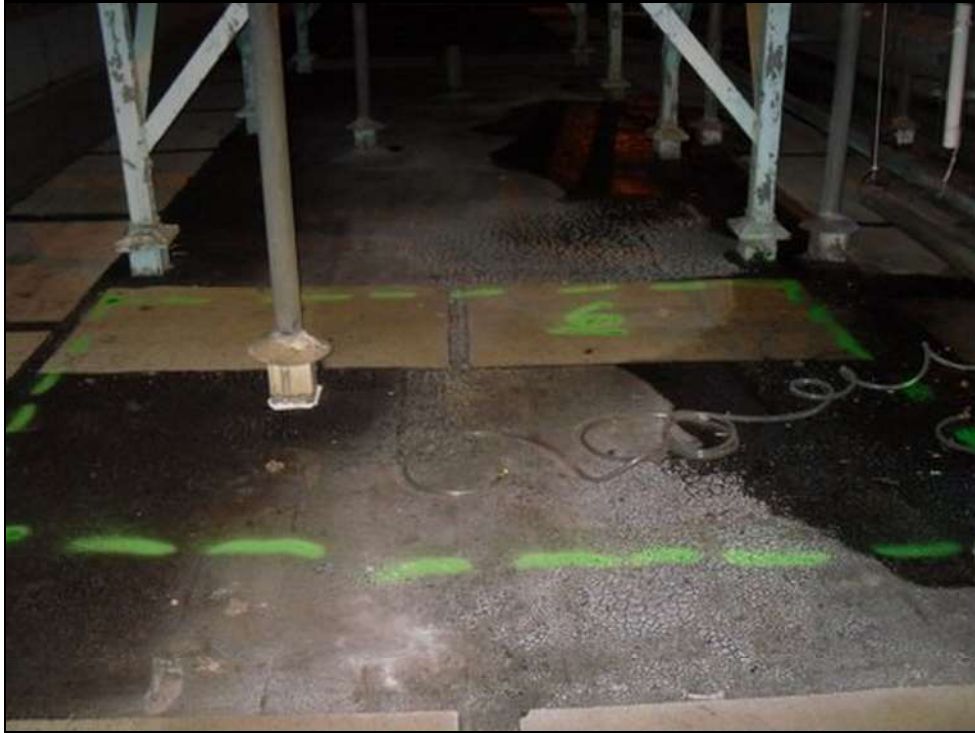
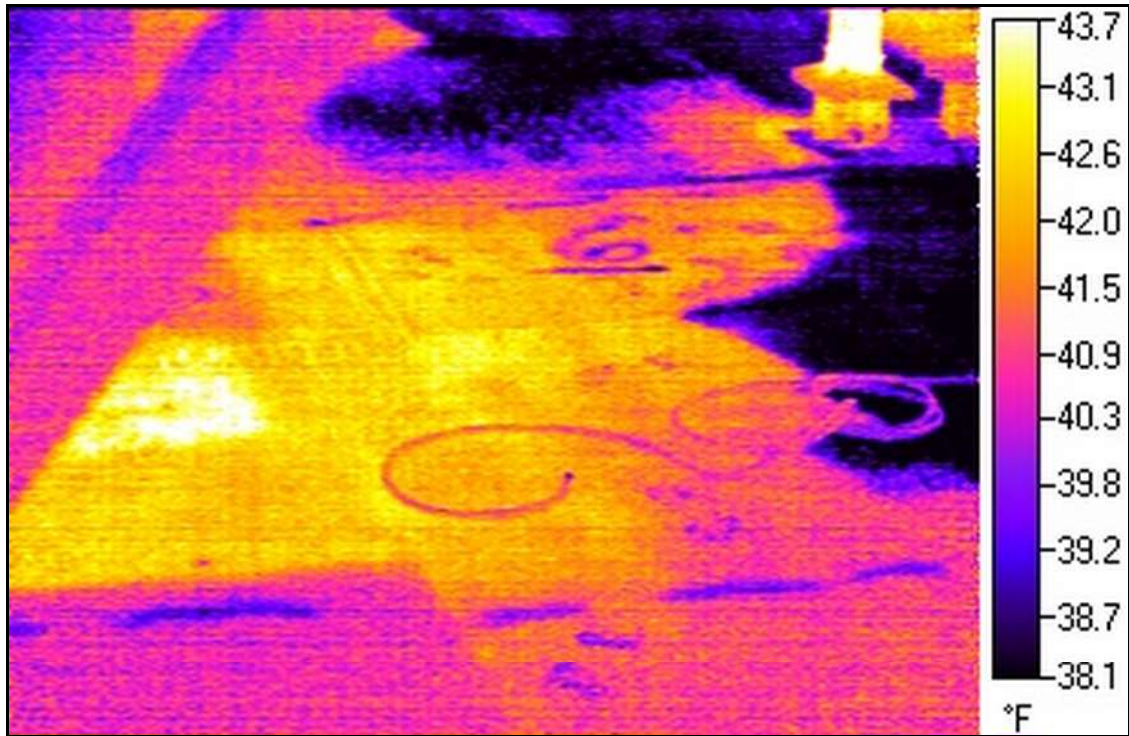
Roof A-Wet Area #6, looking North

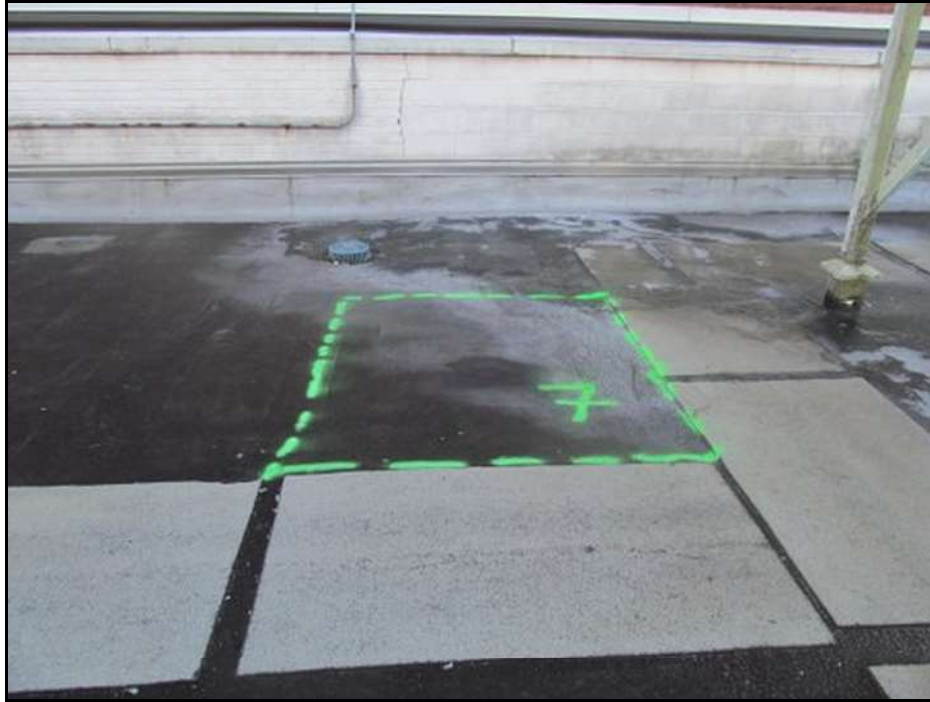
Roof A-Wet Area #7, looking South. This wet area was found using a Capacitance DEC Scanner and therefore there is no thermal image available.

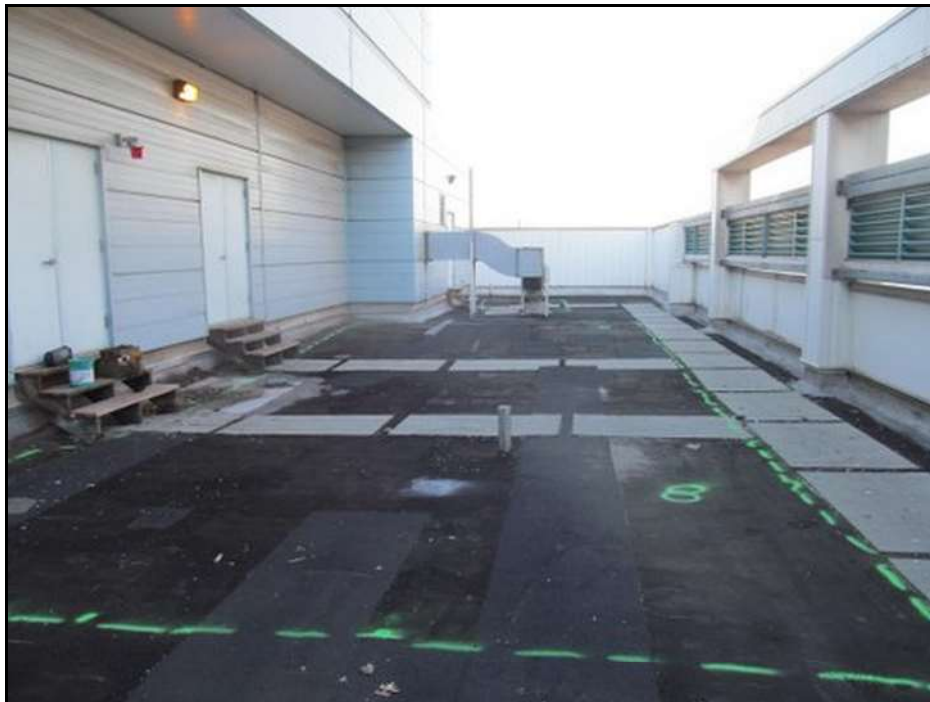
Roof A-Wet Area 8, looking North. This wet area was found using a Capacitance DEC Scanner and therefore there is no thermal image available.

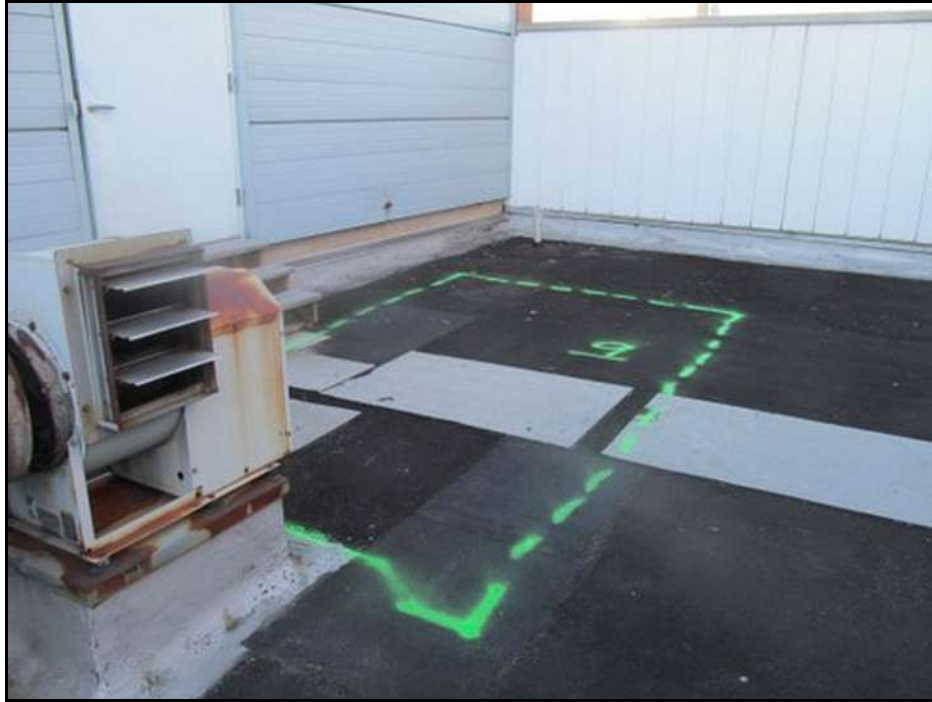
Roof A-Wet Area #9, looking North. This wet area was found using a Capacitance DEC Scanner and therefore there is no thermal image available.

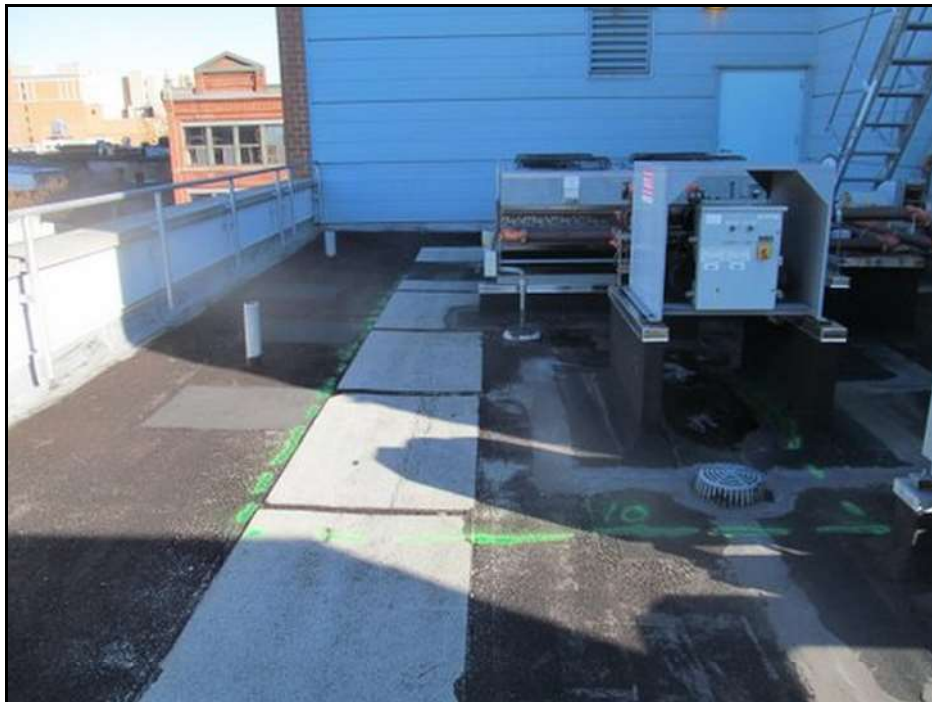
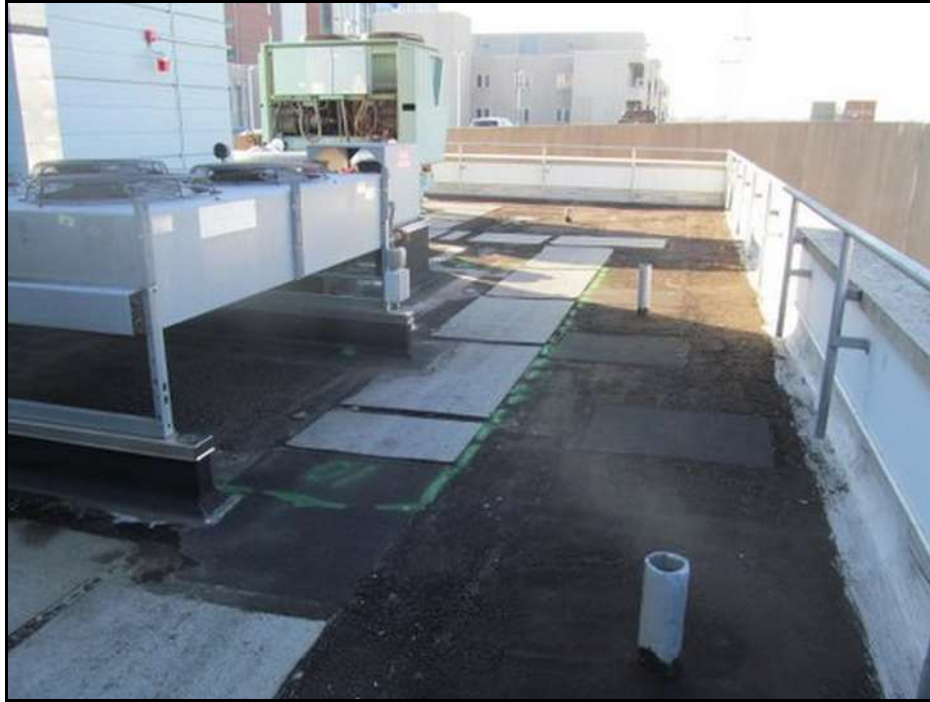
Roof B-Wet Area #10, looking East. This wet area was found using a Capacitance DEC Scanner and therefore there is no thermal image available.

Roof B-Wet Area #10, looking West. This wet area was found using a Capacitance DEC Scanner and therefore there is no thermal image available.

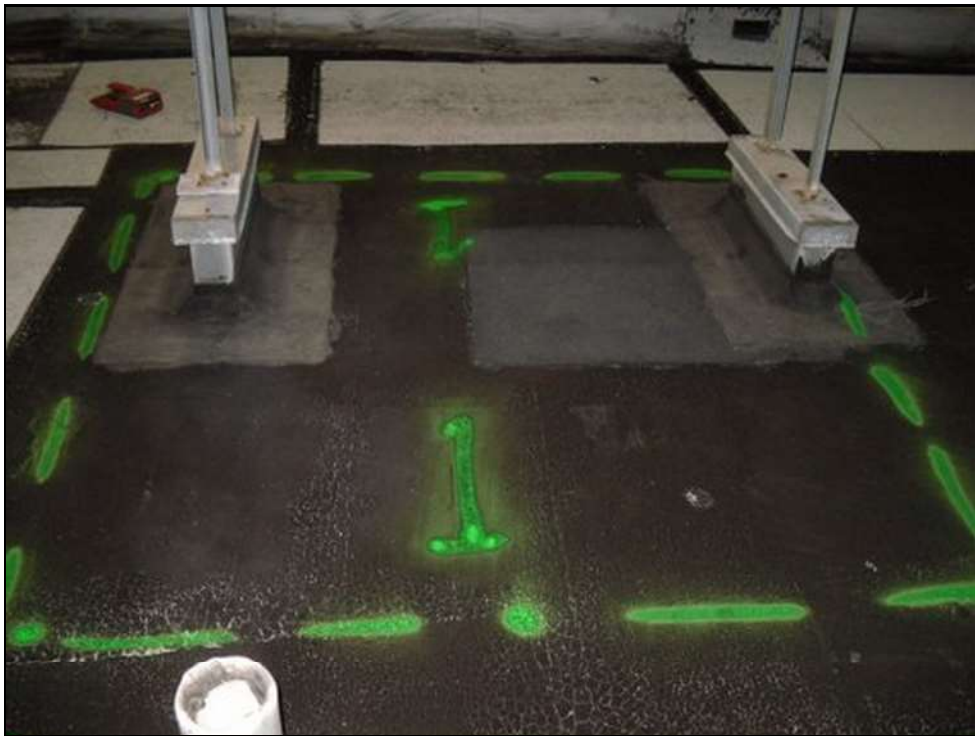
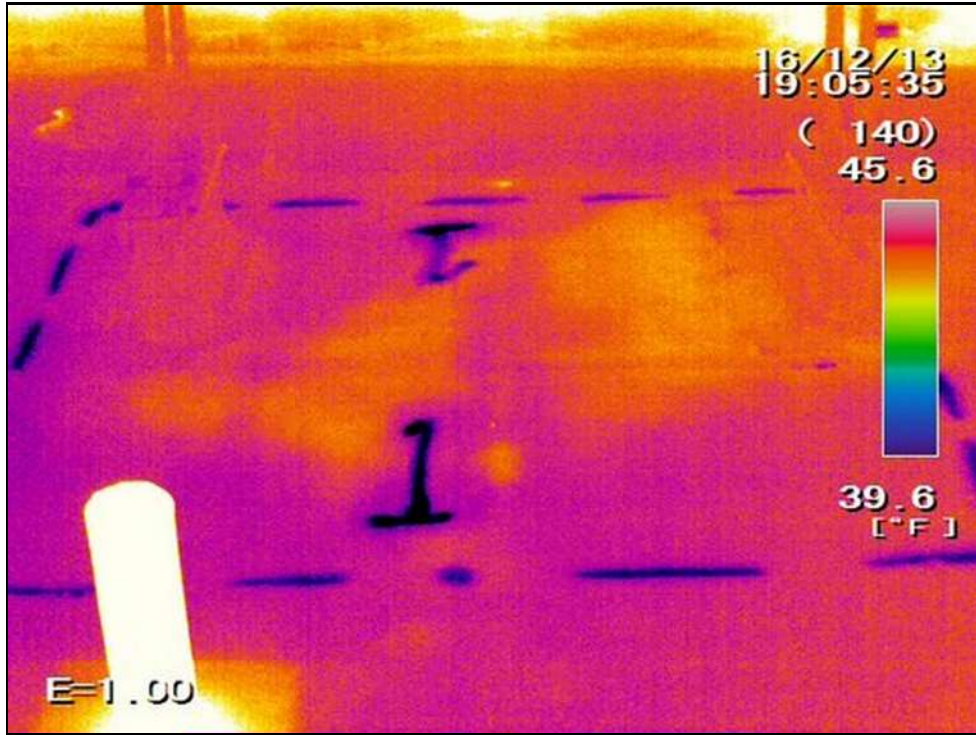
Roof C-Wet Area #1, looking North

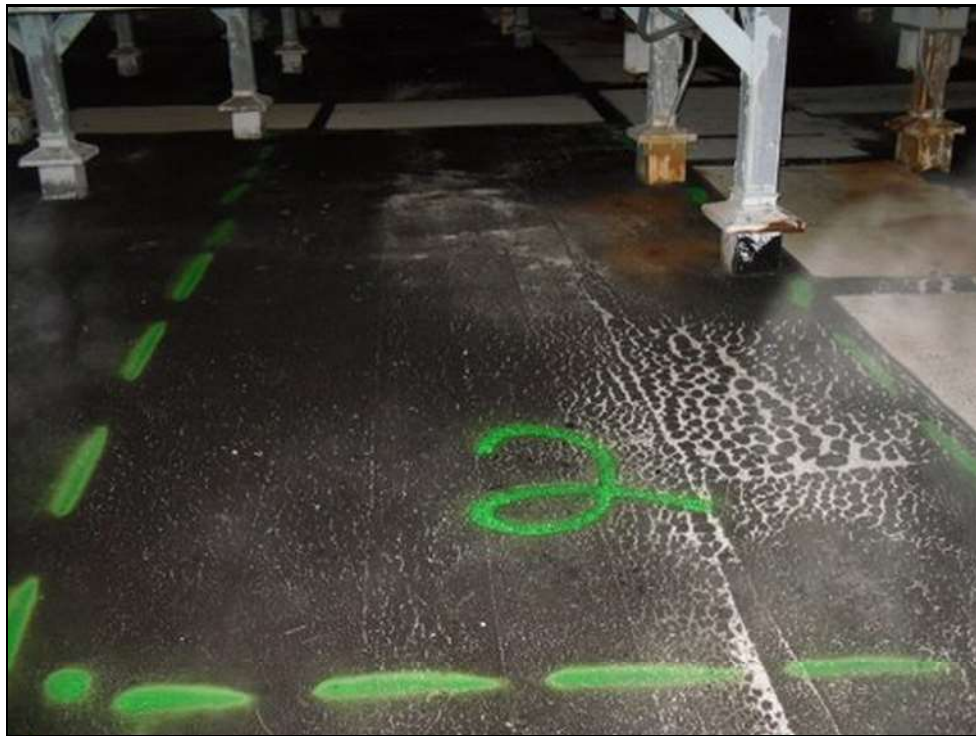
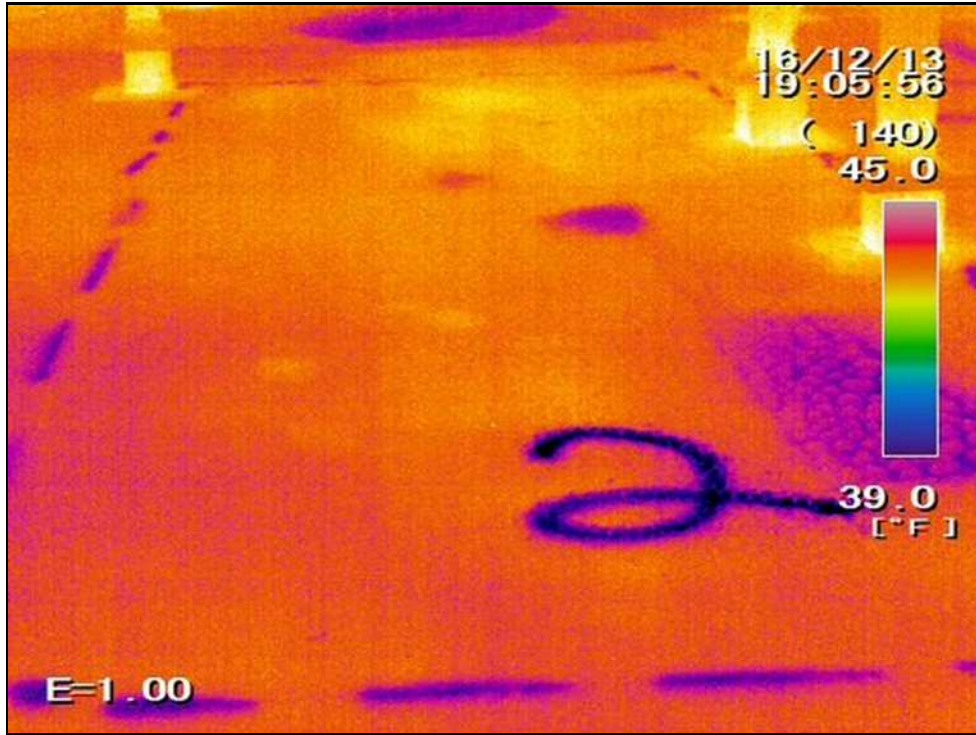
Roof C-Wet Area #2, looking South

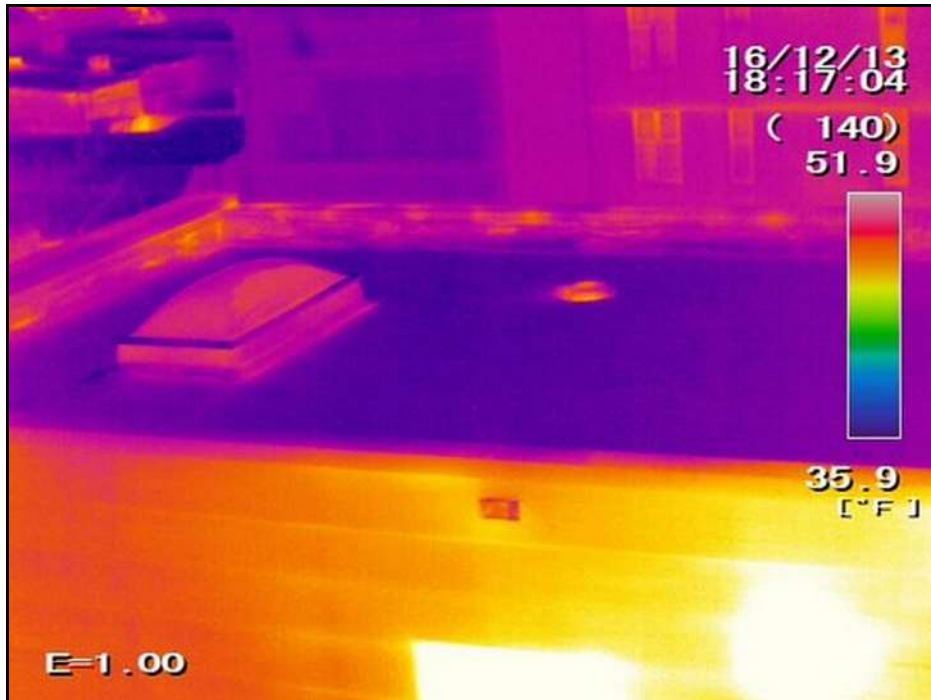
Roof D-Overview, looking East. No thermal anomalies, consistent with moisture intrusion, were noted.

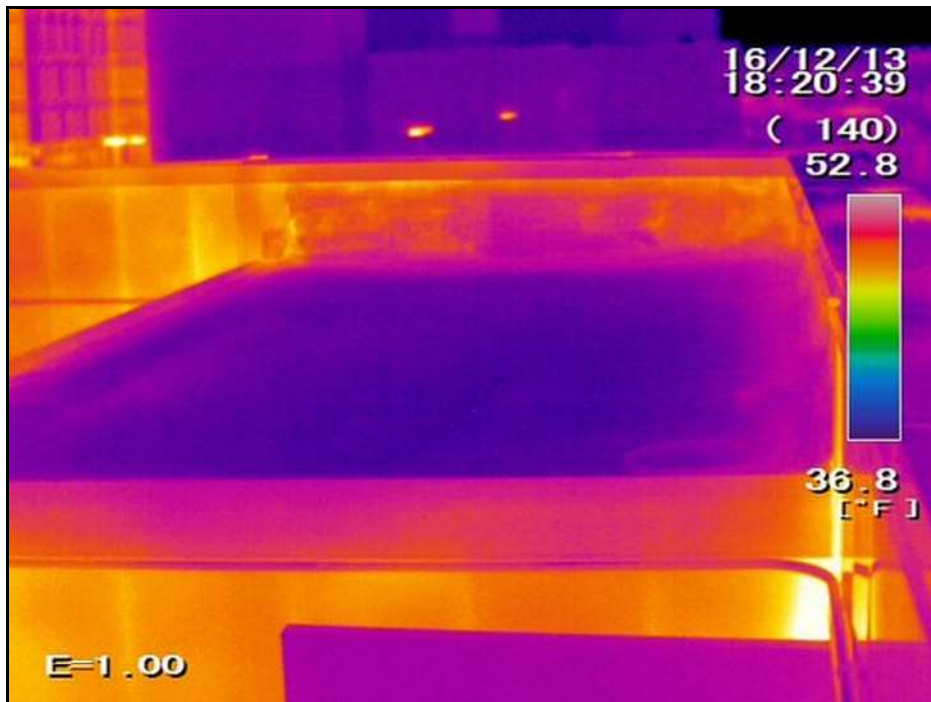
Roof E-Overview, looking West. No thermal anomalies, consistent with moisture intrusion, were noted.

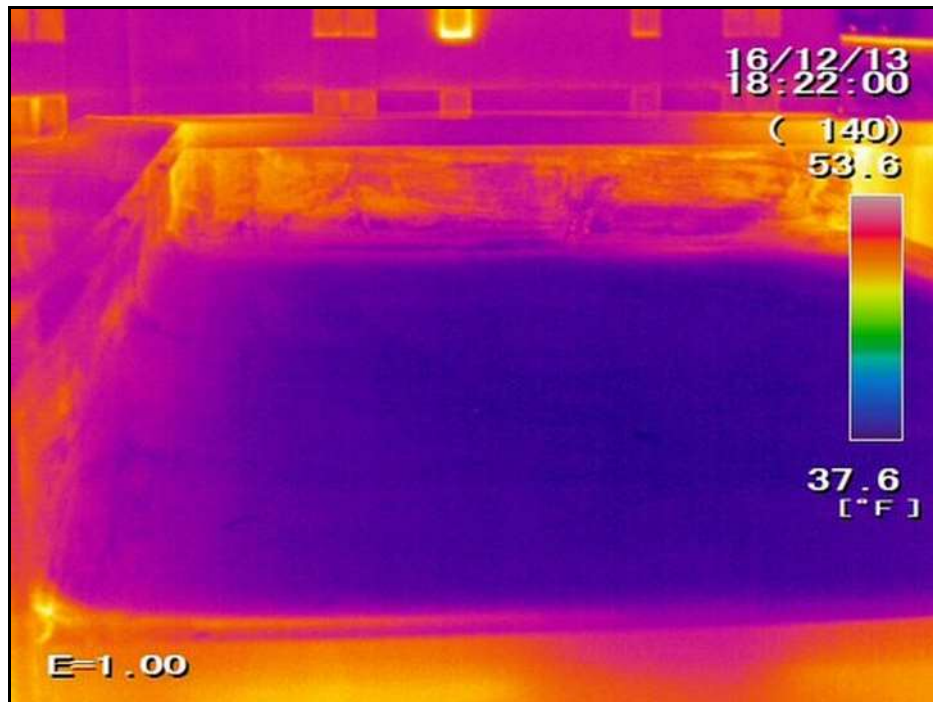
Roof F-Overview, looking East. No thermal anomalies, consistent with moisture intrusion, were noted.

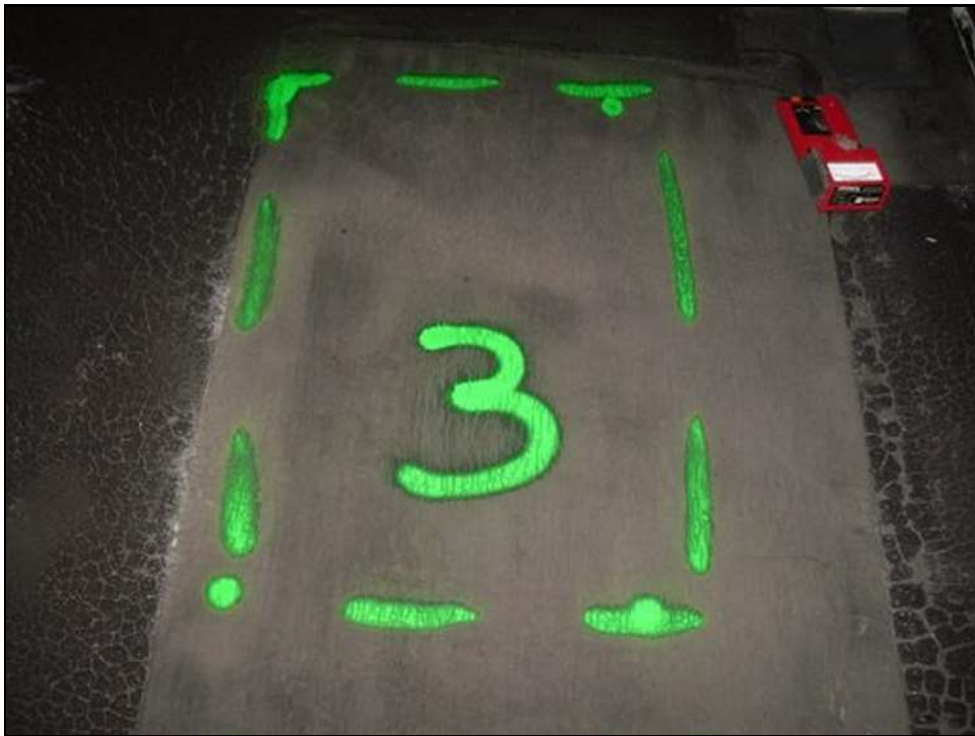
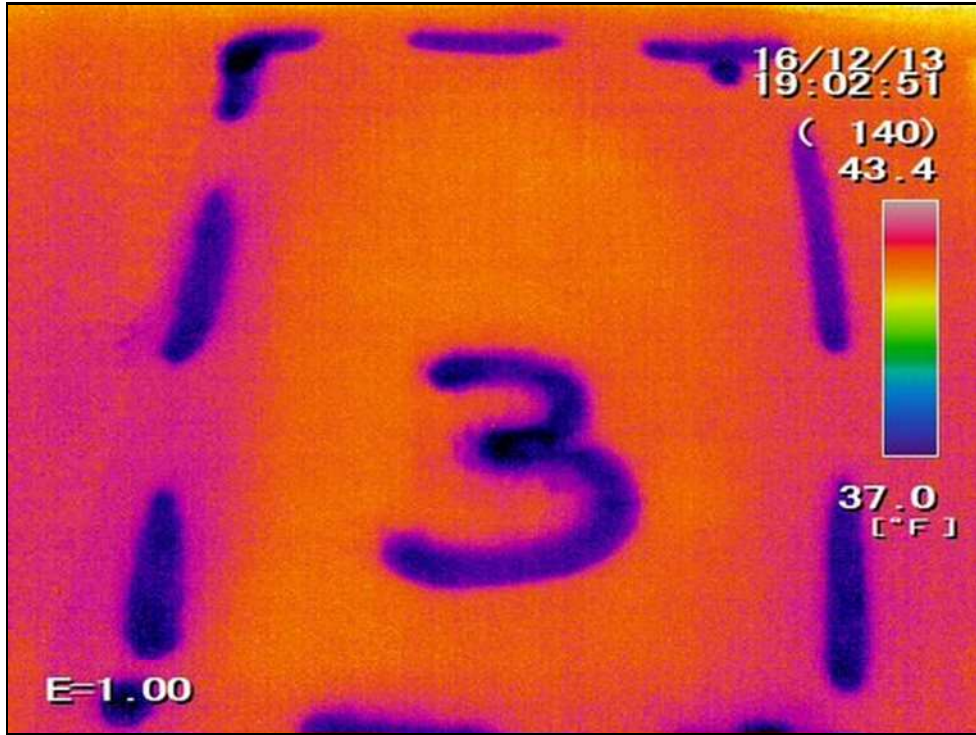
Roof G-Wet Area #3, looking West

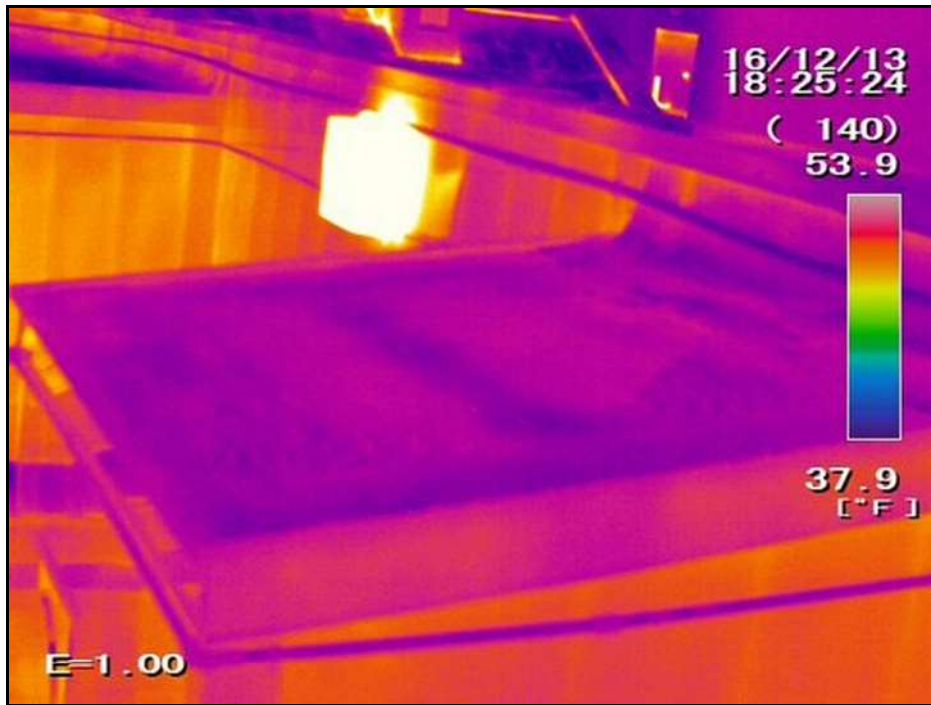
Roof H-Overview, looking East. No thermal anomalies, consistent with moisture intrusion, were noted.

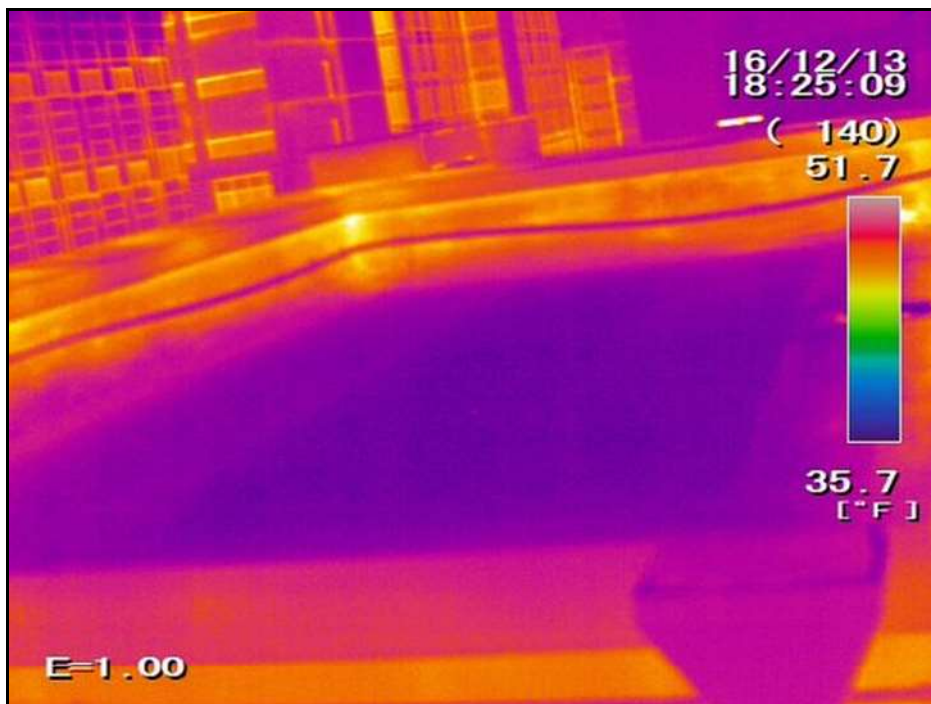
Roof I-Overview, looking West. No thermal anomalies, consistent with moisture intrusion, were noted.

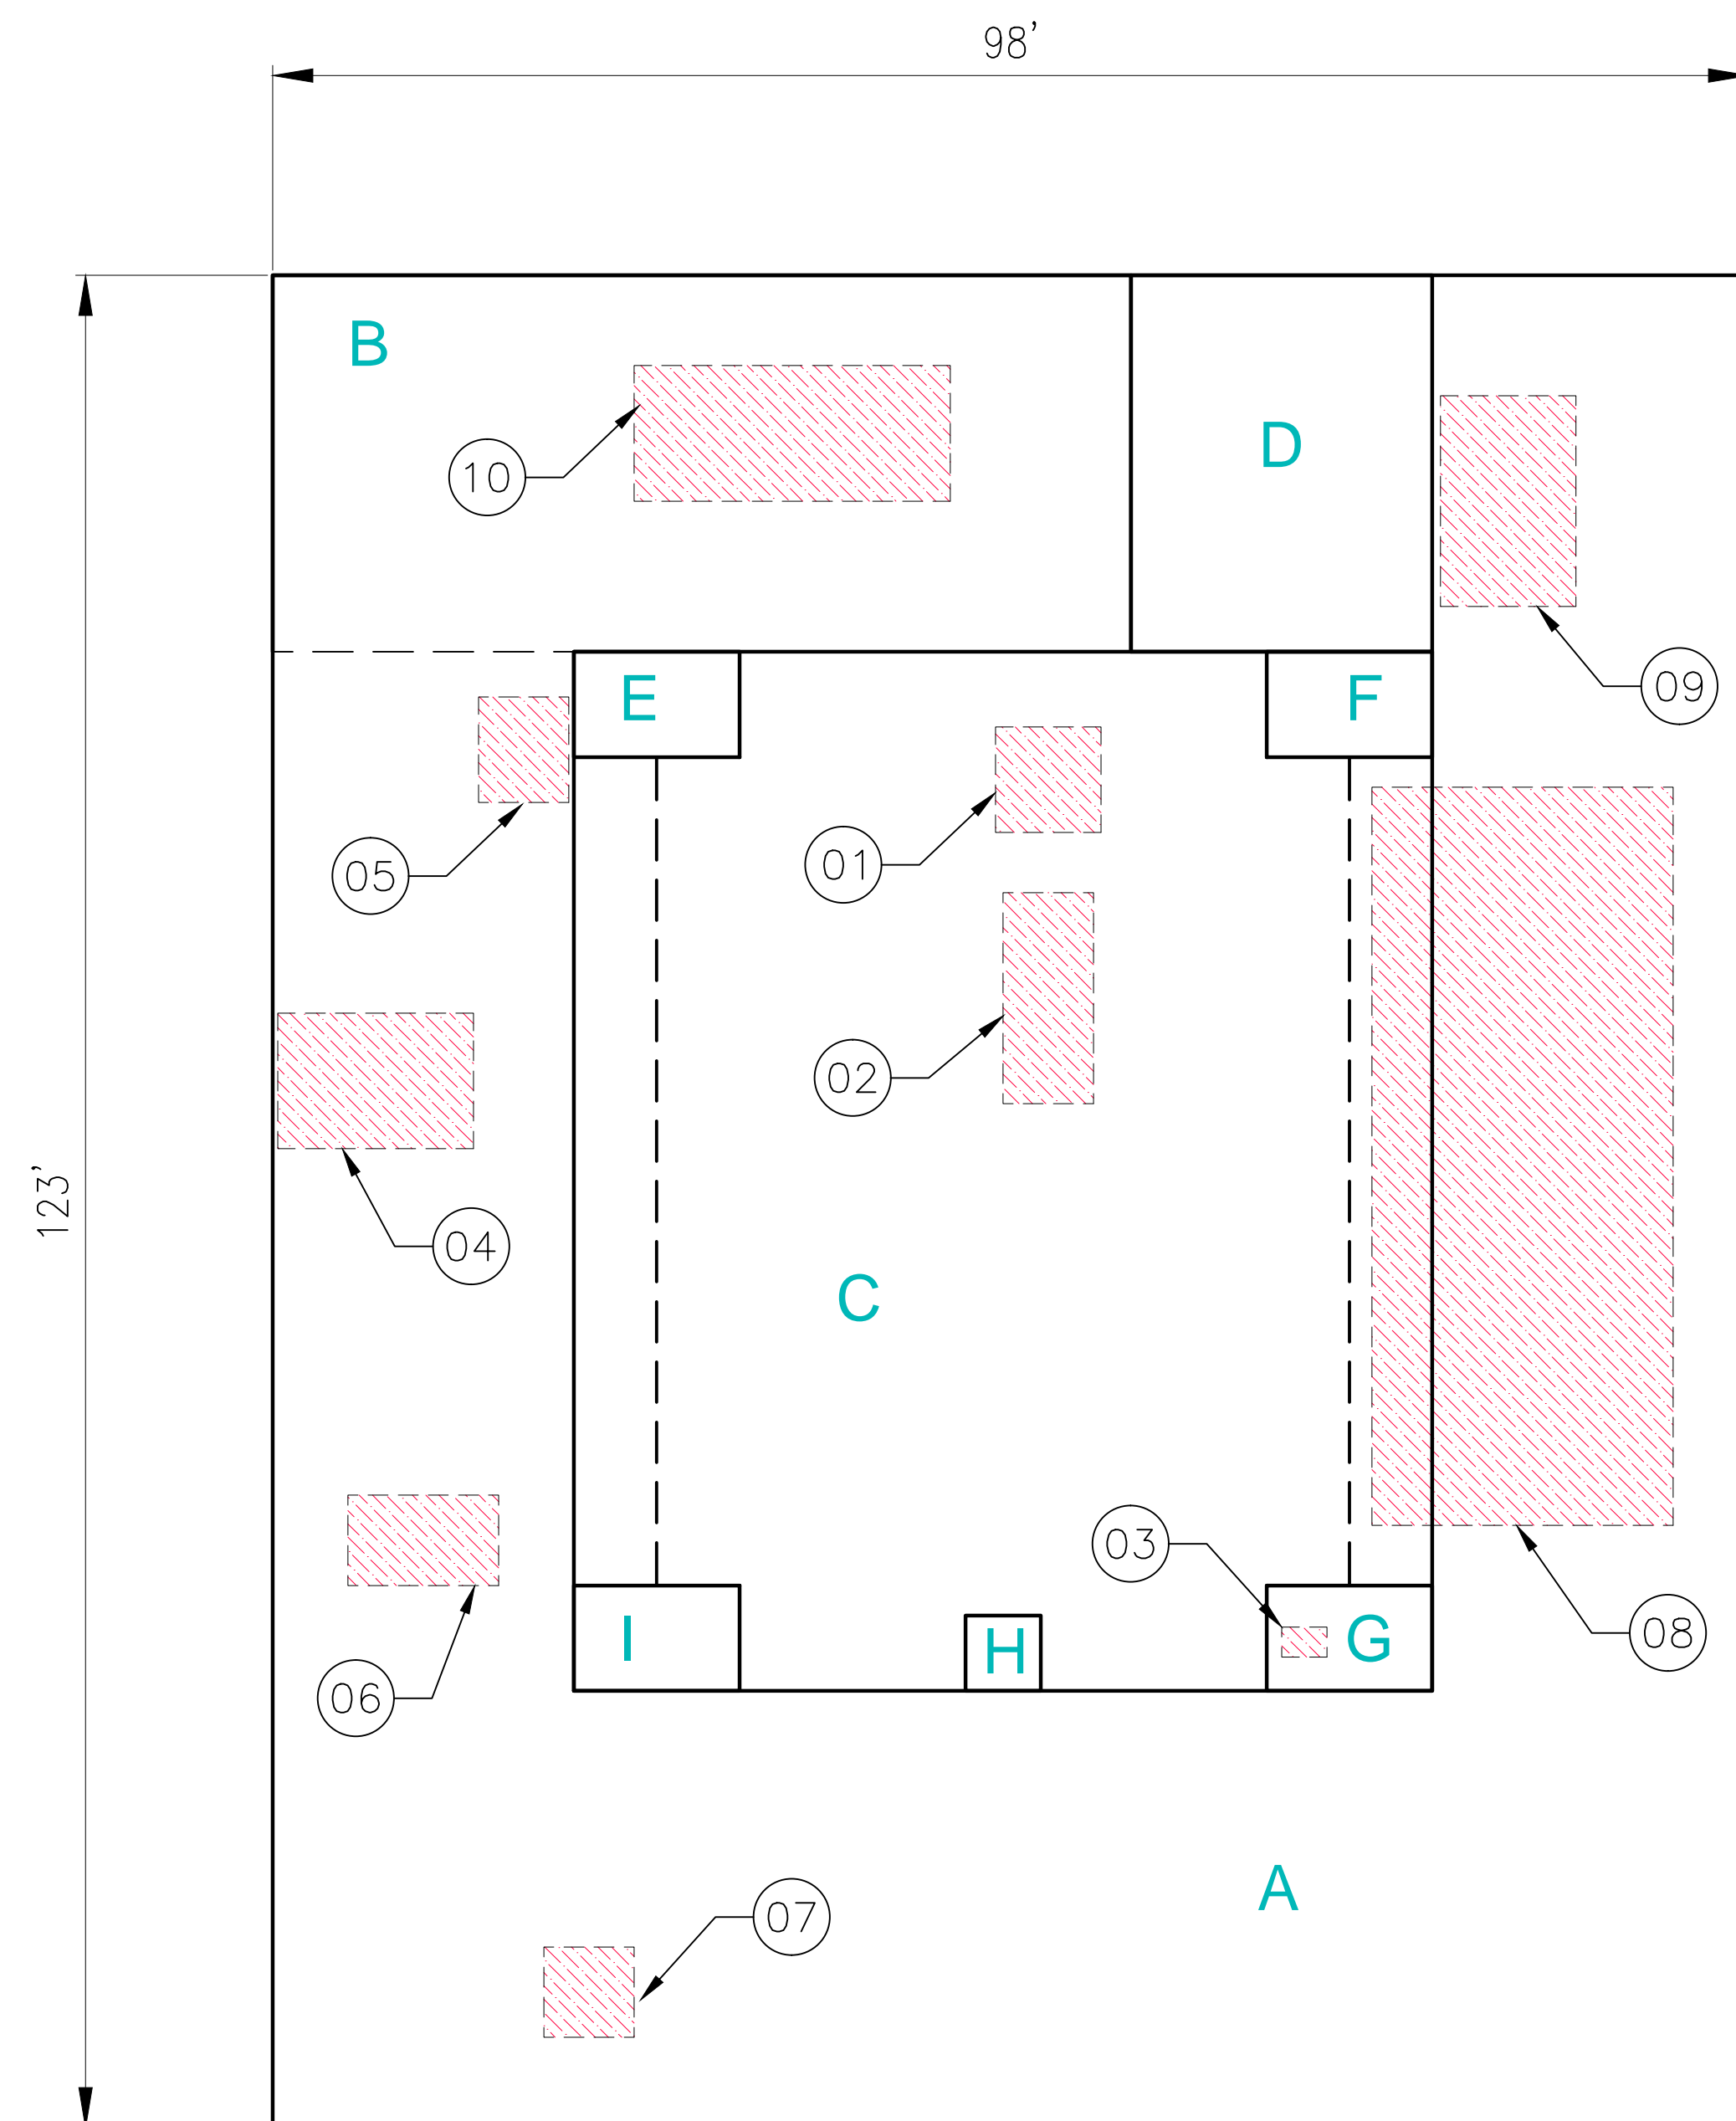
TITLE: **ROOF OVERVIEW - INFRARED SCAN**

SUSP. WET AREA = 1689 SQ FT

Area 01:	7' x 7'	= 49 SQ FT
Area 02:	6' x 14'	= 84 SQ FT
Area 03:	3' x 2'	= 6 SQ FT
Area 04:	13' x 9'	= 117 SQ FT
Area 05:	6' x 7'	= 42 SQ FT
Area 06:	10' x 6'	= 60 SQ FT
Area 07:	6' x 6'	= 36 SQ FT
Area 08:	20' x 49'	= 980 SQ FT
Area 09:	9' x 14'	= 126 SQ FT
Area 10:	21' x 9'	= 189 SQ FT
