**BUILDING CONDITION ASSESSMENT
401 WASHINGTON AVENUE
TOWSON, MD 21204**

FINAL REPORT

29 NOVEMBER 2018

ZIGER | SNEAD ARCHITECTS

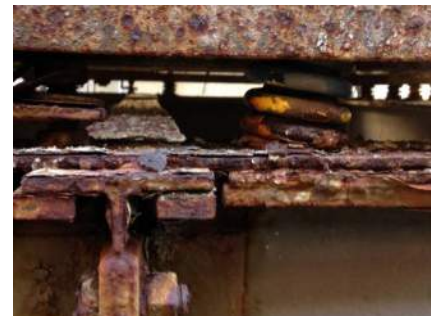
- A. The cooling tower for the building is located on the main roof and is enclosed by metal panel walls. The cooling tower is supported on steel framing elevated approximately 2 feet above the roof. It appears, at some point in time, the original cooling tower was replaced, and the steel framing was modified for support of the new tower loads by welding steel plates to the beams.
 1. The steel framing that supports the cooling tower has significant active corrosion. When steel corrodes, the rust expands to approximately 15 times its original volume. Therefore, corroded steel often looks to be in poorer condition than it actually

is. It is recommended that the steel support framing be properly cleaned, the beams reviewed for the extent of lost area, repairs made if necessary and a new durable coating provided. If the cooling towers are to be replaced, replacement of the steel framing in its entirety should be considered.

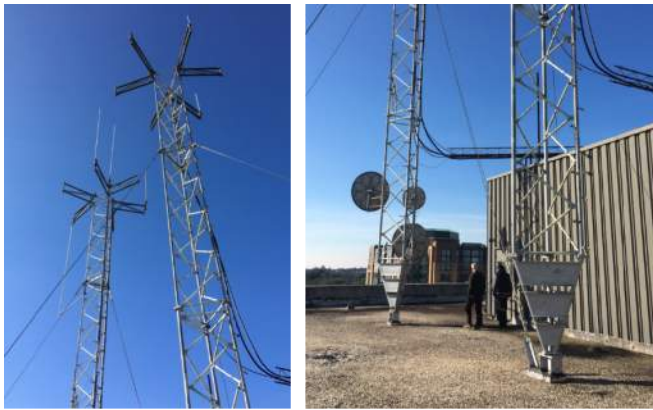
- A. There are two antenna towers located on the roof. Per the Building Manager, they were installed by a previous tenant and are no longer in use. There is no documentation as to how these towers are anchored to the roof structure, although the tower bases appear to correspond with interior structural column locations. If the towers are no longer in use, removal of the towers should be considered.

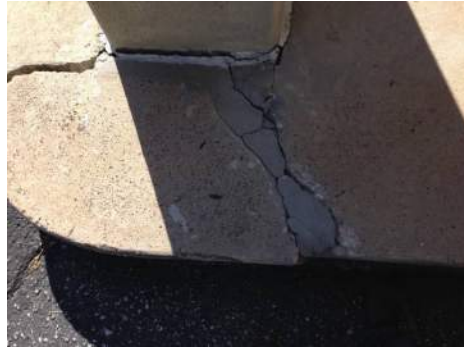
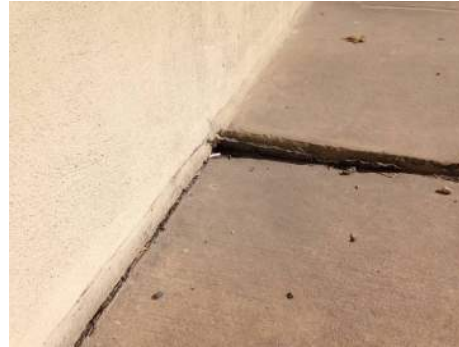
- B. Some of the site concrete on the south and east sides of the building has cracked and settled.

1. The cracked and settled concrete should be removed and replaced to avoid further deterioration and possible tripping hazards.

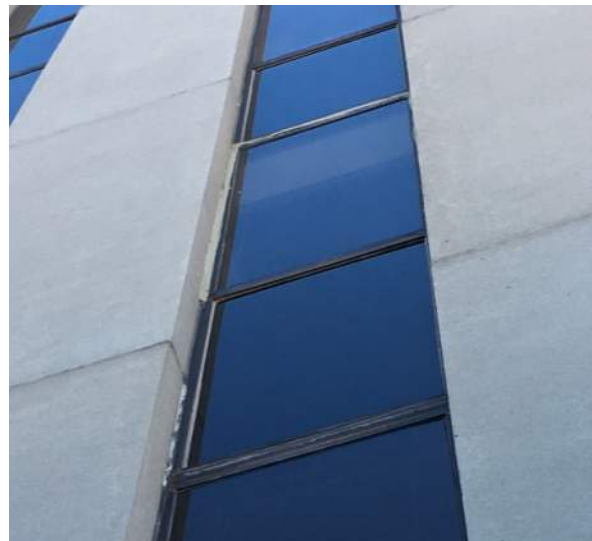
There is visual evidence of ad-hoc repairs to sealant joints around the building, but no sign of a comprehensive sealant replacement effort.

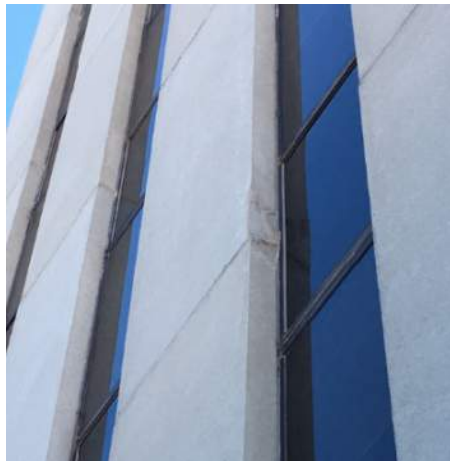
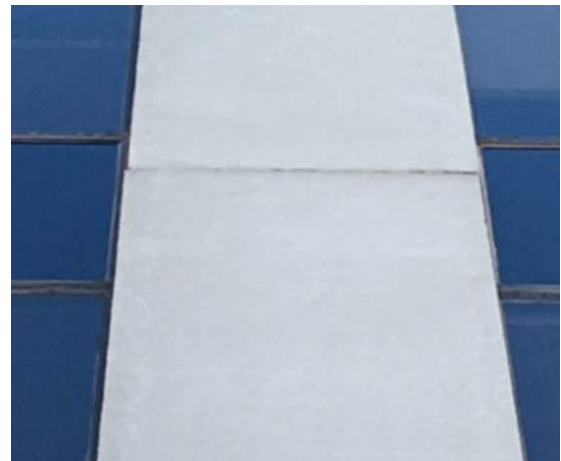
- 1. The wall panels, generally, appear to be in good condition, given their age. There is some visual evidence of patching and repairs to some panels, and inconsistent alignment in some locations. It is not clear if the misalignments are due to active movement or issues with the initial installation.

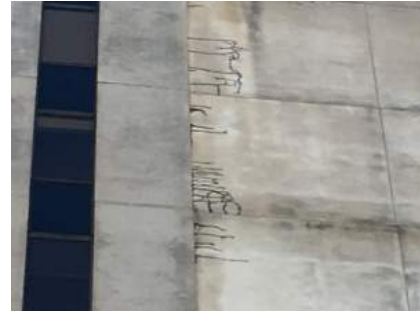
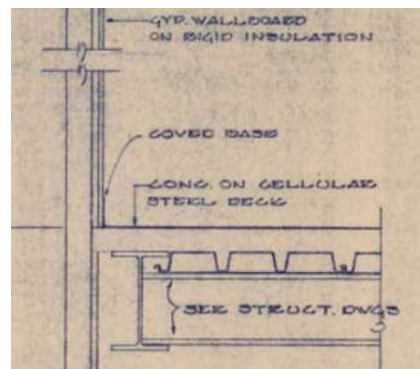
2. Repairs can be seen at the north façade, indicating some of the panels apparently have had crack issues in the past. It is recommended that a closer review of the north side panels be performed to verify if additional cracks and spalls are developing due to the northern exposure.
3. Near the top of the north façade, there are several locations where rust stains can be seen on the concrete. The stains appear to be a result of corrosion of the panel reinforcement. These areas should be repaired to prevent further deterioration.
4. Per the original 1969 drawings there is a 2" layer of rigid insulation and drywall finish attached to the interior face of the precast wall panels. This has not been visually confirmed. There is currently no air/water barrier in the wall assembly.

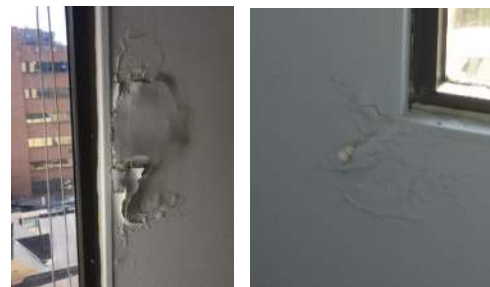
3. The jambs of the window system are anchored to the back of the precast wall panels and sealed with a continuous sealant joint. Some windows were observed to have water damage on the interior that are possibly the result of failed sealant joints.

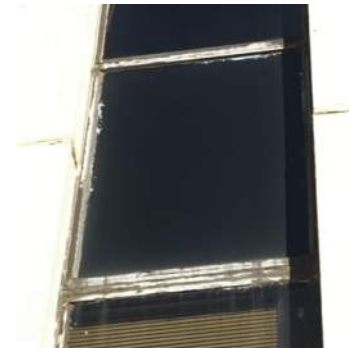
4. Heads and sills are stacked, ganged, and sealed. Some windows showed evidence of sealant having been added, presumably to address water or air infiltration issues.

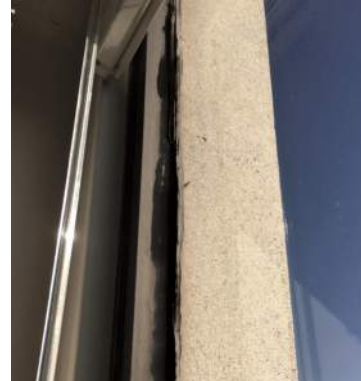
5. Some windows were observed to have failing interior wet seals at the perimeter of the glass. In some cases, attempts had been made (with varying degrees of quality and success) to repair the joints with new sealant.

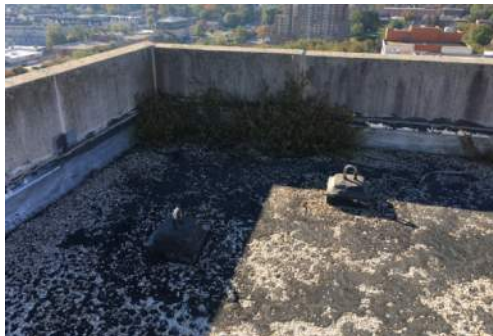
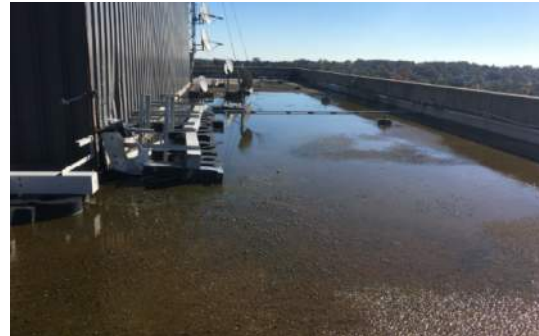
1. The main tower roof is a built-up roof (BUR) with gravel surfacing. Its age and maintenance/replacement history is unknown. It is, however, in very poor condition due in large part to inadequate slope and drainage, leading to significant ponding over the southwest quadrant of the roof. Warranty status is unknown.

2. There appear to only be three roof drains, located near the center of the roof, to serve the entire roof area. There are two small overflow scuppers through the parapet at the northeast and northwest corners to serve the entire roof area. The size and quantity are insufficient for a roof of this size. There is no visual evidence of positive slope to any of the roof drains.

6. Recommendations: The existing main roof has clearly exceeded its service life, and the drainage deficiencies must be addressed. **Replacement of the existing main roof is a likely short-term need for this building.** Some concerns to be considered:

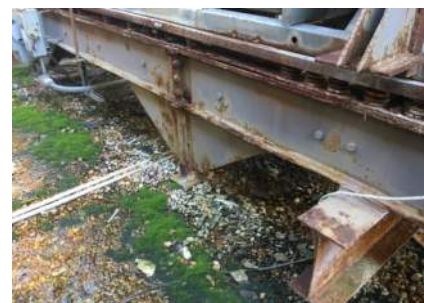
- a. The ponding water on the roof may, in part, have its source in an ongoing leak at the cooling tower. There is a significant amount of organic material and moss growing on the roof in the

vicinity of the cooling tower, suggesting that this has been an ongoing condition.

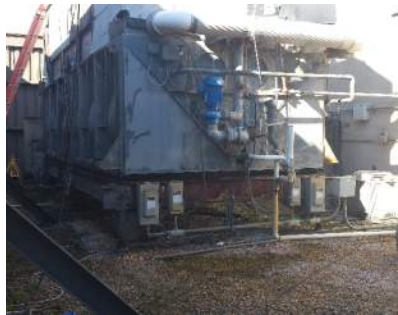
Figure M1: The existing Cooling Tower

while the condenser water pumps appear to be in adequate condition, we believe that they have exceeded the ASHRAE recommended service life.

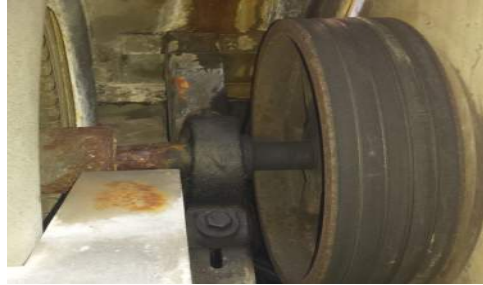
Figure M2: Corroding Fan Drive Shaft

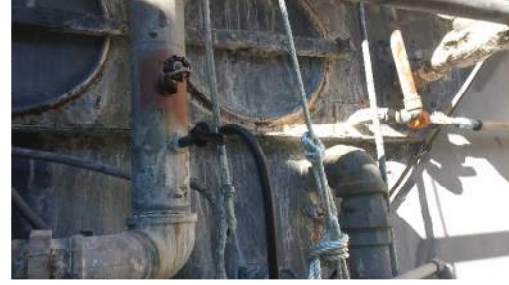
Figure M3: Evidence of Past Leaks

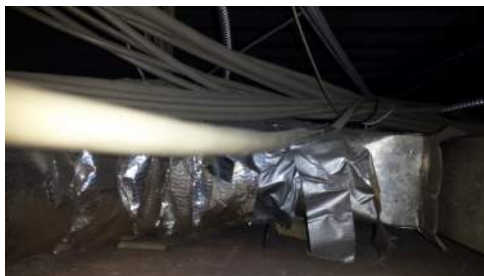
Figure M7: Poorly sealed ductwork

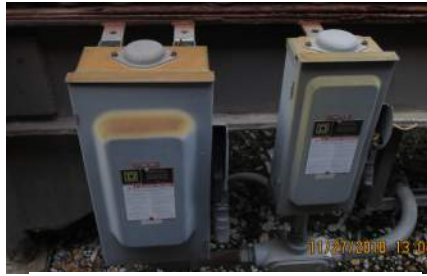
The disconnect switches for cooling tower on roof are rusty (see Figure E10). The disconnect switches for elevators in elevator room are in good condition. The existing disconnect switches for existing air handling units and existing duct heater in mechanical rooms on each floors are in good condition (see Figure E11).

Figure E10: Disconnect Switches of Roof
