23-382 SOM Allied Health Hydraulic Passenger Elev - 5-Story - Cab 1 & Cab 2

Site Visit Type	Scope Development Walk	Site Visit Date	12.06.2023
------------------------	------------------------	------------------------	------------

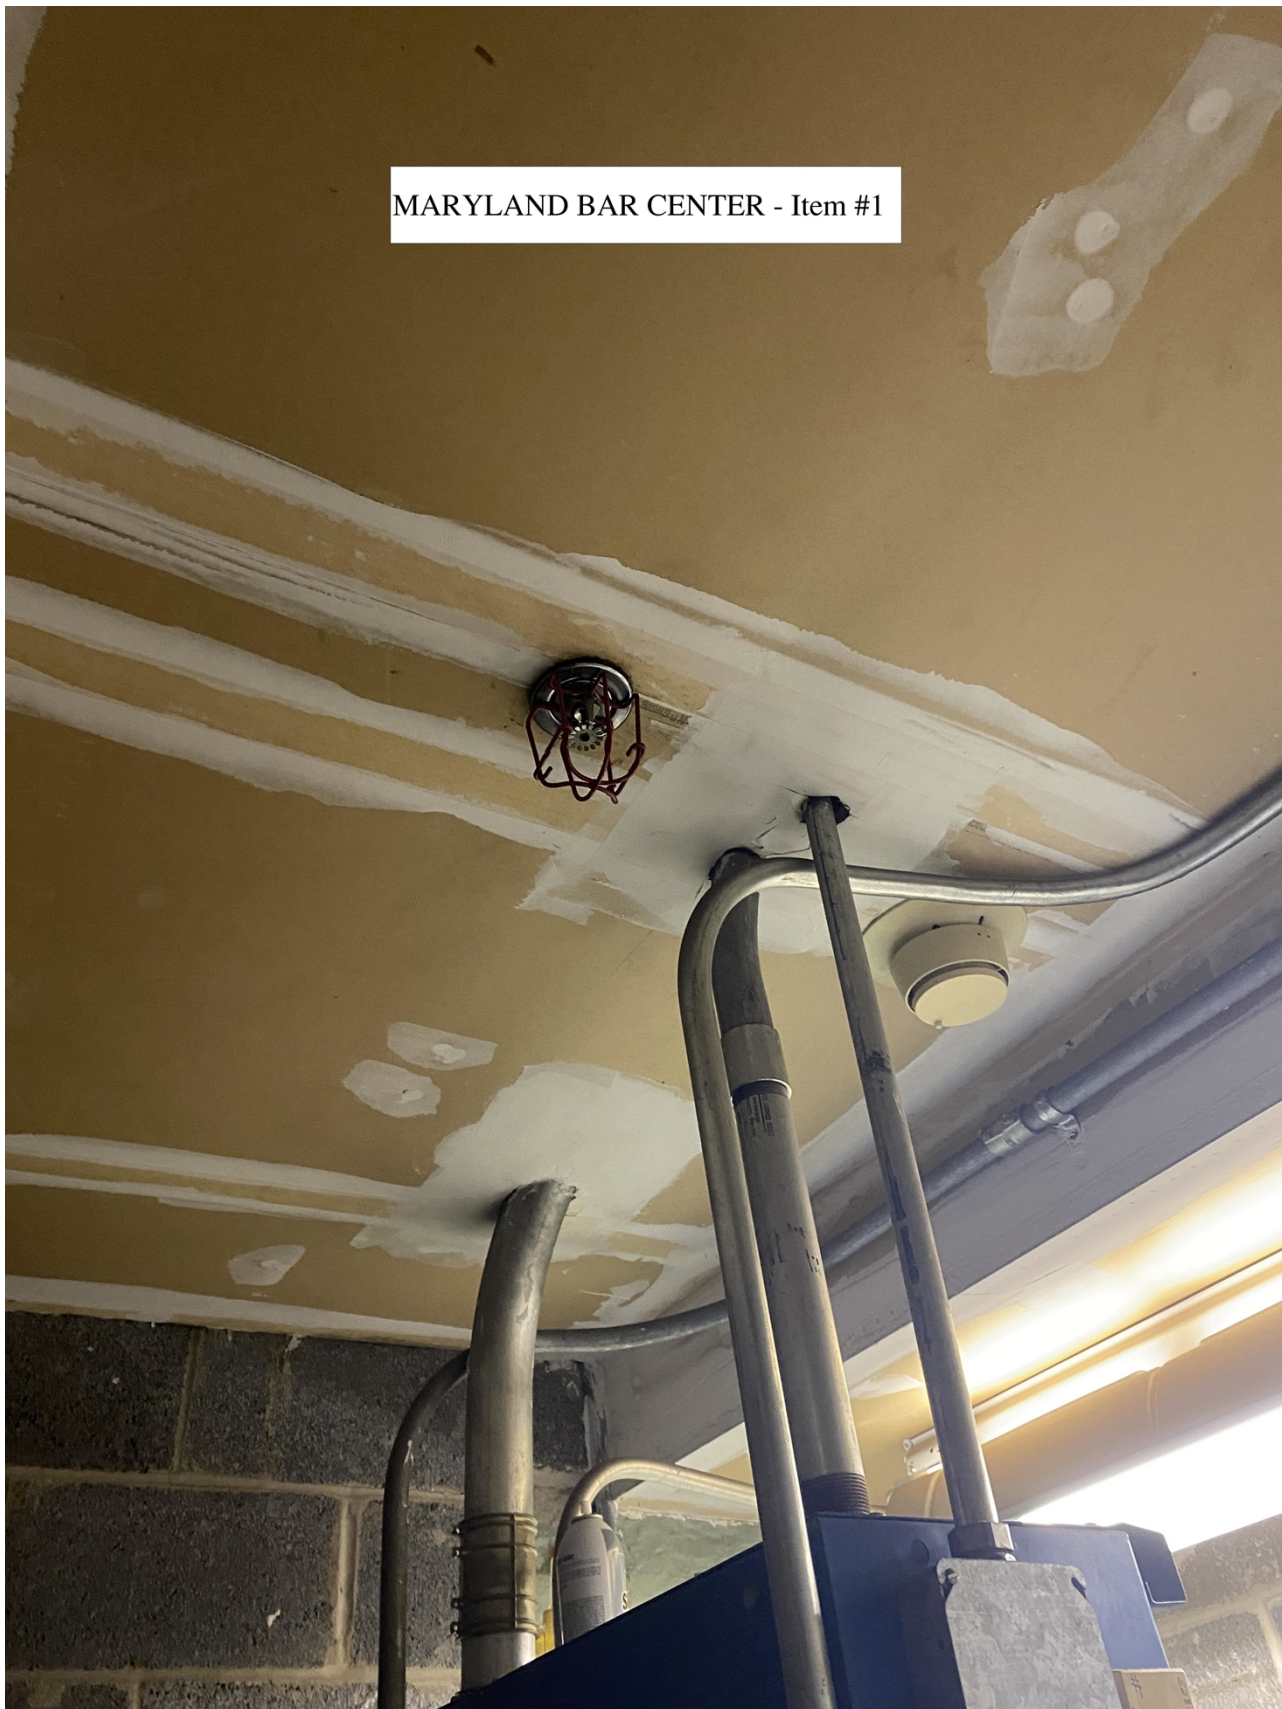
MARYLAND BAR CENTER - Item #1

TYPICAL - UNSEALED PENETRATION

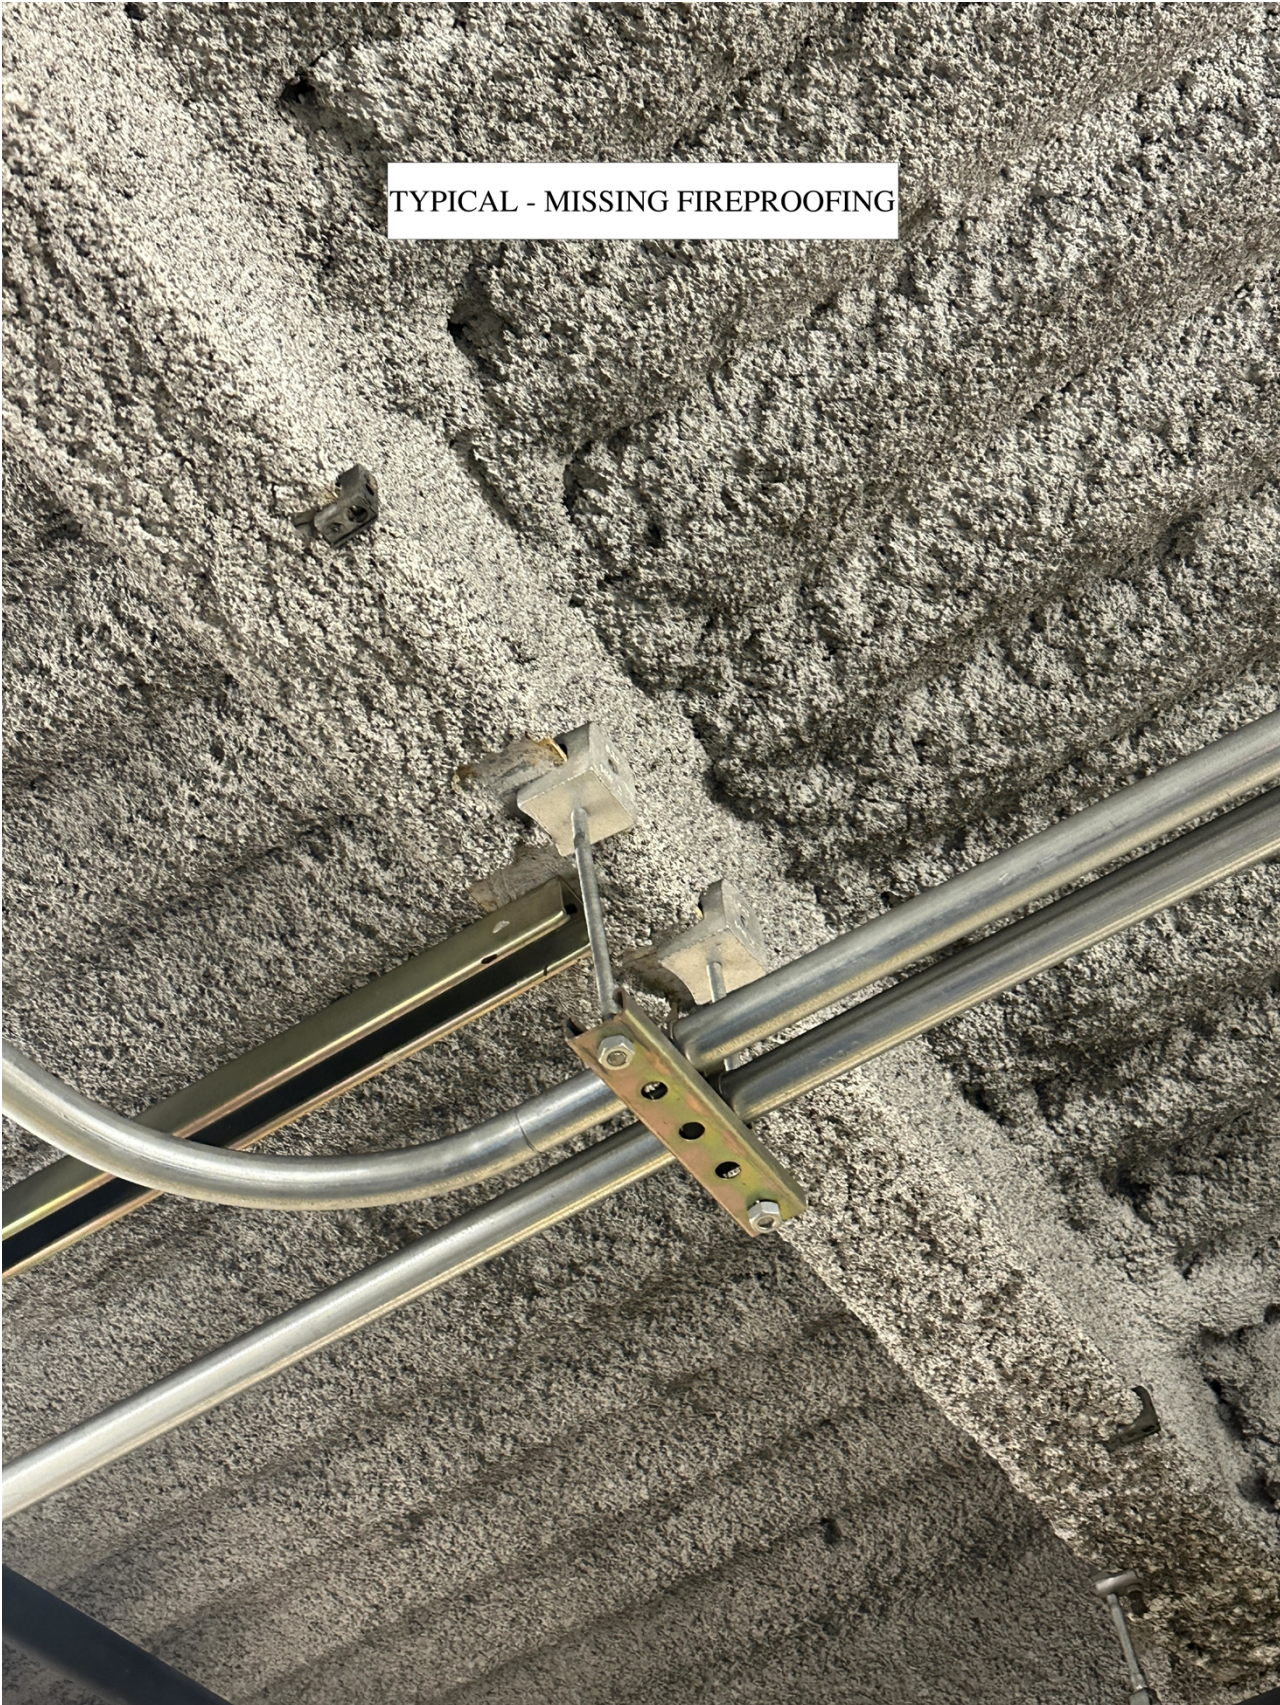
TYPICAL - NO FIRE DAMPERS
