**23-382 SOM Allied Health Hydraulic Passenger Elev -  
5-Story - Cab 1 & Cab 2**

<b>Site Visit Type</b>	Scope Development Walk	<b>Site Visit Date</b>	12.06.2023
------------------------	------------------------	------------------------	------------

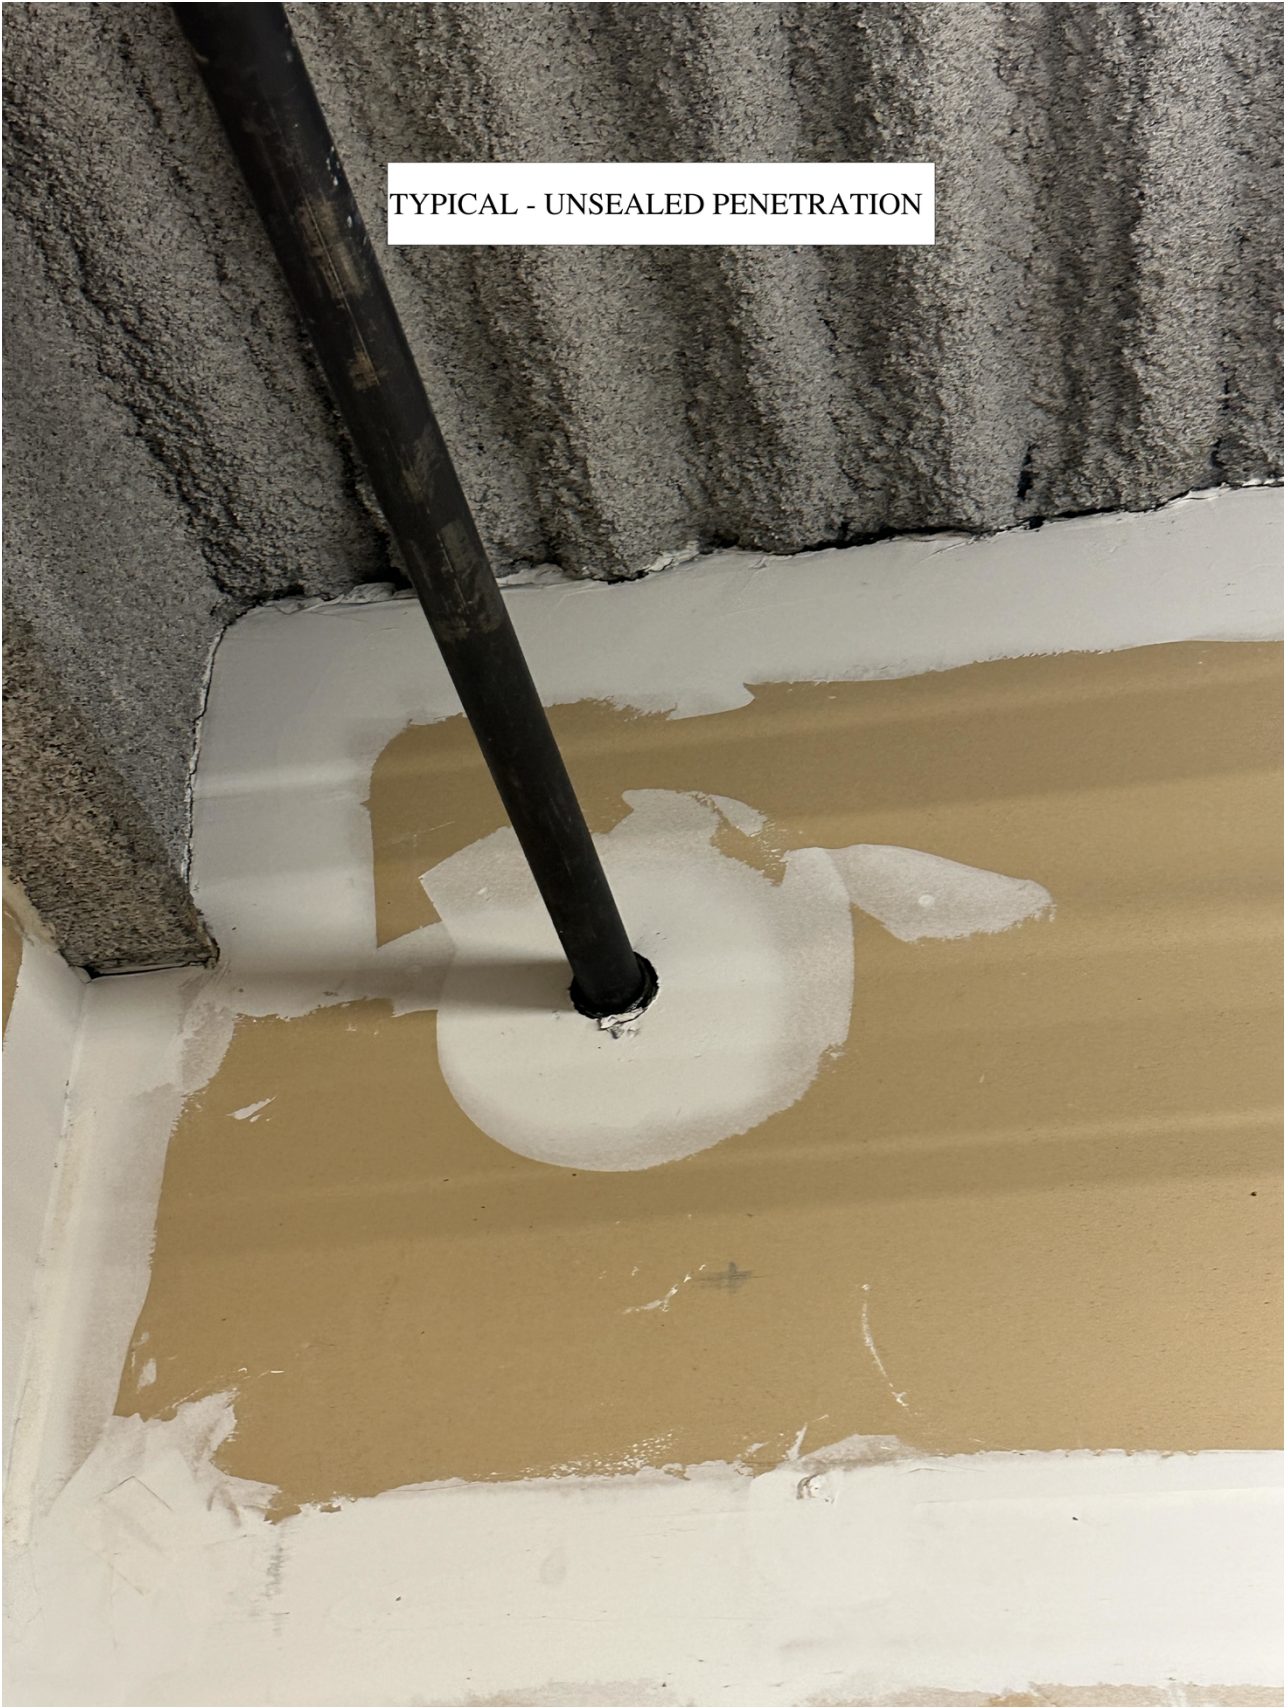
TYPICAL - UNSEALED PENETRATION

- All penetrations through fire-rated Elevator Machine Room walls are not firestopped. Provide firestopping at all existing unsealed penetrations as required by NFPA 1 Section 12.3.3.1.
- Fireproofing on existing structural members is damaged and/or missing. Repair damaged and missing fireproofing as required by NFPA 1 Section 12.3.3.1.
- Duct penetrations are not fire/smoke tight and do not appear to have fire dampers. Confirm if required based on HVAC configuration and provide fire dampers as required by NFPA 90A Section 5.3.1 and repair duct penetrations.

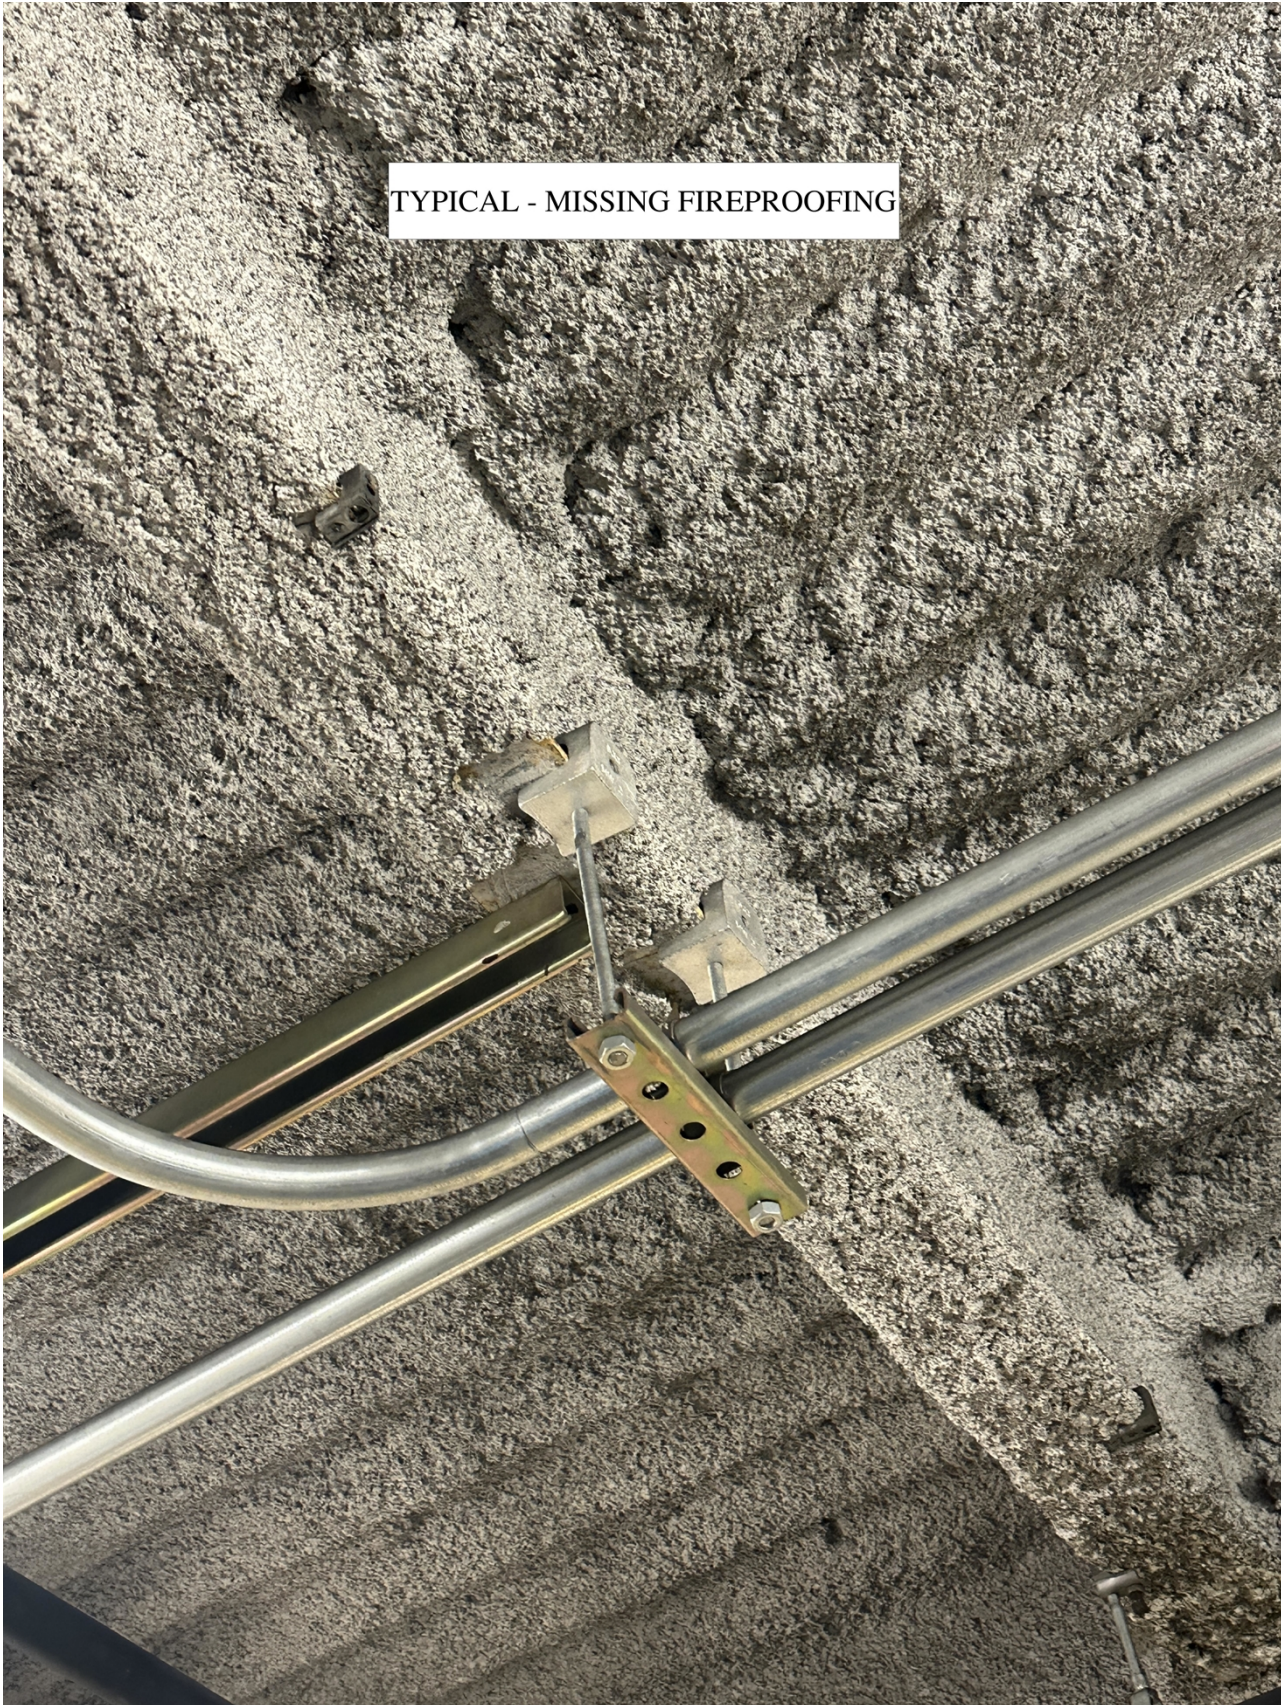
TYPICAL - MISSING FIREPROOFING

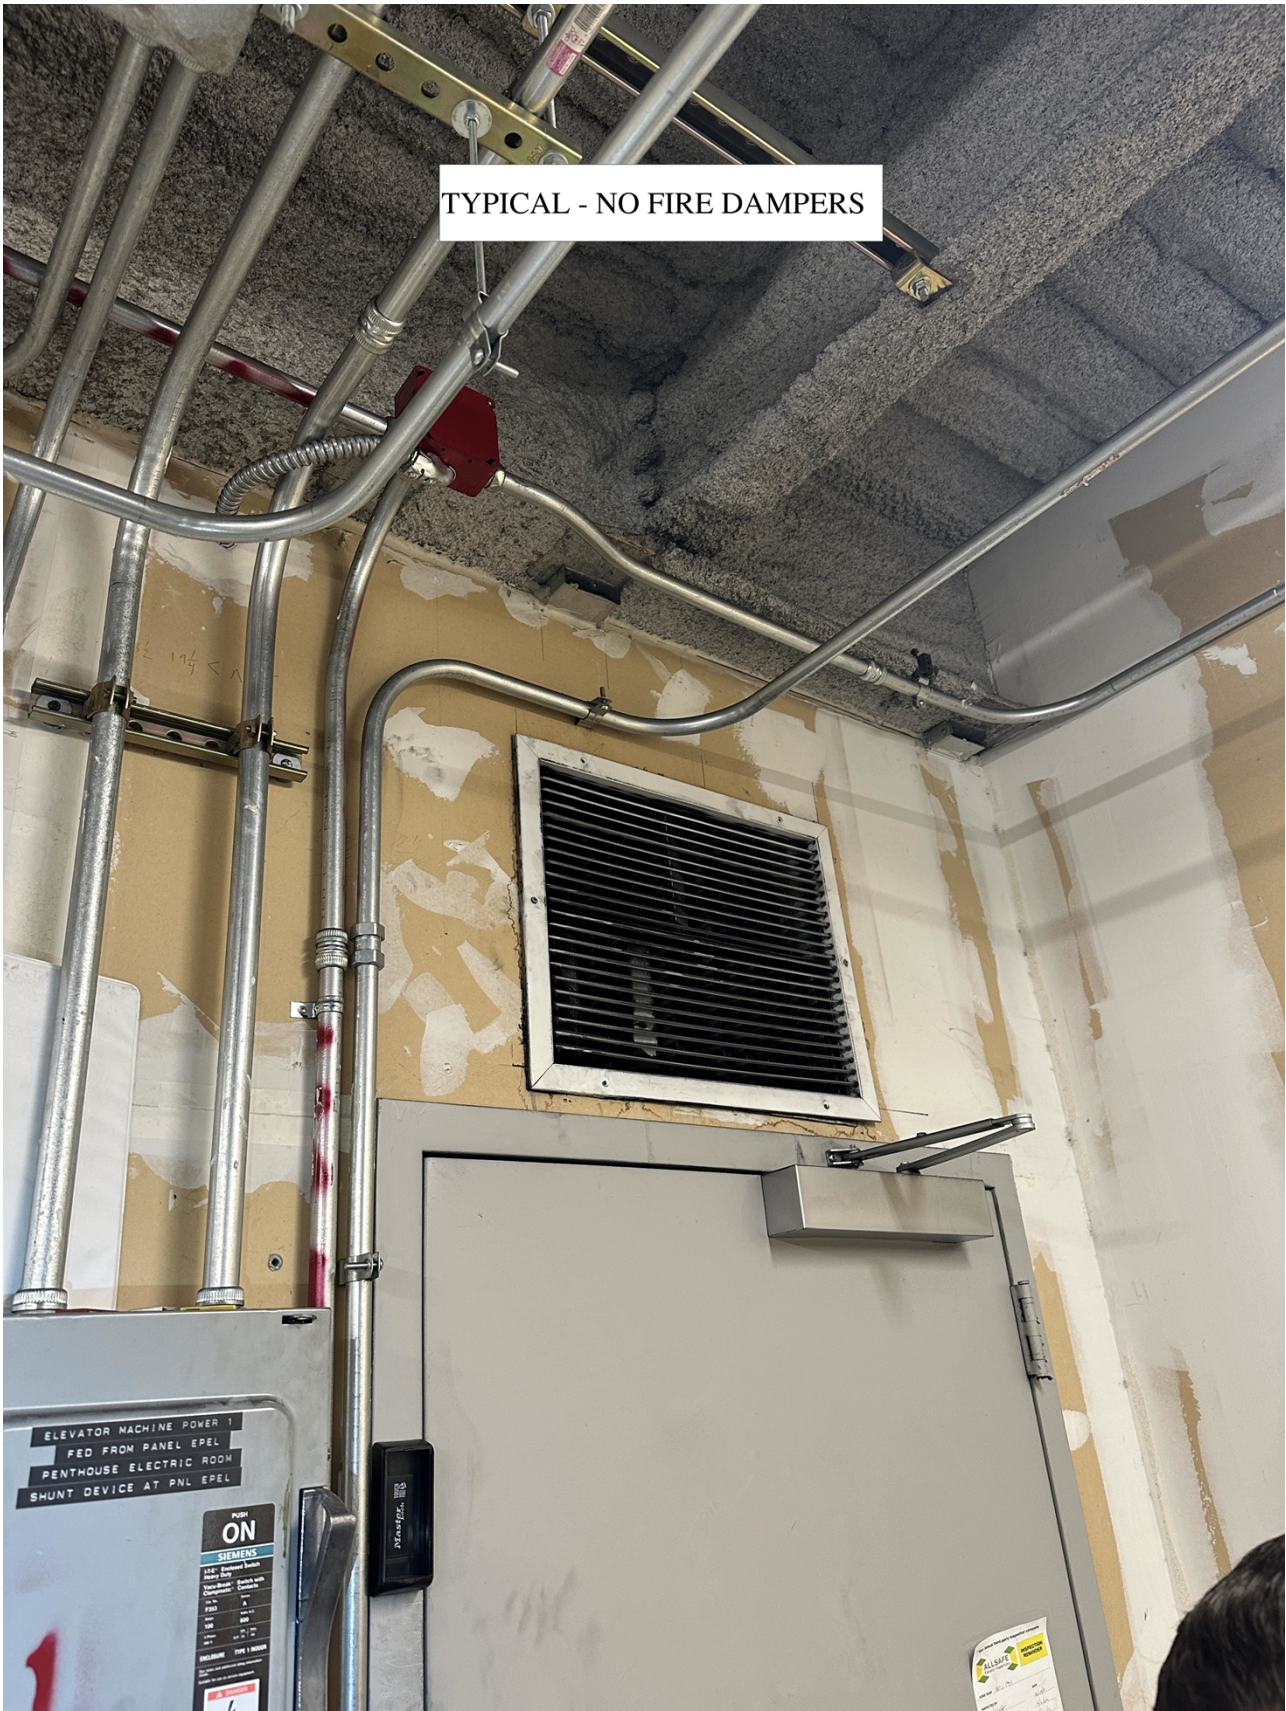
TYPICAL - NO FIRE DAMPERS

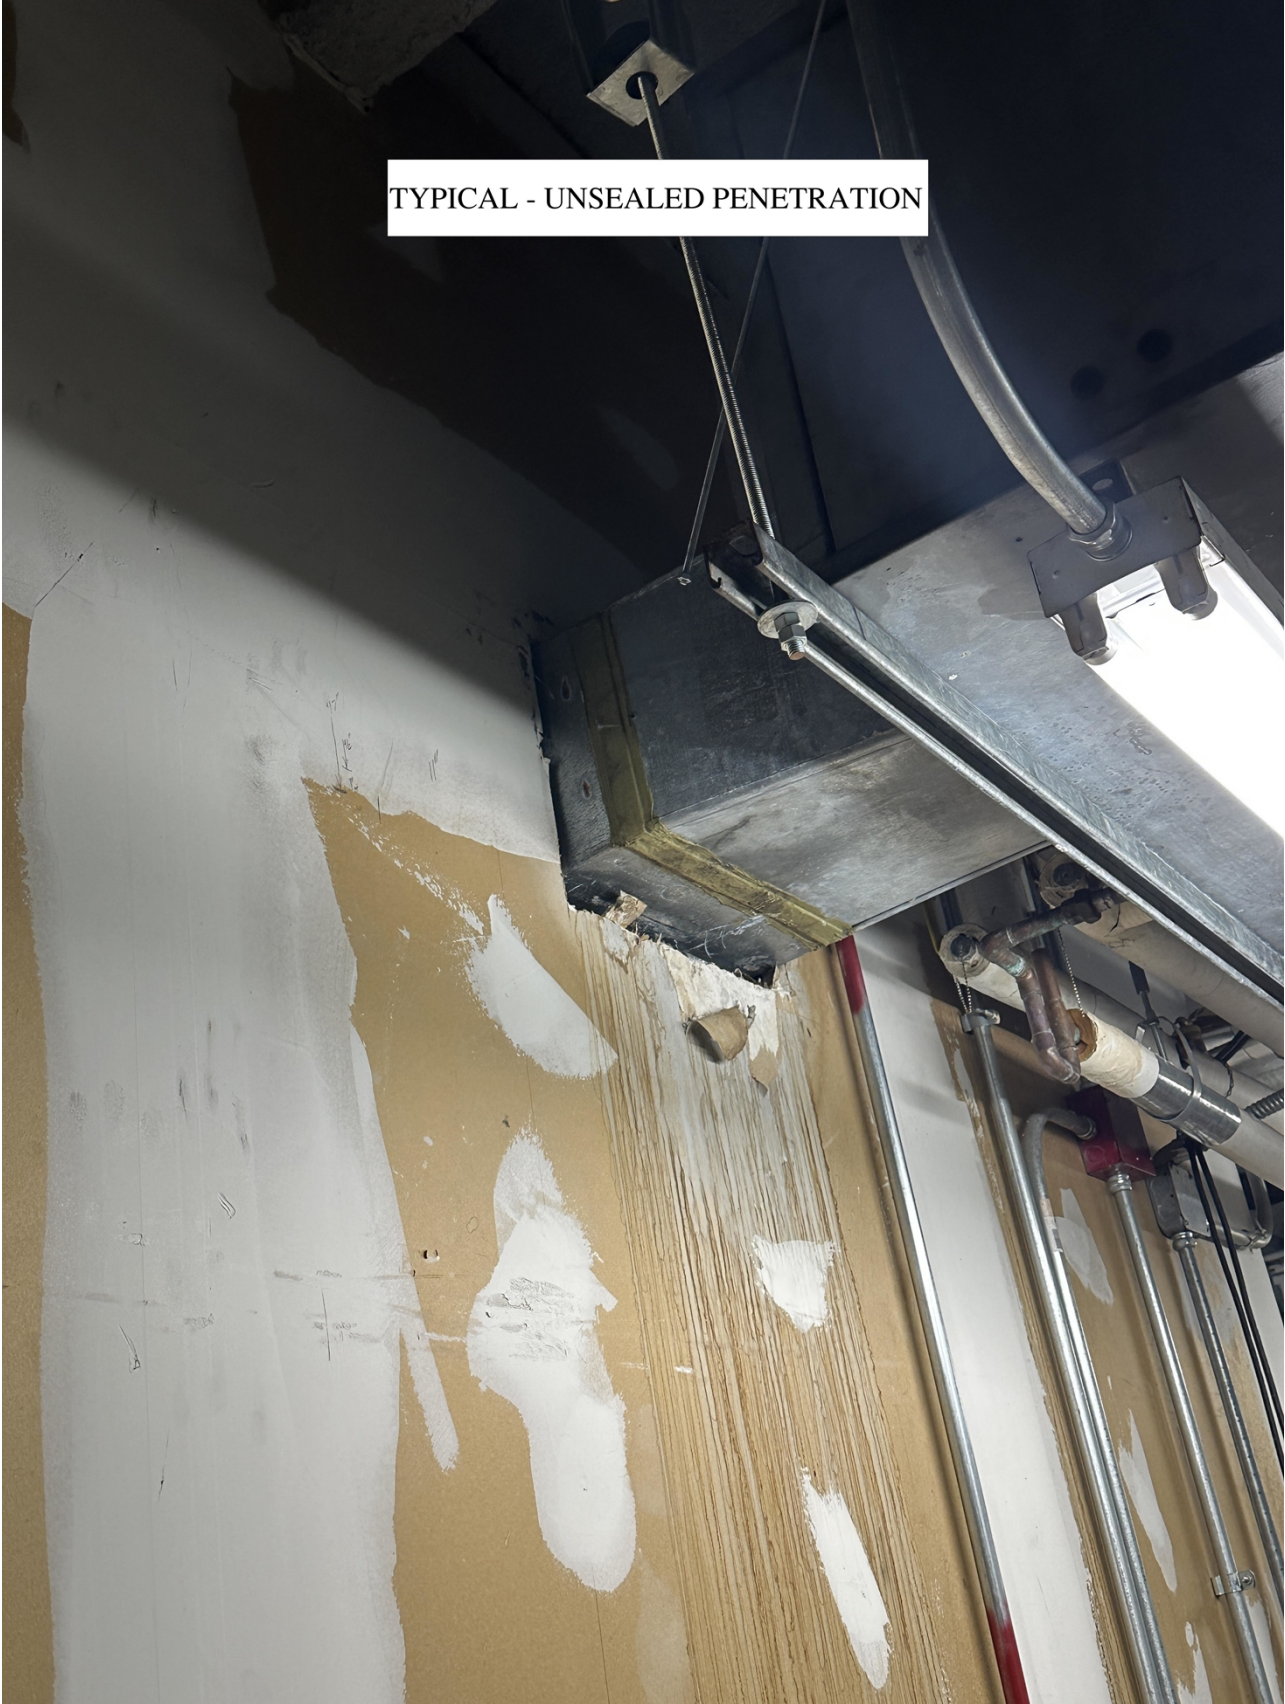
TYPICAL - UNSEALED PENETRATION
