**23-382 SOM Allied Health Hydraulic Passenger Elev -  
5-Story - Cab 1 & Cab 2****Site Visit Type** Scope Development Walk**Site Visit Date** 12.06.2023**Participants**

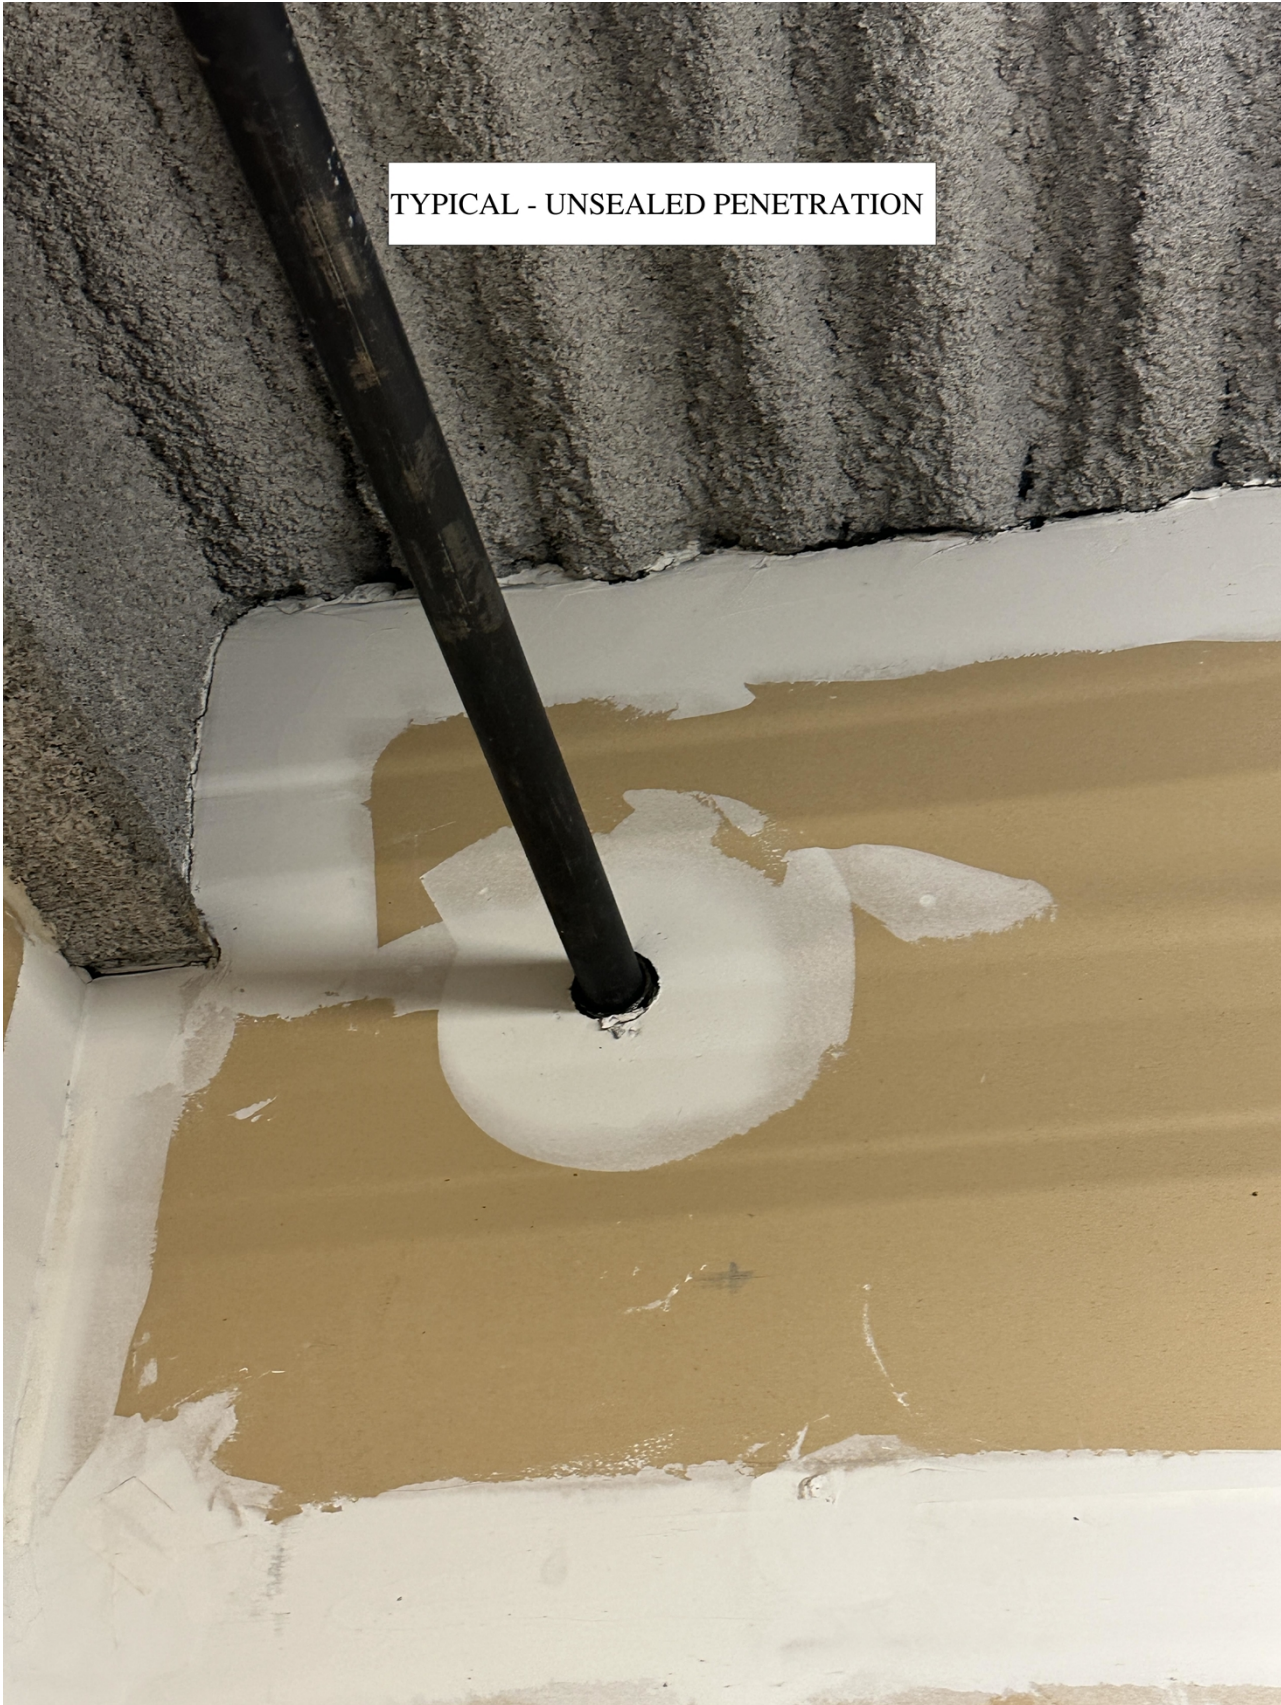
TYPICAL - UNSEALED PENETRATION

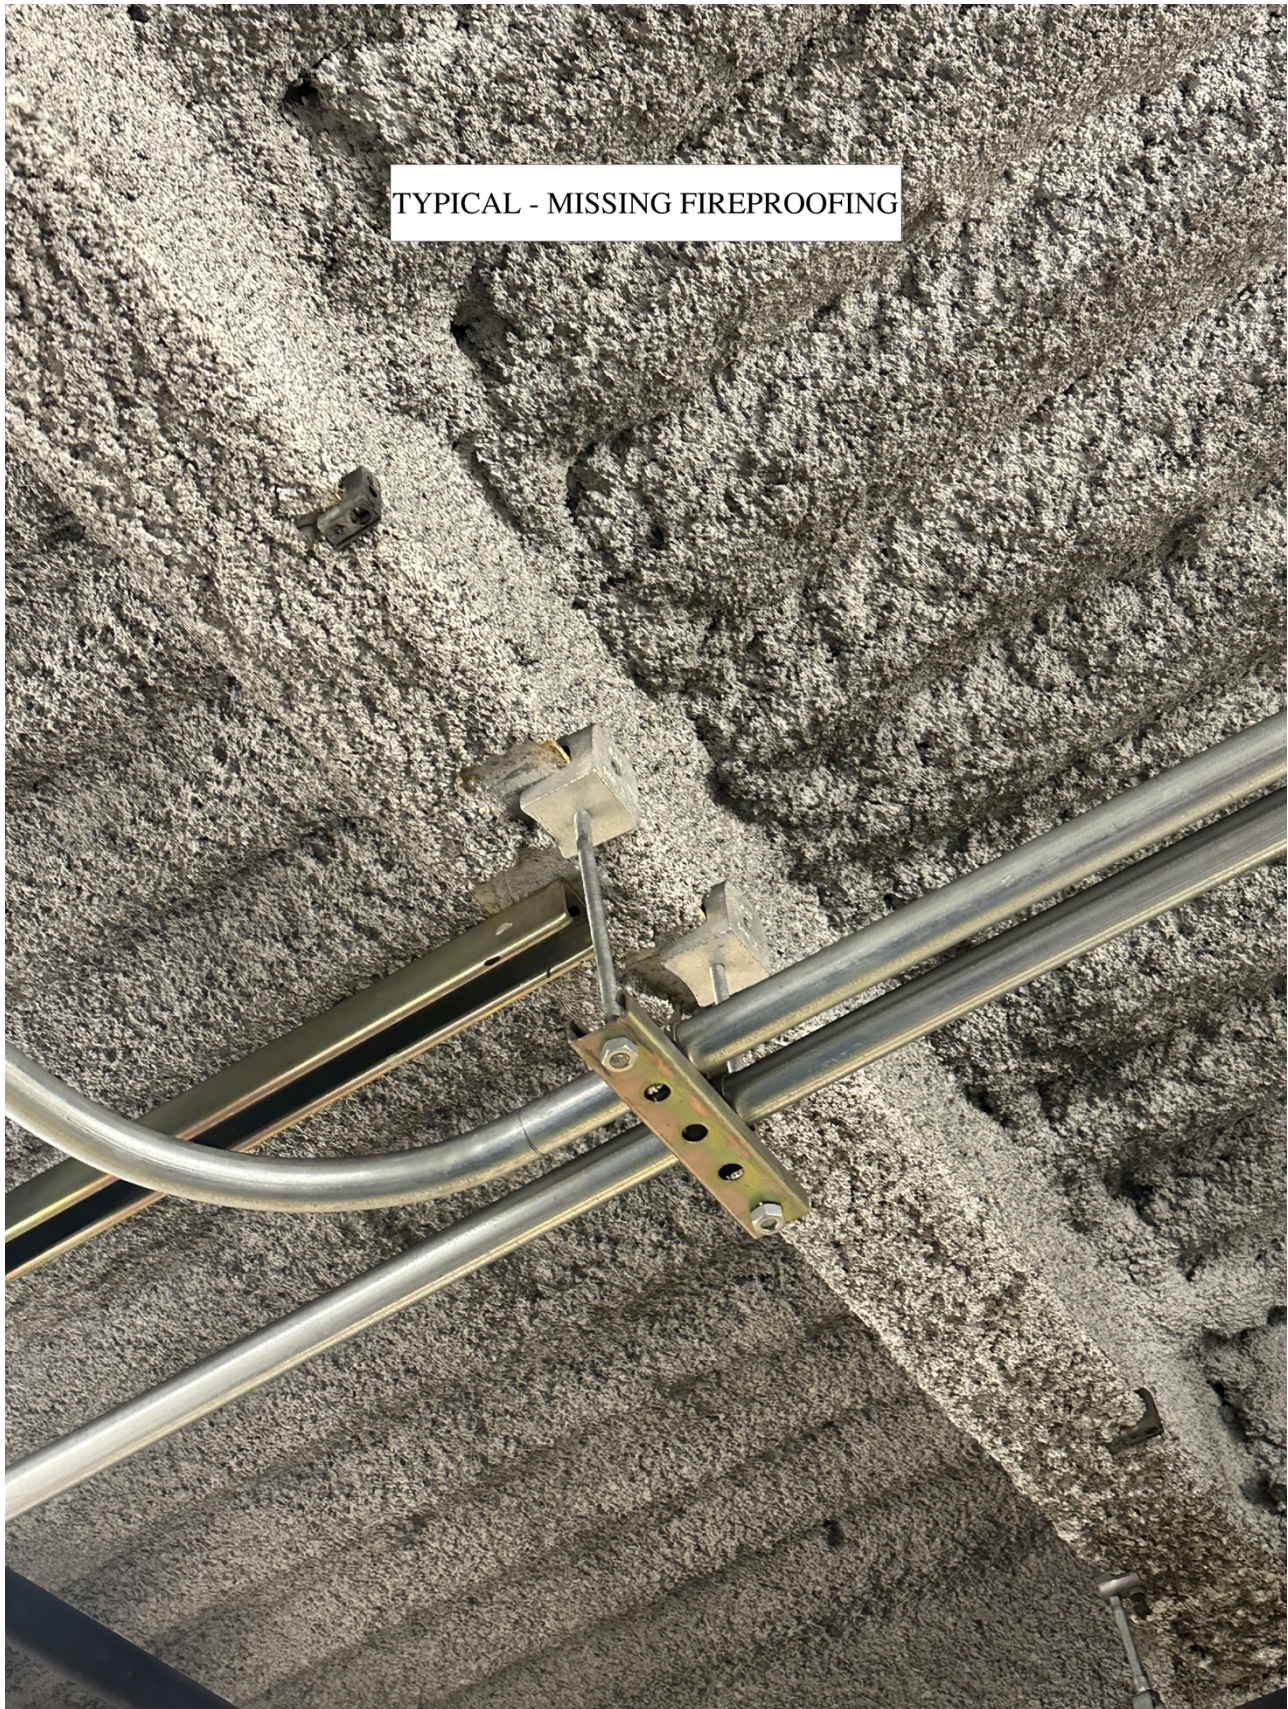
TYPICAL - MISSING FIREPROOFING

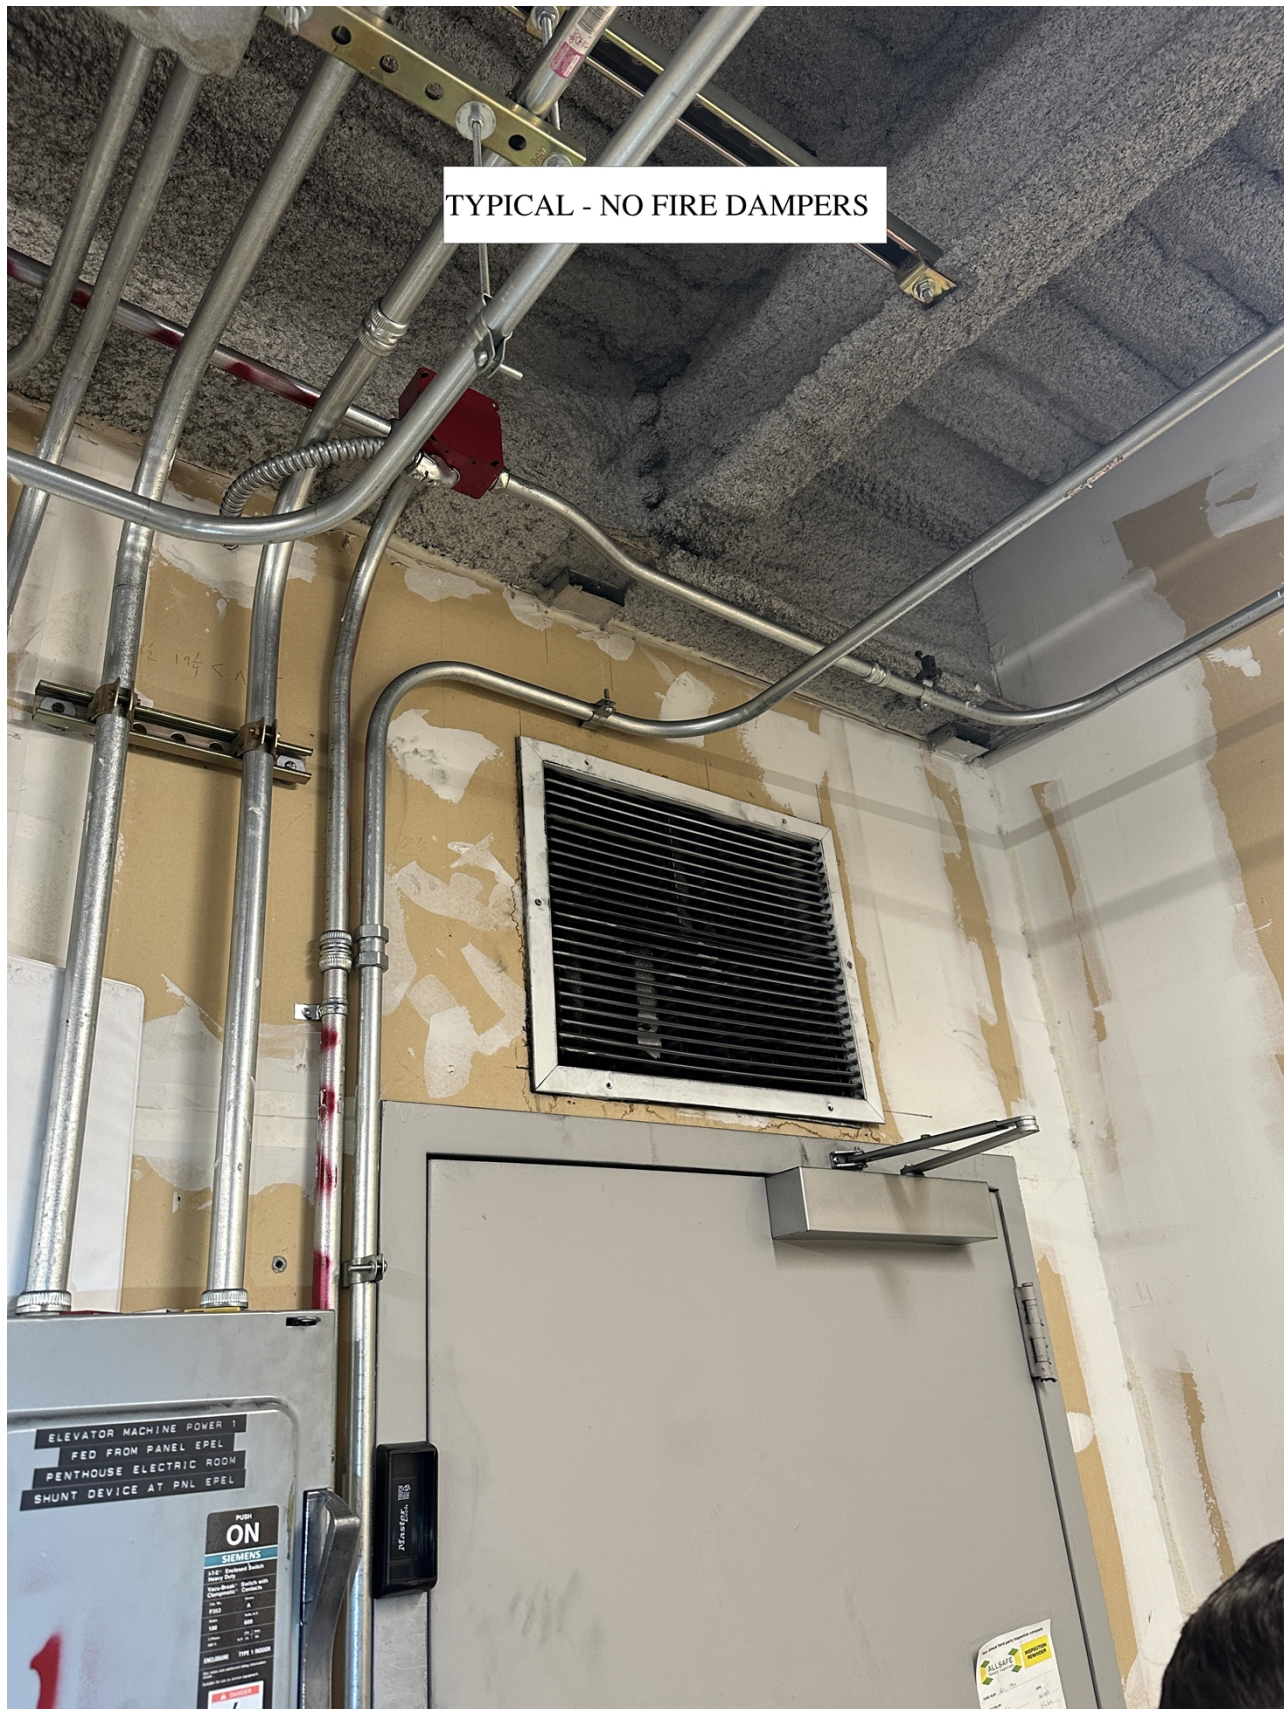
TYPICAL - NO FIRE DAMPERS

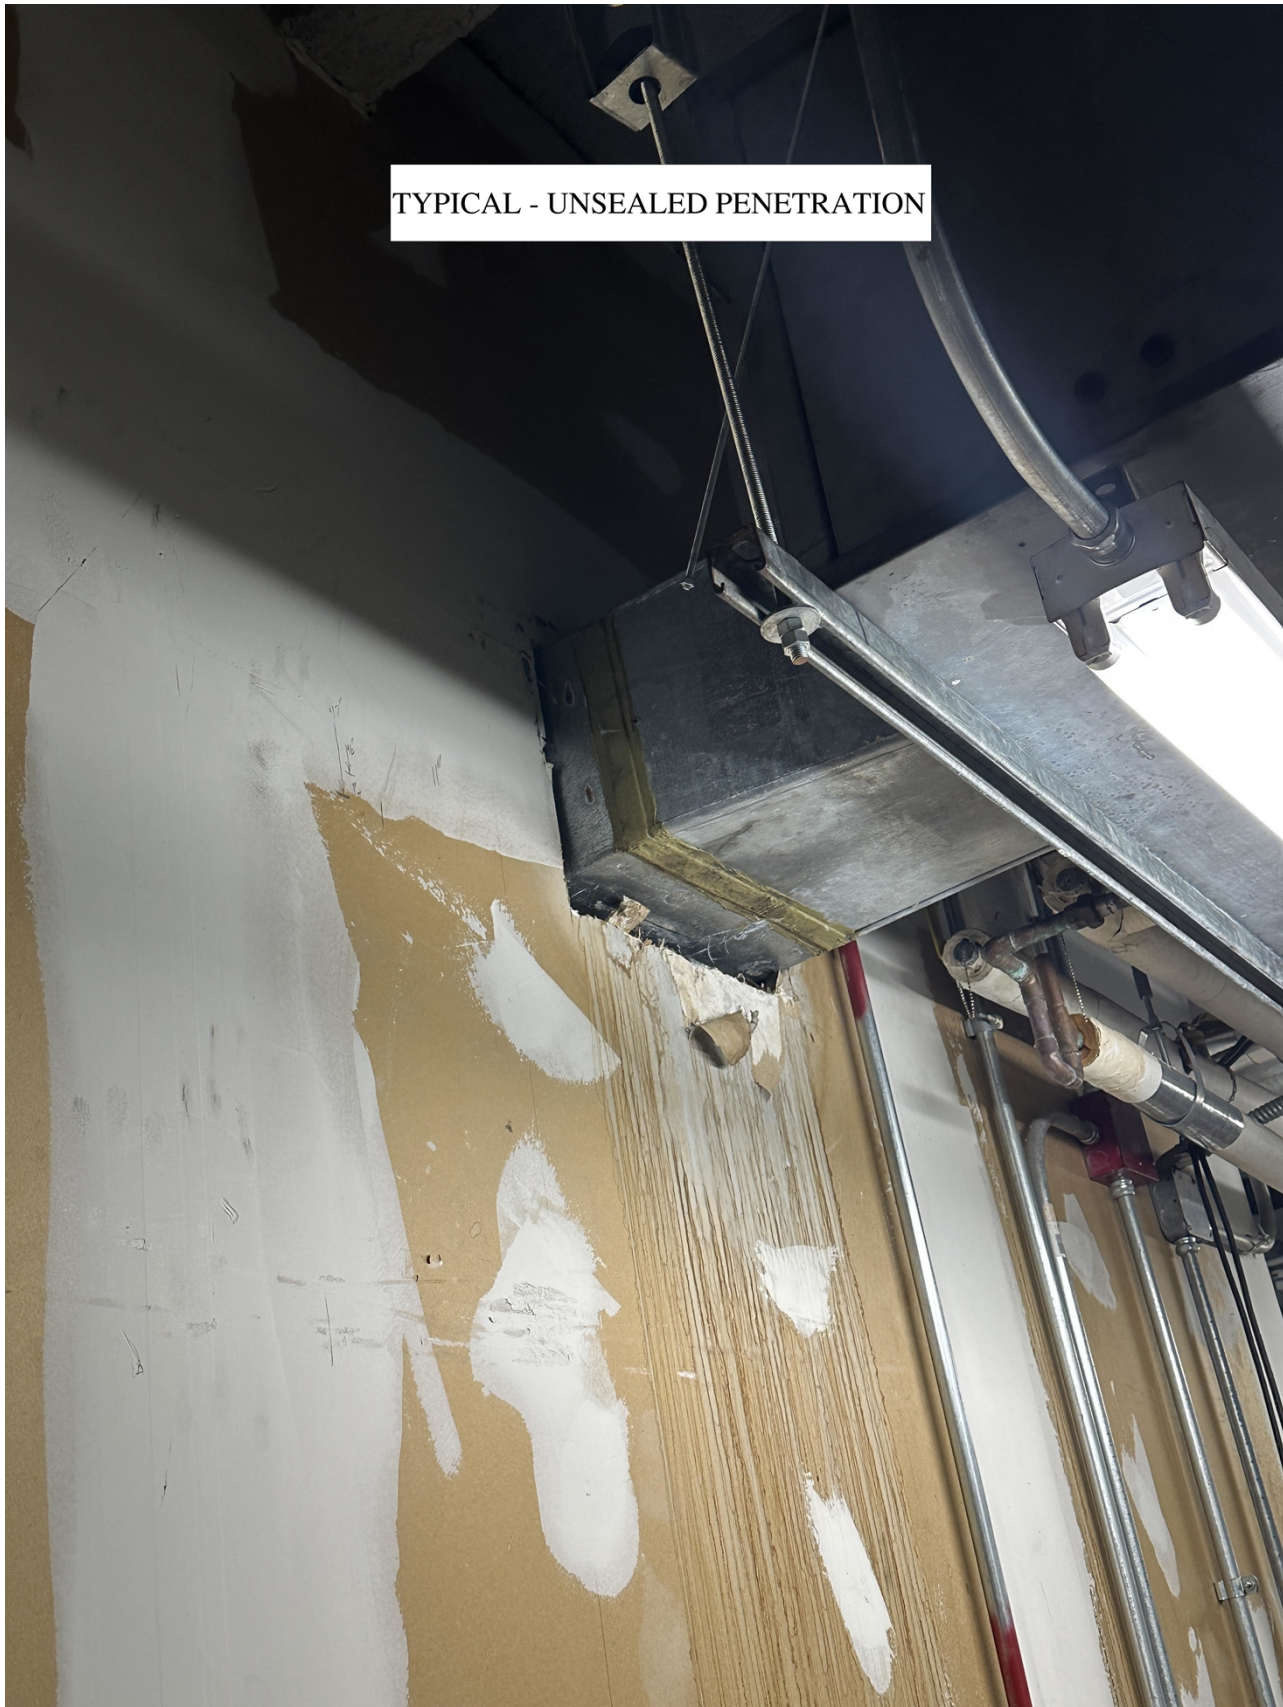
TYPICAL - UNSEALED PENETRATION
