School of Medicine – Medical School Teaching Facility (MSTF) Documents:

INFRARED ROOF INSPECTION

University of Maryland-Baltimore Medical Teaching Facility (MSTF)

July 23, 2019

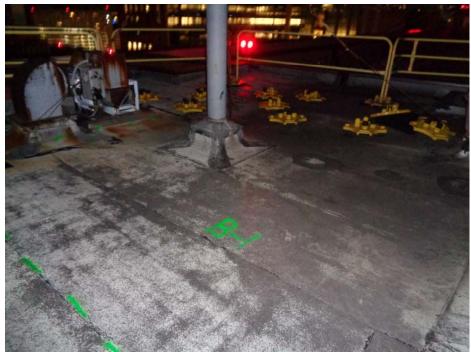
- MFTS: Two (2) suspected wet areas were found.
 - o One (1) core cut (#CC3) was taken on this roof section at wet area #D1.
 - ¾" Mod Bit
 - 1/4" Wood Fiber (Compressed) (Top: 99.9%: Bottom: 99.9%)
 - ¼" Wood Fiber (Compressed) (Top: 95.9%: Bottom: 99.9%)
 - 1/4" Asphalt
 - 4+" Perlite (Top: 99.9%: Bottom: 99.9%)

10 Pine-Roof D, wet area D-1 North end, looking East. (Mislabeled as B1 in photo)

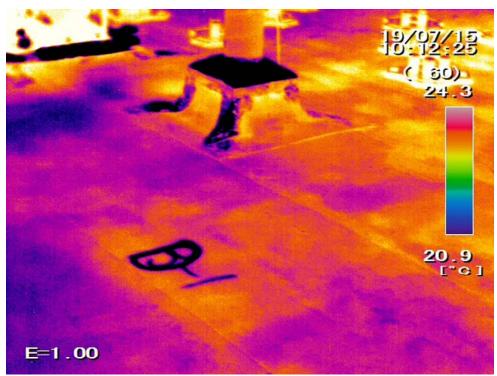
Wet area D-1, Northend

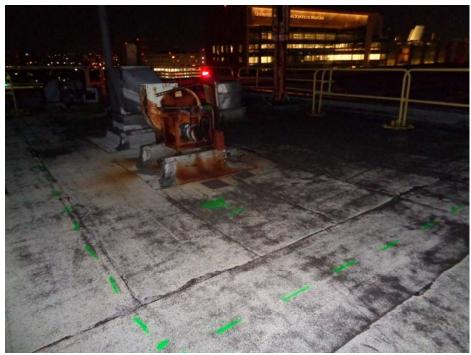
Roof D-Wet area D-1, South end, looking East. (Mislabeled as B1 in photo)

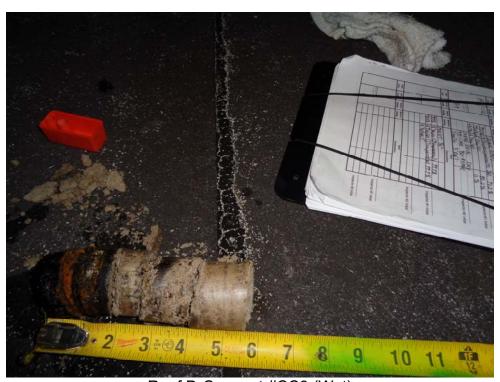
Roof D-Core cut #CC3 (Wet)

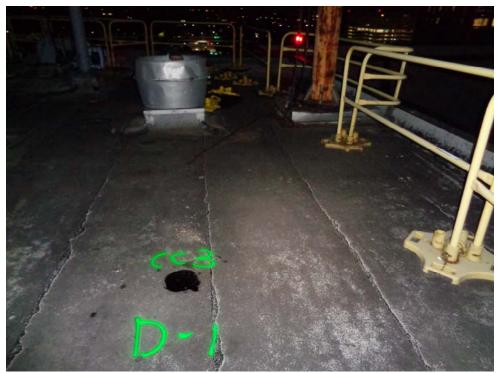
Roof D-Core cut #CC3 repaired, looking North

Cut into roof with two inch (2") circumference roof sampling tool. Repair core cuts with appropriate material.

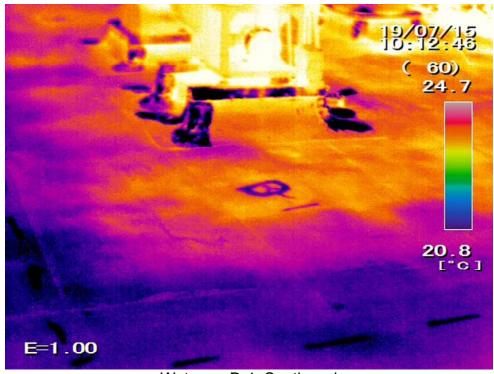
Wet area D-1, South end

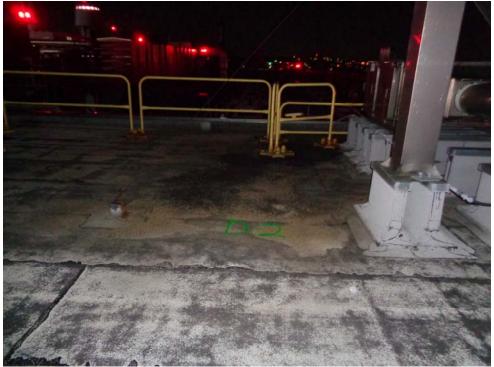
Roof D-Northeast corner, suspected wet area D-2, looking West

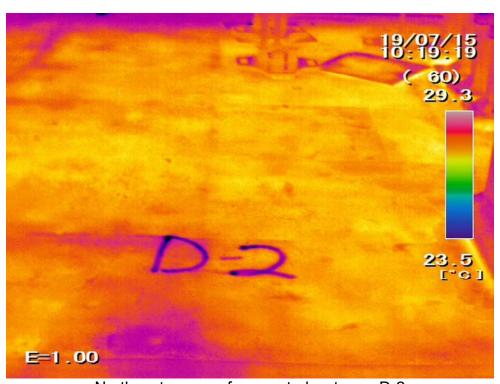
Northeast corner of suspected wet area D-2

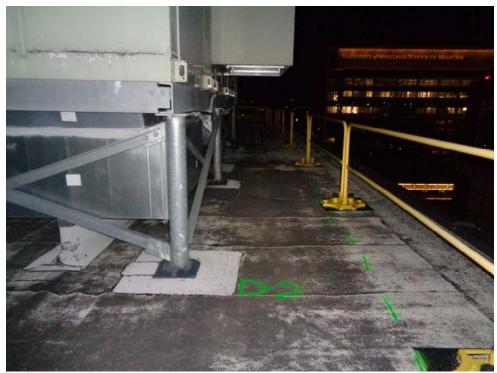
Roof D-East side of suspected wet area D-2, looking North

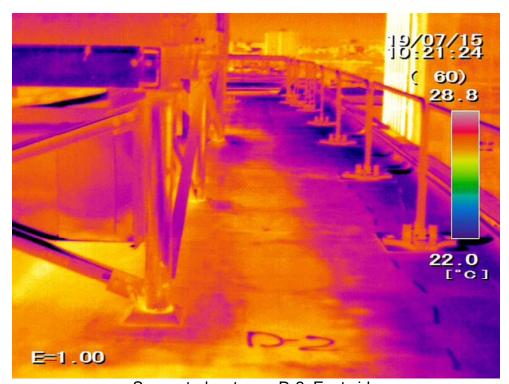
Suspected wet area D-2, East side

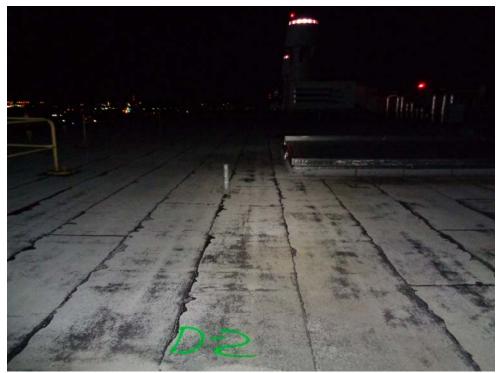
Roof D-Suspected wet area D-2, Southeast corner, looking West

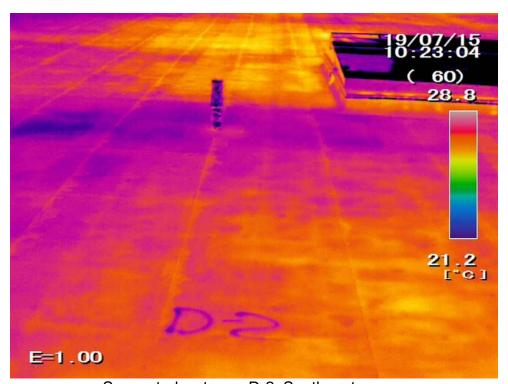
Suspected wet area D-2, Southeast corner

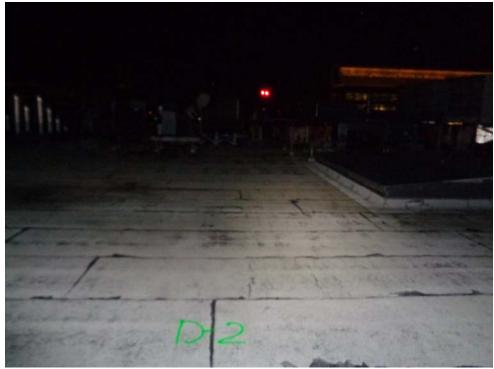
Roof D-Suspected wet area D-2, East side center, looking North

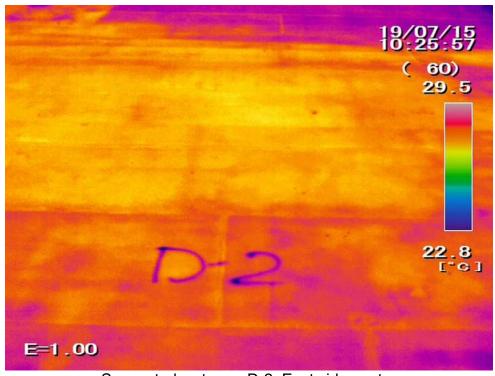
Suspected wet area D-2, East side center

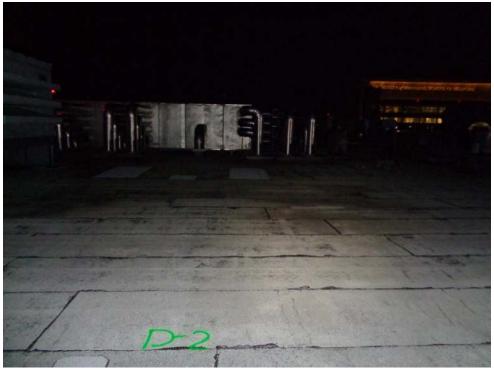
Roof D-Suspected wet area D-2, center, looking North

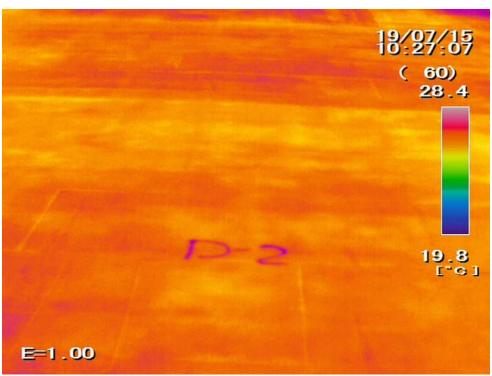
Suspected wet area D-2, Center

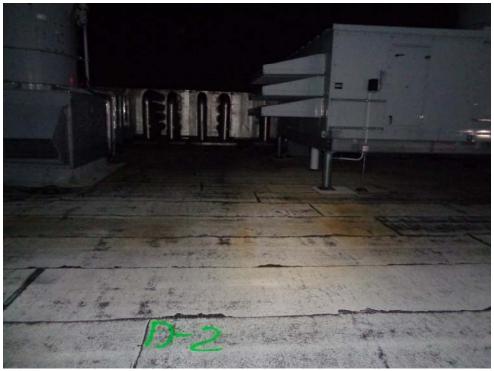
Roof D-Suspected wet area D-2, West side center, looking North

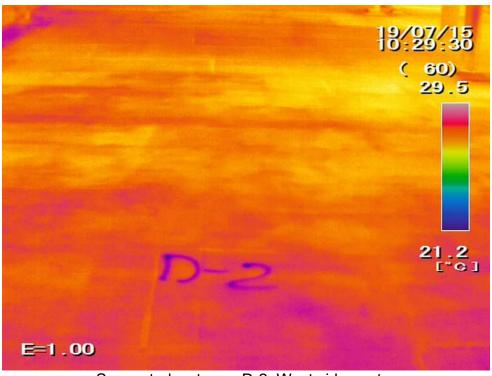
Suspected wet area D-2, West side center

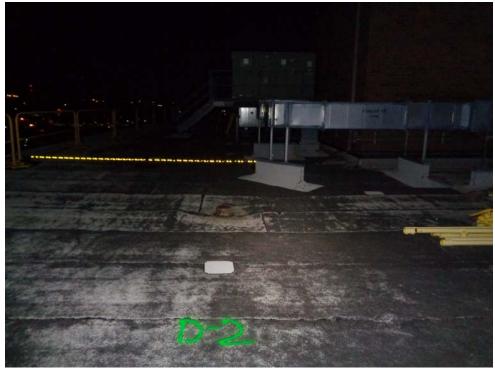
Roof D-Suspected wet area D-2, Southwest corner, looking North

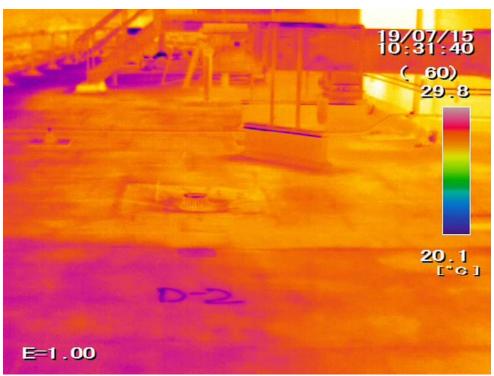
Suspected wet area D-2, Southwest corner

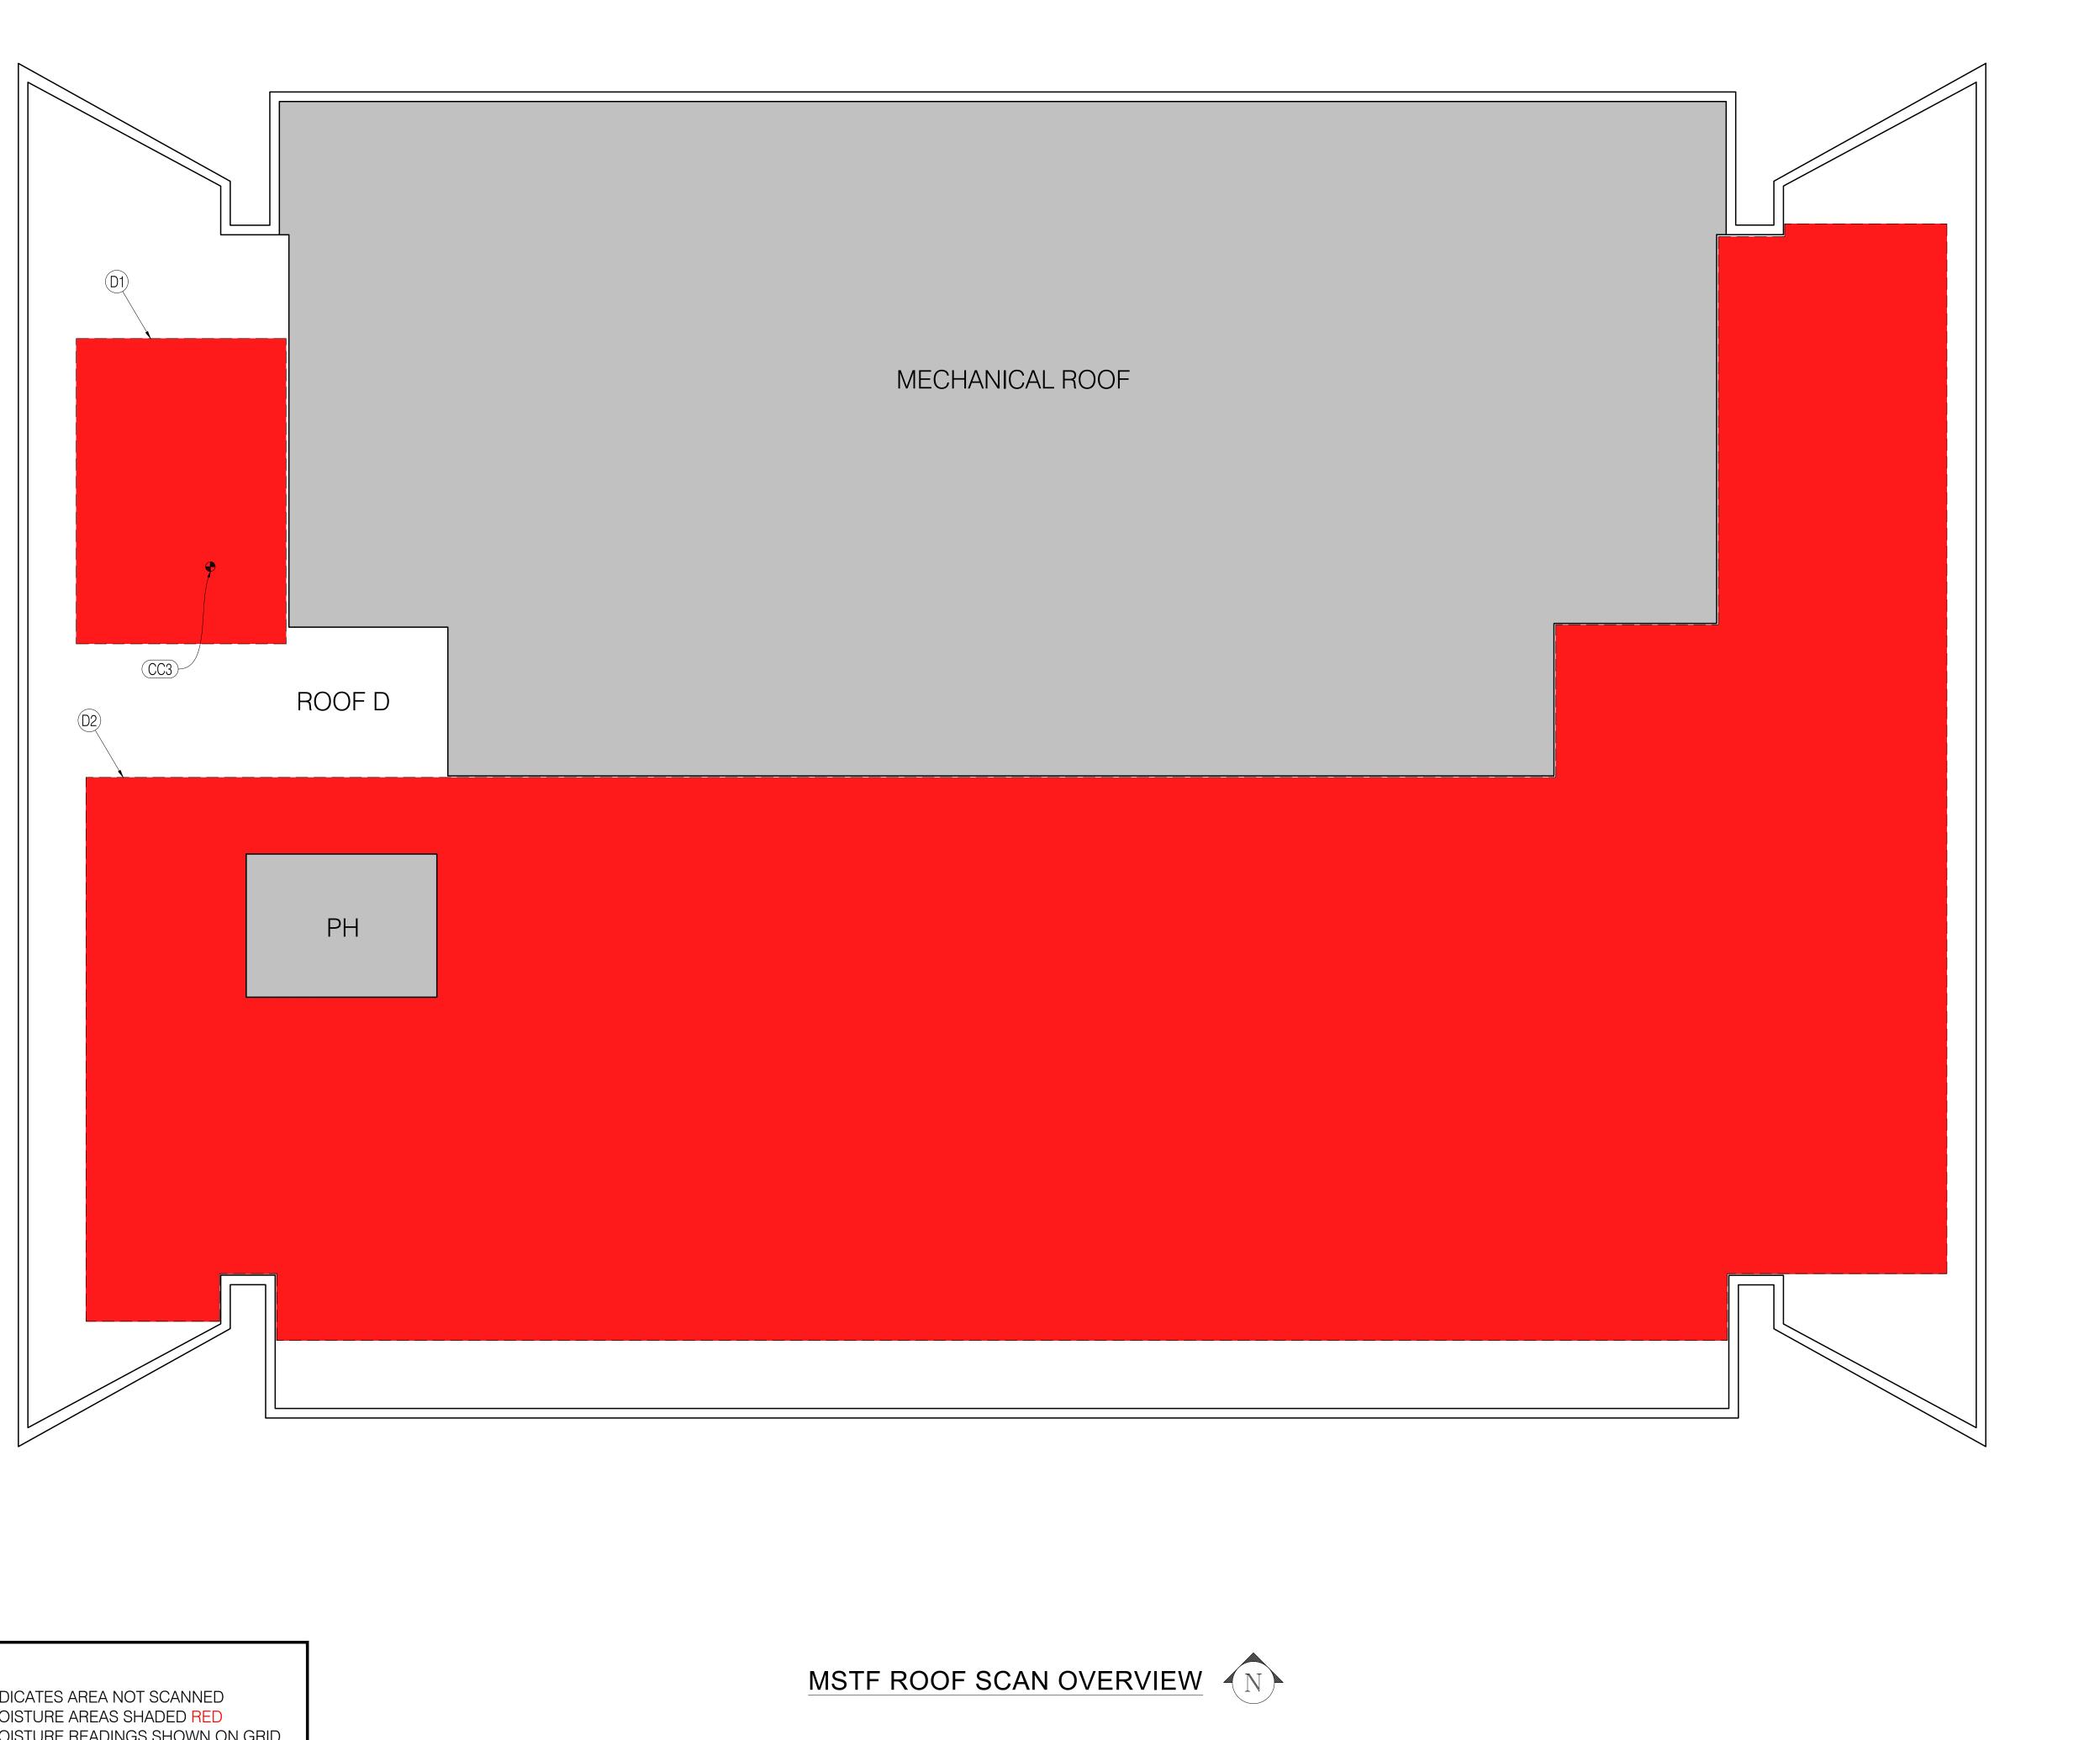
BUILDING ROOF - MOISTURE SCAN

TOTAL SUSPECTED WET SQ FT = 13029 SQ FT SIZE NOTES 22 x 32 704 CC3 193 x 113 12325 *SEE DRAWING
