#### **School of Pharmacy (SOP) – South Documents:**

## **NUCLEAR BACKSCATTER INSPECTION**

UMB School of Pharmacy

BUILDING ROOF - MOISTURE SCAN

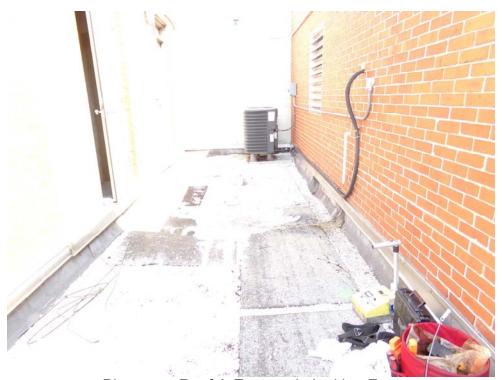
• Eight (8) suspected wet areas were found on this roof section.

Pharmacy Roof A-East neck, looking East

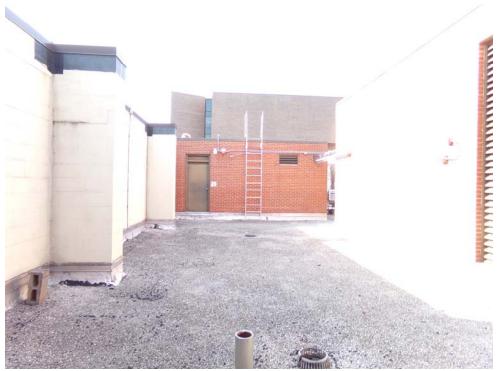
Pharmacy Roof A-East side, looking South

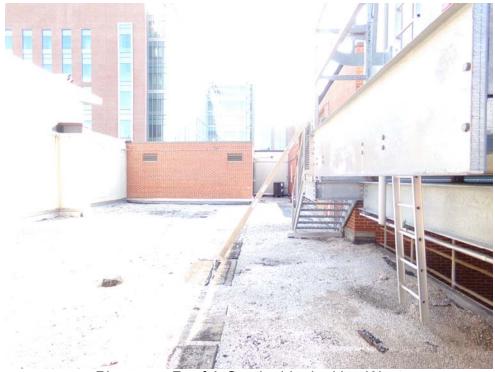
Pharmacy Roof A-South side, looking West

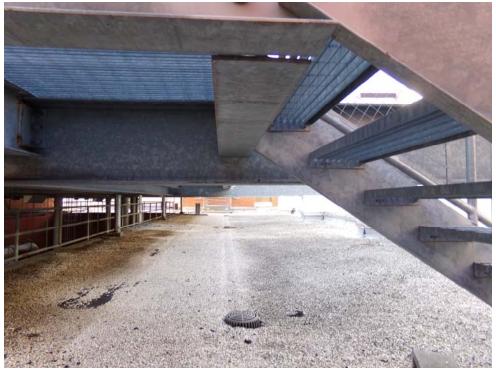
Pharmacy Roof A-West side, looking South

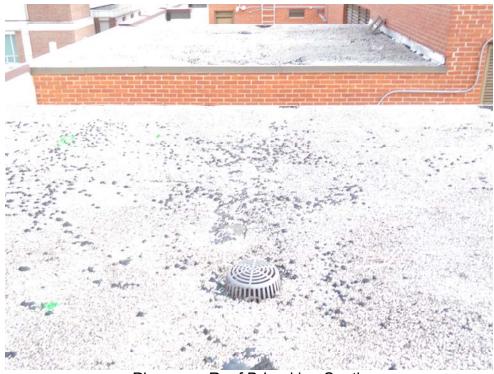
• One (1) suspected wet area was found on this roof section.

Pharmacy Roof B-Looking South

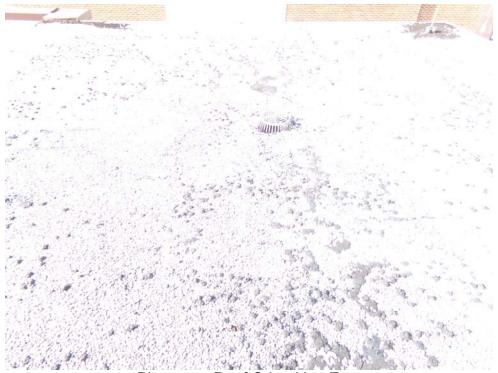
• Three (3) suspected wet areas were found on this roof section.

Pharmacy Roof C-Looking East

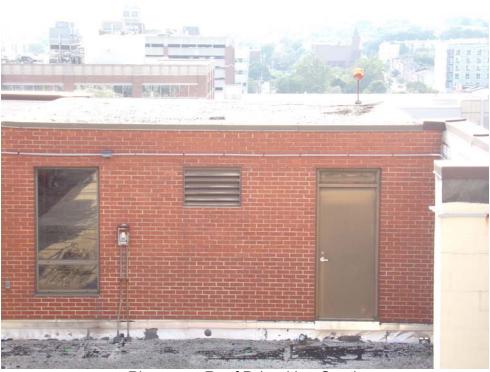
• Two (2) suspected wet areas were found on this roof section.

Pharmacy Roof D-Looking South

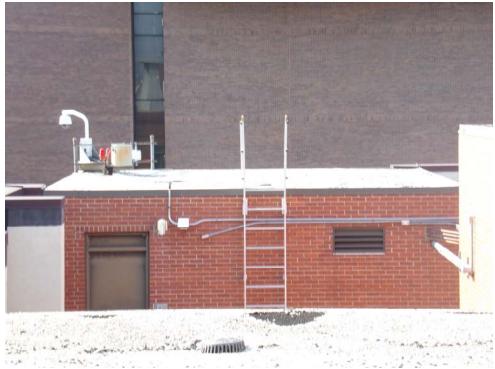
• Two (2) suspected wet areas were found on this roof section.

Pharmacy Roof E-Looking South

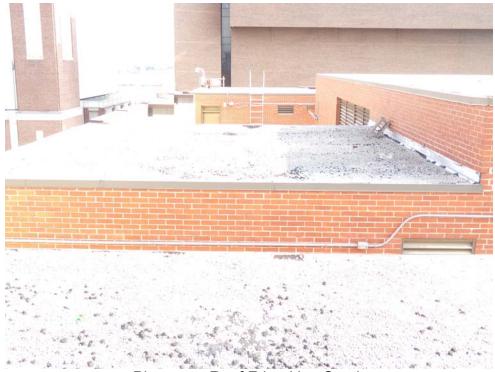
• Two (2) suspected wet areas were found on this roof section.

Pharmacy Roof F-Looking South

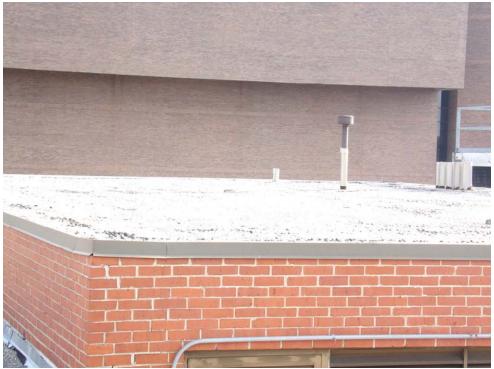
No thermal anomalies were noted on this roof section.

Pharmacy Roof G-LookingSouth

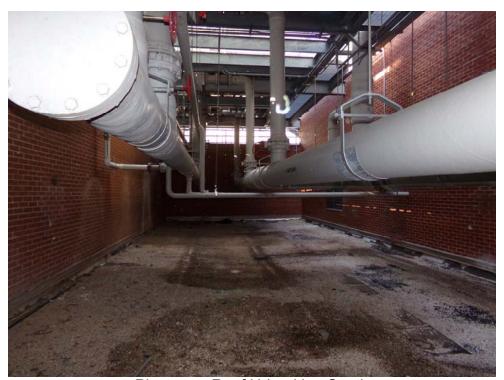
• One (1) suspected wet area was found on this roof section.

Pharmacy Roof H-Looking South

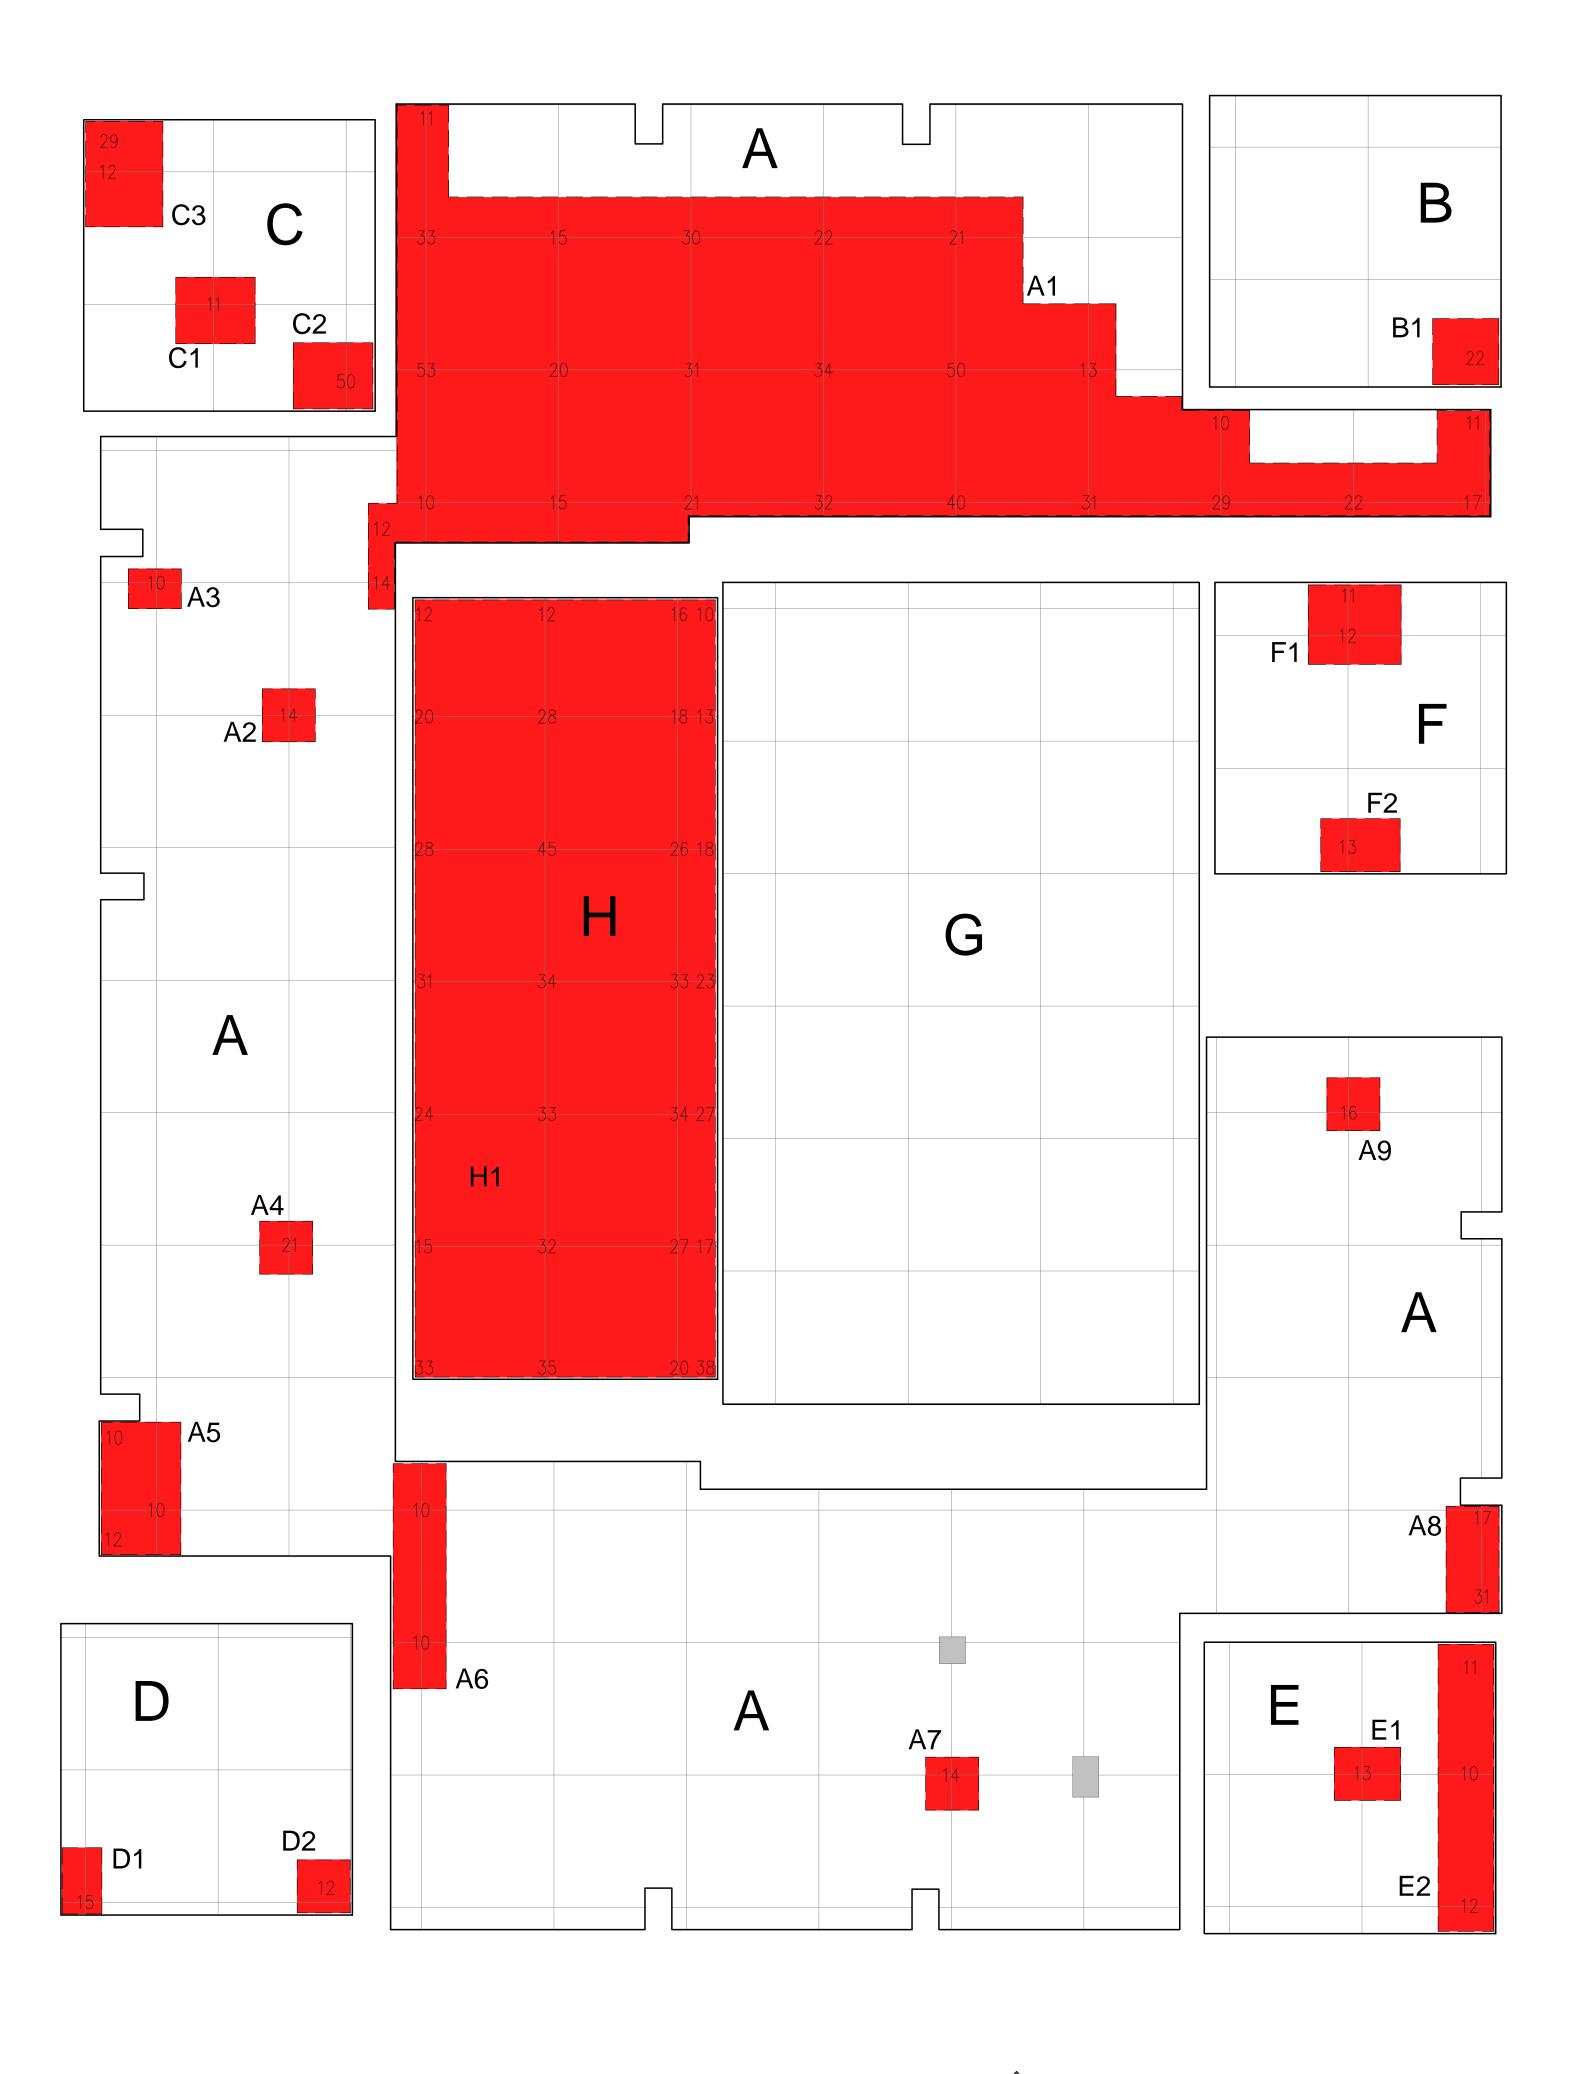
'^	'A' TOTAL SUSPECTED WET SQ FT =1730									
AREA	Ç	SIZI	Ξ	SQ FT	NOTES					
A1	84	X	33	1510	*SEE DRAWING					
A2	4	X	4	16	_					
А3	4	X	3	12	_					
Α4	4	X	4	16	_					
A5	6	X	10	60	_					
A6	4	X	17	68						
Α7	4	X	4	16	_					
A8	4	×	8	32

'B' TOTAL SUSPECTED WET SQ FT = 25									
AREA	SIZE		SQ FT	NOTES					
В1	5	X	5	25	_

'C	'C' TOTAL SUSPECTED WET SQ FT =108										
AREA	SIZE			SQ FT	NOTES						
C1	6	X	5	30	_						
C2	6	X	5	30	_						
С3	6	×	8	48	_

'D' TOTAL SUSPECTED WET SQ FT = 31									
AREA	SIZE		SQ FT	NOTES					
D1	3	X	5	15	_				
D2	4	×	4	16	_

'F' TOTAL SUSPECTED WET SQ FT = 66								
AREA	SIZE		SQ FT	NOTES				
F1	7	X	6	42	_			
F2	6	×	4	24

'H' TOTAL SUSPECTED WET SQ FT =1357					
AREA	SIZE		SQ FT	NOTES	
H1	23	×	59	1357	_

Core sampling was not allowed, but it is recommended to verify findings, especially near edges with high readings. These could be due to moisture, but can also be caused by a build-up of roofing materials in these areas.
