**BUILDING CONDITION ASSESSMENT
401 WASHINGTON AVENUE
TOWSON, MD 21204**

FINAL REPORT

29 NOVEMBER 2018

ZIGER | SNEAD ARCHITECTS

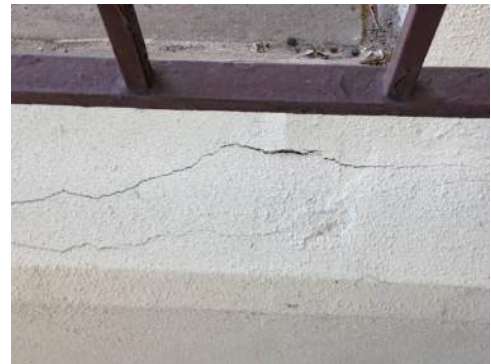
- A. At several locations around the building perimeter, the steel framing extends outside the building envelope. At these locations, the steel frame is encased with reinforced concrete for protection. Some of the concrete is starting to crack and become loose due to corrosion of the reinforcing steel. This condition is also occurring at some of the site retaining walls.

1. The cracked concrete should be removed, the steel reinforcing properly cleaned and prepared, and new repair material installed.

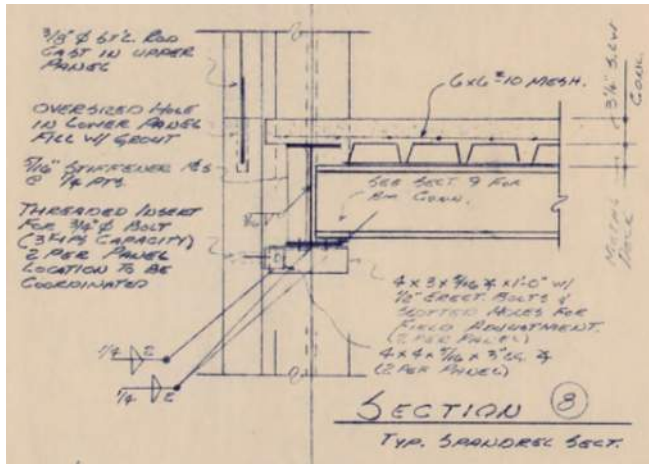
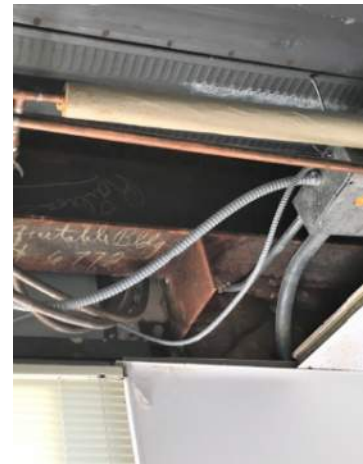
- A. The typical exterior façade consists of 5" thick precast concrete panels supported from the perimeter structural steel framing. The bottom of each panel is doweled into the top of the panel below.

- 1. The wall panels, generally, appear to be in good condition, given their age. There is some visual evidence of patching and repairs to some panels, and inconsistent alignment in some locations. It is not clear if the misalignments are due to active movement or issues with the initial installation.

1. A comprehensive engineering survey should be undertaken to review the condition and stability of the exterior concrete panels. Since these panels are the primary weather barrier for the building, any cracks or movement could lead to water or air infiltration into the building.
2. Sealant joints between panels should be surveyed and comprehensively addressed and maintained. Past ad-hoc sealant repairs have left a patchwork of sealant joints of varying types, ages, and conditions.

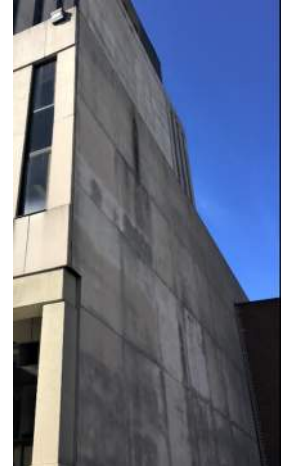
- A. The north façade of the north wing which abuts the property line is a CMU structural wall surfaced with cement stucco, panelized in a fashion similar to the precast concrete wall panels.
- B. The stucco appears to be original to the building, and is showing its age and heavy weathering. However, it does appear to be generally sound.
- C. Recommendations:
 - 1. General cleaning and replacement of sealant joints.

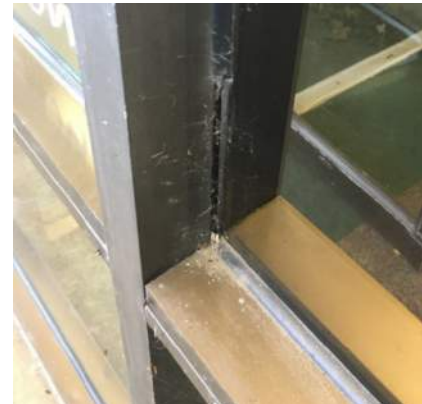
- A. The typical windows and entrances at the main and lower levels are a conventional 2" x 4-1/2" center-glazed aluminum storefront system with aluminum storefront doors.
 - 1. The glazing appears to be 1/4" monolithic glass.
 - 2. Finish is dark bronze anodized.
 - 3. Condition of glazing gaskets and seals should be comprehensively surveyed.

- B. The main entrance vestibule utilizes automatic sliding doors with motion sensor activation.
- C. Recommendations:
 - 1. The existing storefront systems are thermally inefficient, but otherwise appear to be in serviceable condition. Replacement does not appear to be necessary, unless contemplated as part of a major building renovation with the goal of complying with modern energy codes.

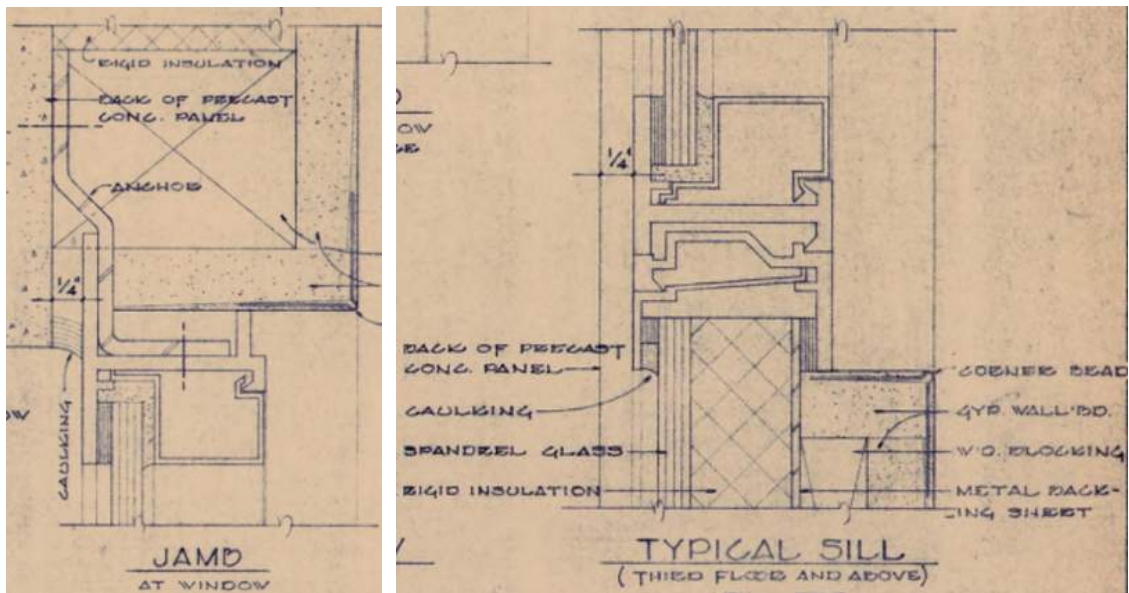
- A. The typical Tower windows are a 1-1/2"-deep aluminum-framed window system arranged in continuous vertical strips between the precast concrete panels.
1. Finish: Dark Bronze anodized.
 2. The window system is glazed with 1/4" "solar bronze" tinted glass lites at each occupied level, alternating with opaque insulated spandrel glass panels at each floor line. The window system bypasses the slab edge, so it is a continuous strip for the full height of the tower. The framing system has ganged horizontal mullions at each transition from spandrel panel to vision glass.

3. The jambs of the window system are anchored to the back of the precast wall panels and sealed with a continuous sealant joint. Some windows were observed to have water damage on the interior that are possibly the result of failed sealant joints.

2. The air- and water-tightness of the entire envelope is reliant upon the sealant joints at the exterior window jambs and at the ganged mullion conditions. These sealant joints should be surveyed and comprehensively addressed and maintained. Past ad-hoc sealant repairs have left a patchwork of sealant joints of varying types, ages, and conditions.

3. Interior glazing seals appear to be failing and should be comprehensively addressed. Exterior glazing seals could not be visually assessed, but it is presumed that they would need to be addressed concurrently. The windows are interior-glazed, so a seal rehabilitation effort would not require exterior access to the windows.

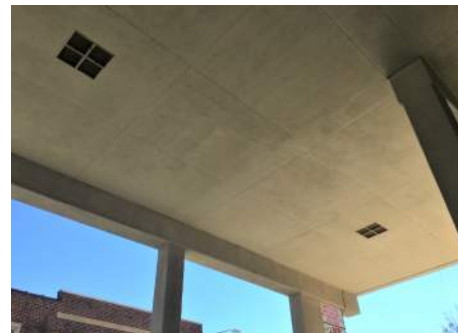
- A. Exterior soffits at overhanging conditions at the Main Level are cement stucco.
- B. Stucco soffits around the building appear to be in good condition.
- C. Recommendations: No changes should be required.

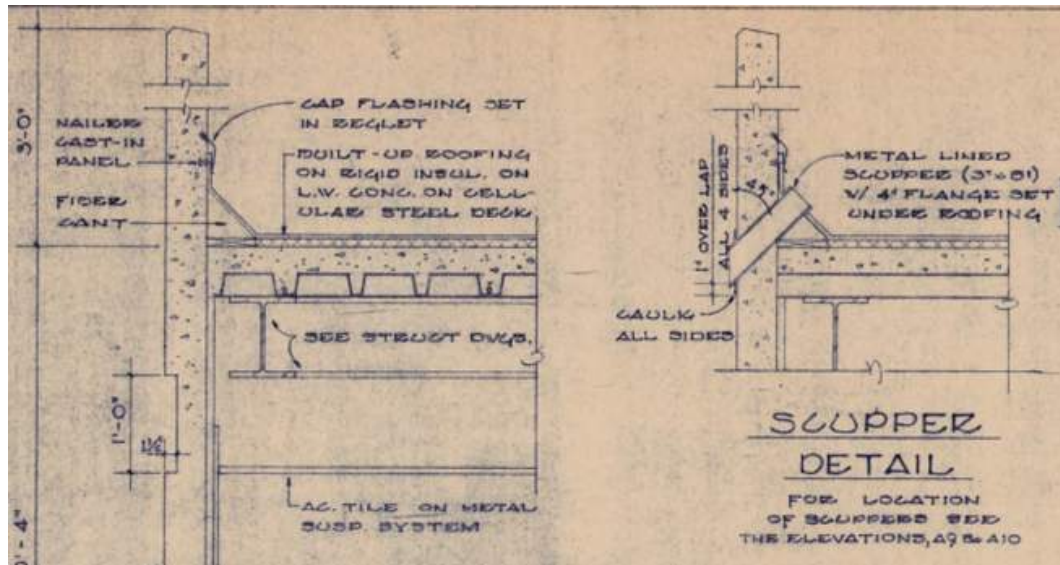
- 3. Per the original 1969 drawings, the insulation thickness was minimal. The roof perimeter is flashed to the precast concrete parapet with a stainless steel reglet and counterflashing consistent with the original project details. Perimeter flashings appear to be intact, and the sealant joints between the precast concrete parapet panels appear to have been well-maintained.

6. Recommendations: The existing main roof has clearly exceeded its service life, and the drainage deficiencies must be addressed. **Replacement of the existing main roof is a likely short-term need for this building.** Some concerns to be considered:

- a. Replacement of the roof should include a thicker layer of insulation to improve the thermal performance of the building. All roof penetrations (including pitch pockets, roof curbs, etc.) would have to be modified to account for the thicker roof assembly.

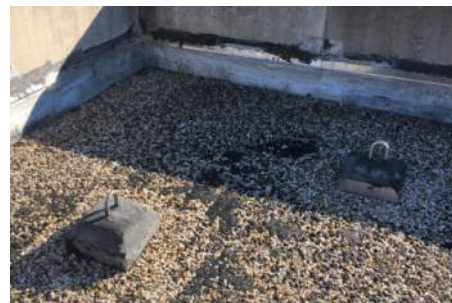
- 4. A series of structural connection points for window-washing equipment have been provided around the perimeter of the roof, with pitch pockets. Per the Building Manager, these have been in use, with no known functional issues.

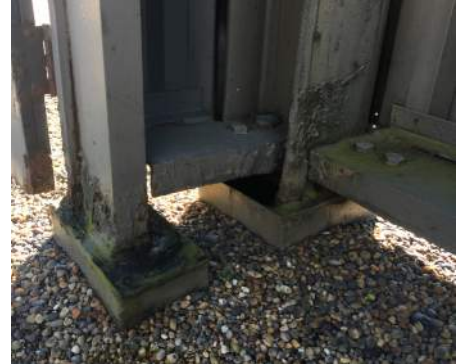
5. Roof penetrations for the equipment screen supports, cooling tower dunnage frame supports, and other similar items are waterproofed with pitch pockets. Per the facilities staff, these pitch pockets have been periodically maintained.

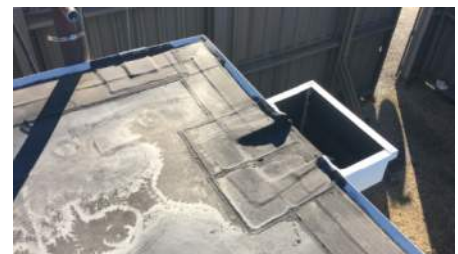
- A. The roof of the mechanical penthouse is a 60-mil EPDM single-ply membrane by Carlisle. This roof appears to be relatively recent and in good condition. Warranty status is unknown.
- B. Recommendations: No modifications should be required. Regular maintenance should be performed per manufacturer's recommendations.

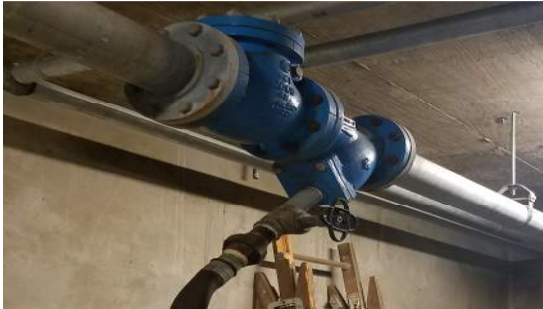
Figure P1: Existing Strainer and Check Valve Assembly.

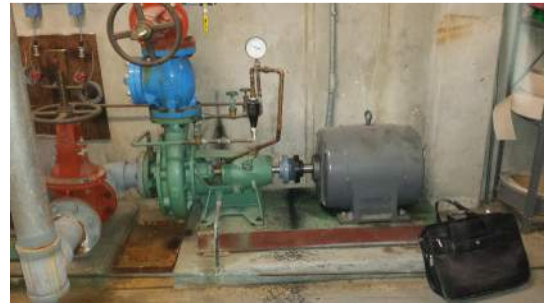
Figure P2: Domestic Water Booster Pump.

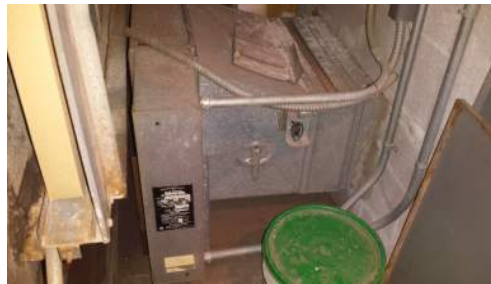
Figure M4: OA Duct in a Central Mechanical Room

Ventilation is provided to the building via a 7'x4' central ventilation riser which distributes outdoor air to the central mechanical room on each floor. The air is driven through the riser by a roof-mounted single width-single inlet centrifugal fan with airfoil blades (Trane model 81). The fan is original to the building and has superficial rust, but appears to be operational. Within the mechanical rooms, a branch duct with integral balancing damper, filter housing, and electric heater (See Figure M4) is used

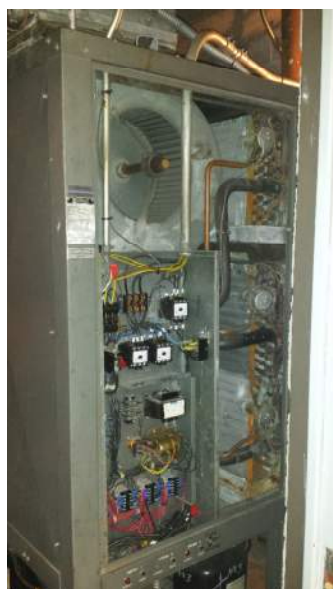
Each floor of the building is served by a dedicated central water-cooled self-contained unit (See Figure M5) that provides cooling, and ventilation for the core spaces. The central mechanical unit on each floor serves as a mixing plenum for return air and outdoor air. The mixed air is then drawn through the unit where it is filtered, cooled, and distributed to the floor through the existing ductwork. These self-contained units (American Standard model VWS) are original to the building, and consequently, vendor literature is not available to ascertain capacities or performance characteristics. Each unit utilizes multiple water-cooled compressors that employ R-22 refrigerant and forward-curved centrifugal fans. Some of the units include duct-mounted smoke detectors which will de-energize the unit upon detection of smoke in the air

Figure M5: Existing Central AHU

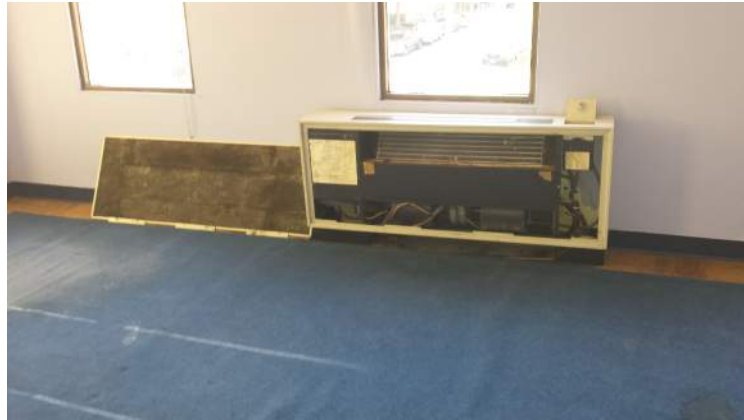
The envelope load for the building is treated with console water-source heat pump units located at the perimeter of the building (See Figure M6). These units (Singer model ECC-WW-WM-90 & -120) are original to the building and also use R-22 refrigerant. Each unit includes a water-cooled compressor and dual forward-curved centrifugal

Figure M6: Existing Perimeter WSHP Console Unit

Based on a spot-testing of units located on the third floor, only some of the units are functioning properly (cooling/heating), and all produce a significant amount of compressor noise while operating. These units are also well past their useful service lifespan of 19 years per ASHRAE recommendation. Lastly, the imminent phase-out of R-22 refrigerant will escalate maintenance costs.

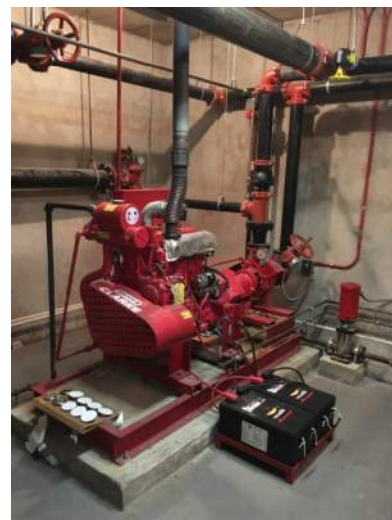
The fire pump and the associated equipment have been recently installed and appear to be in good condition. The fire pump is diesel-fueled and serves two fire hose standpipes. The #2 Diesel fuel tank is located in the fire pump room. The fire pump is Armstrong Model #4X3X8.5FM with a capacity of 173 ft. of head at 400 gpm. There is also a jockey pump

We recommend a separate water service connection into the building to serve the fire pump, instead of the existing condition where the same water connection is supplying both the domestic water and the fire pump. Also, the fire pump room should be 2 hour rated enclosure, but one of the doors is louvered. The louvered door opening would compromise the 2-hour rating.

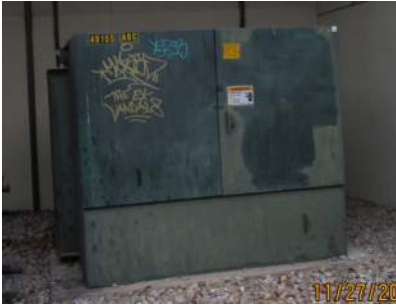
The incoming electrical service to the building enters from the pad mounted utility transformer (see Figure E1) at the northeast corner of building via eight 4" underground conduits to pull box (see Figure E2) in utility room in sub-basement. The electrical service feeds a metal-enclosed draw-out switchgear (see Figure E3) rated at 3200amp, 480volt, 3 phase, 4 wires. The service equipment is by Westinghouse. This service delivers approximately 20 watts per square-foot which is ample for this type of building. An average of 12-15 watts per square-foot is more common.

Figure E1: Existing Utility Transformer

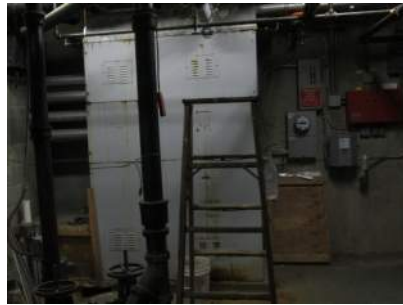
Figure E2: Existing Utility Pullbox

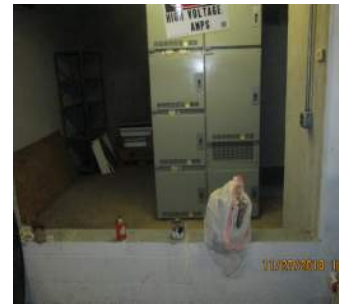
Figure E3: Existing Switchgear

There is not enough working space in front & right side of switchgear and it does not have a clear egress path about switchgear (see Figure E3) which violates NEC 2014-110.26(A)(1) & 110.26(C)(1). The identifications for service & distributions are missing on switchgear. This is also in violation of NEC-230.2(E).

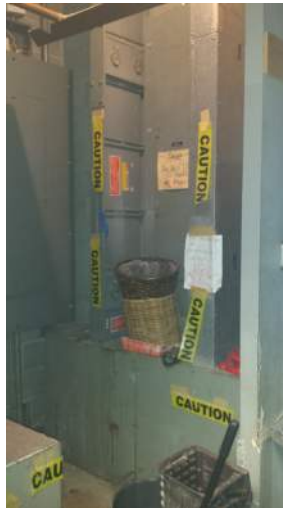
- One 2000amp, 4P buss duct (see Figure E4) serves mechanical/power/lighting loads from the basement to the 12th floor. It appears to be installed in early 1970.
- One 400amp, 4P buss duct (see Figure E5) serves panelboard "H1", "H2", "H3", "H4" for heat pumps. It appears to be installed in early 1970.

Figure E4: 2000 amp Buss Risers

There are labels on these buss ducts with a date of March 1996 indicating the last time they were torqued.

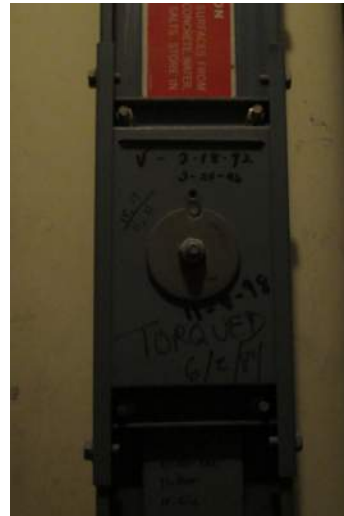
Figure E5: 400 amp Buss Risers

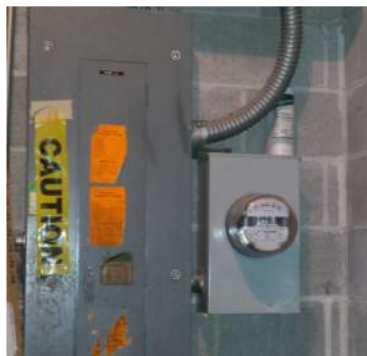
- There are three tenant spaces on 1st floor and are all appear to be sub-metered:
 1. Charles SCHWAB" (see Figure E6)
 2. NY Deli on 1st floor (see Figure E7).
 3. And an empty tenant space is being serving by one 100amp, 480/277V panelboard with submeter and one 125amp, 208/120V panelboard located in the tenant space.

Figure E6: Sub-meter for Charles Schwab

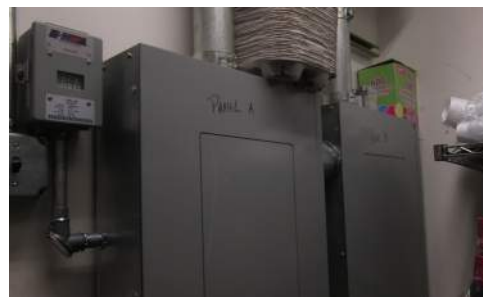
Figure E7: Sub-meter for Deli

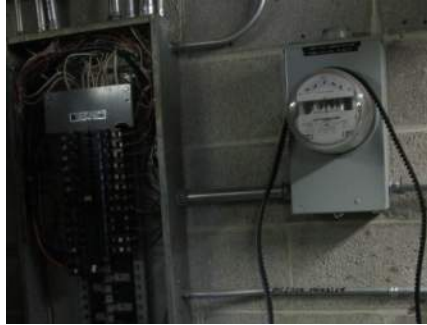
- There are panelboards with submeters for Antenna system (see Figure E8) & Signage on penthouse (see Figure E9). Those systems are disconnected and are no longer in use.

Figure E8: Sub-meter for Antenna

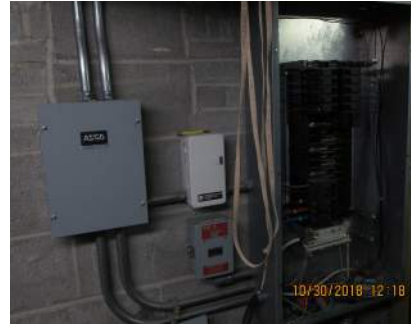
Figure E9: Sub-meter for Signage

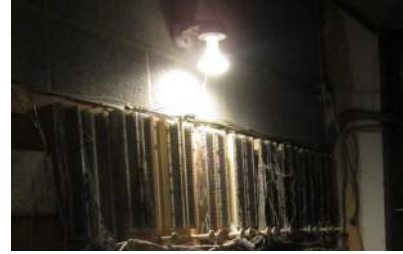
Figure E13: Typ. CFL Light Bulb in Mech. Room

- a. The current interior light fixtures and controls are not complied with International energy conservation code.
- b. Emergency light shall be in west stairwell, electrical rooms & mechanical rooms. It is violation per NEC 700.12(F).

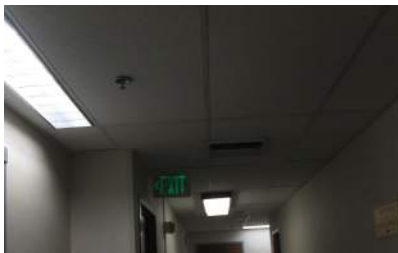
Figure E14: Typ. Fluorescent Ltg. Corridor & Exit Sign

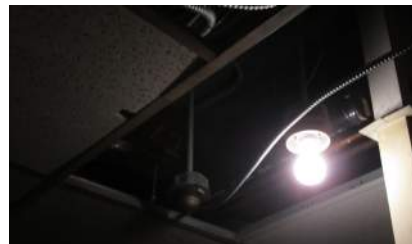
Figure E15: Typ. CFL Light Bulb in Elec. Room

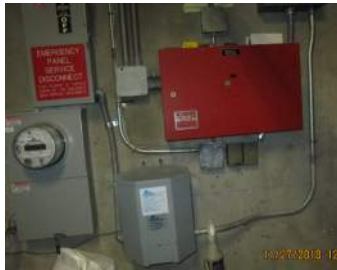
The existing emergency lighting system does not comply with current building codes. It is in poor condition.

Figure E18: Emergency Light from Service

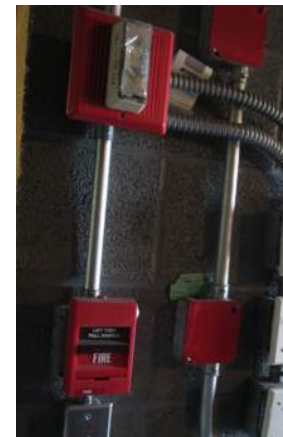
All addressable Fire Alarm System appears to be installed in 2003 or later and in good condition. Fire alarm control panel is located in utility room on subbasement, and five fire alarm booster panel located on 1st, 2nd, 5th, 8th, 11th floor. Fire alarm annunciator panel is located in lobby on 1st floor. All detectors & strobes/horns are fed from those fire alarm panels.

Figure E22: Typ. Fire Alarm Devices
