#### **School of Pharmacy (SOP) – South Documents:**

## **NUCLEAR BACKSCATTER INSPECTION**

UMB School of Pharmacy

BUILDING ROOF - MOISTURE SCAN

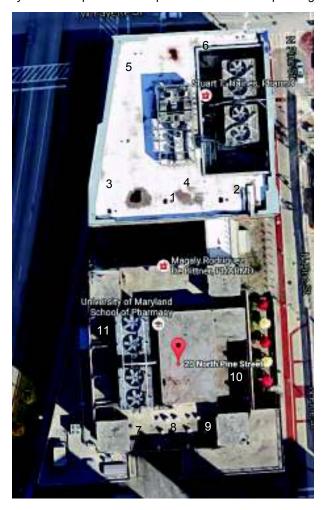
Pull #6 ha	Pull #6 had a thicker roofing assembly and required a 10" fastener to be used.

Roof plan not to scale. Identify where the pullouts were performed with corresponding test number.

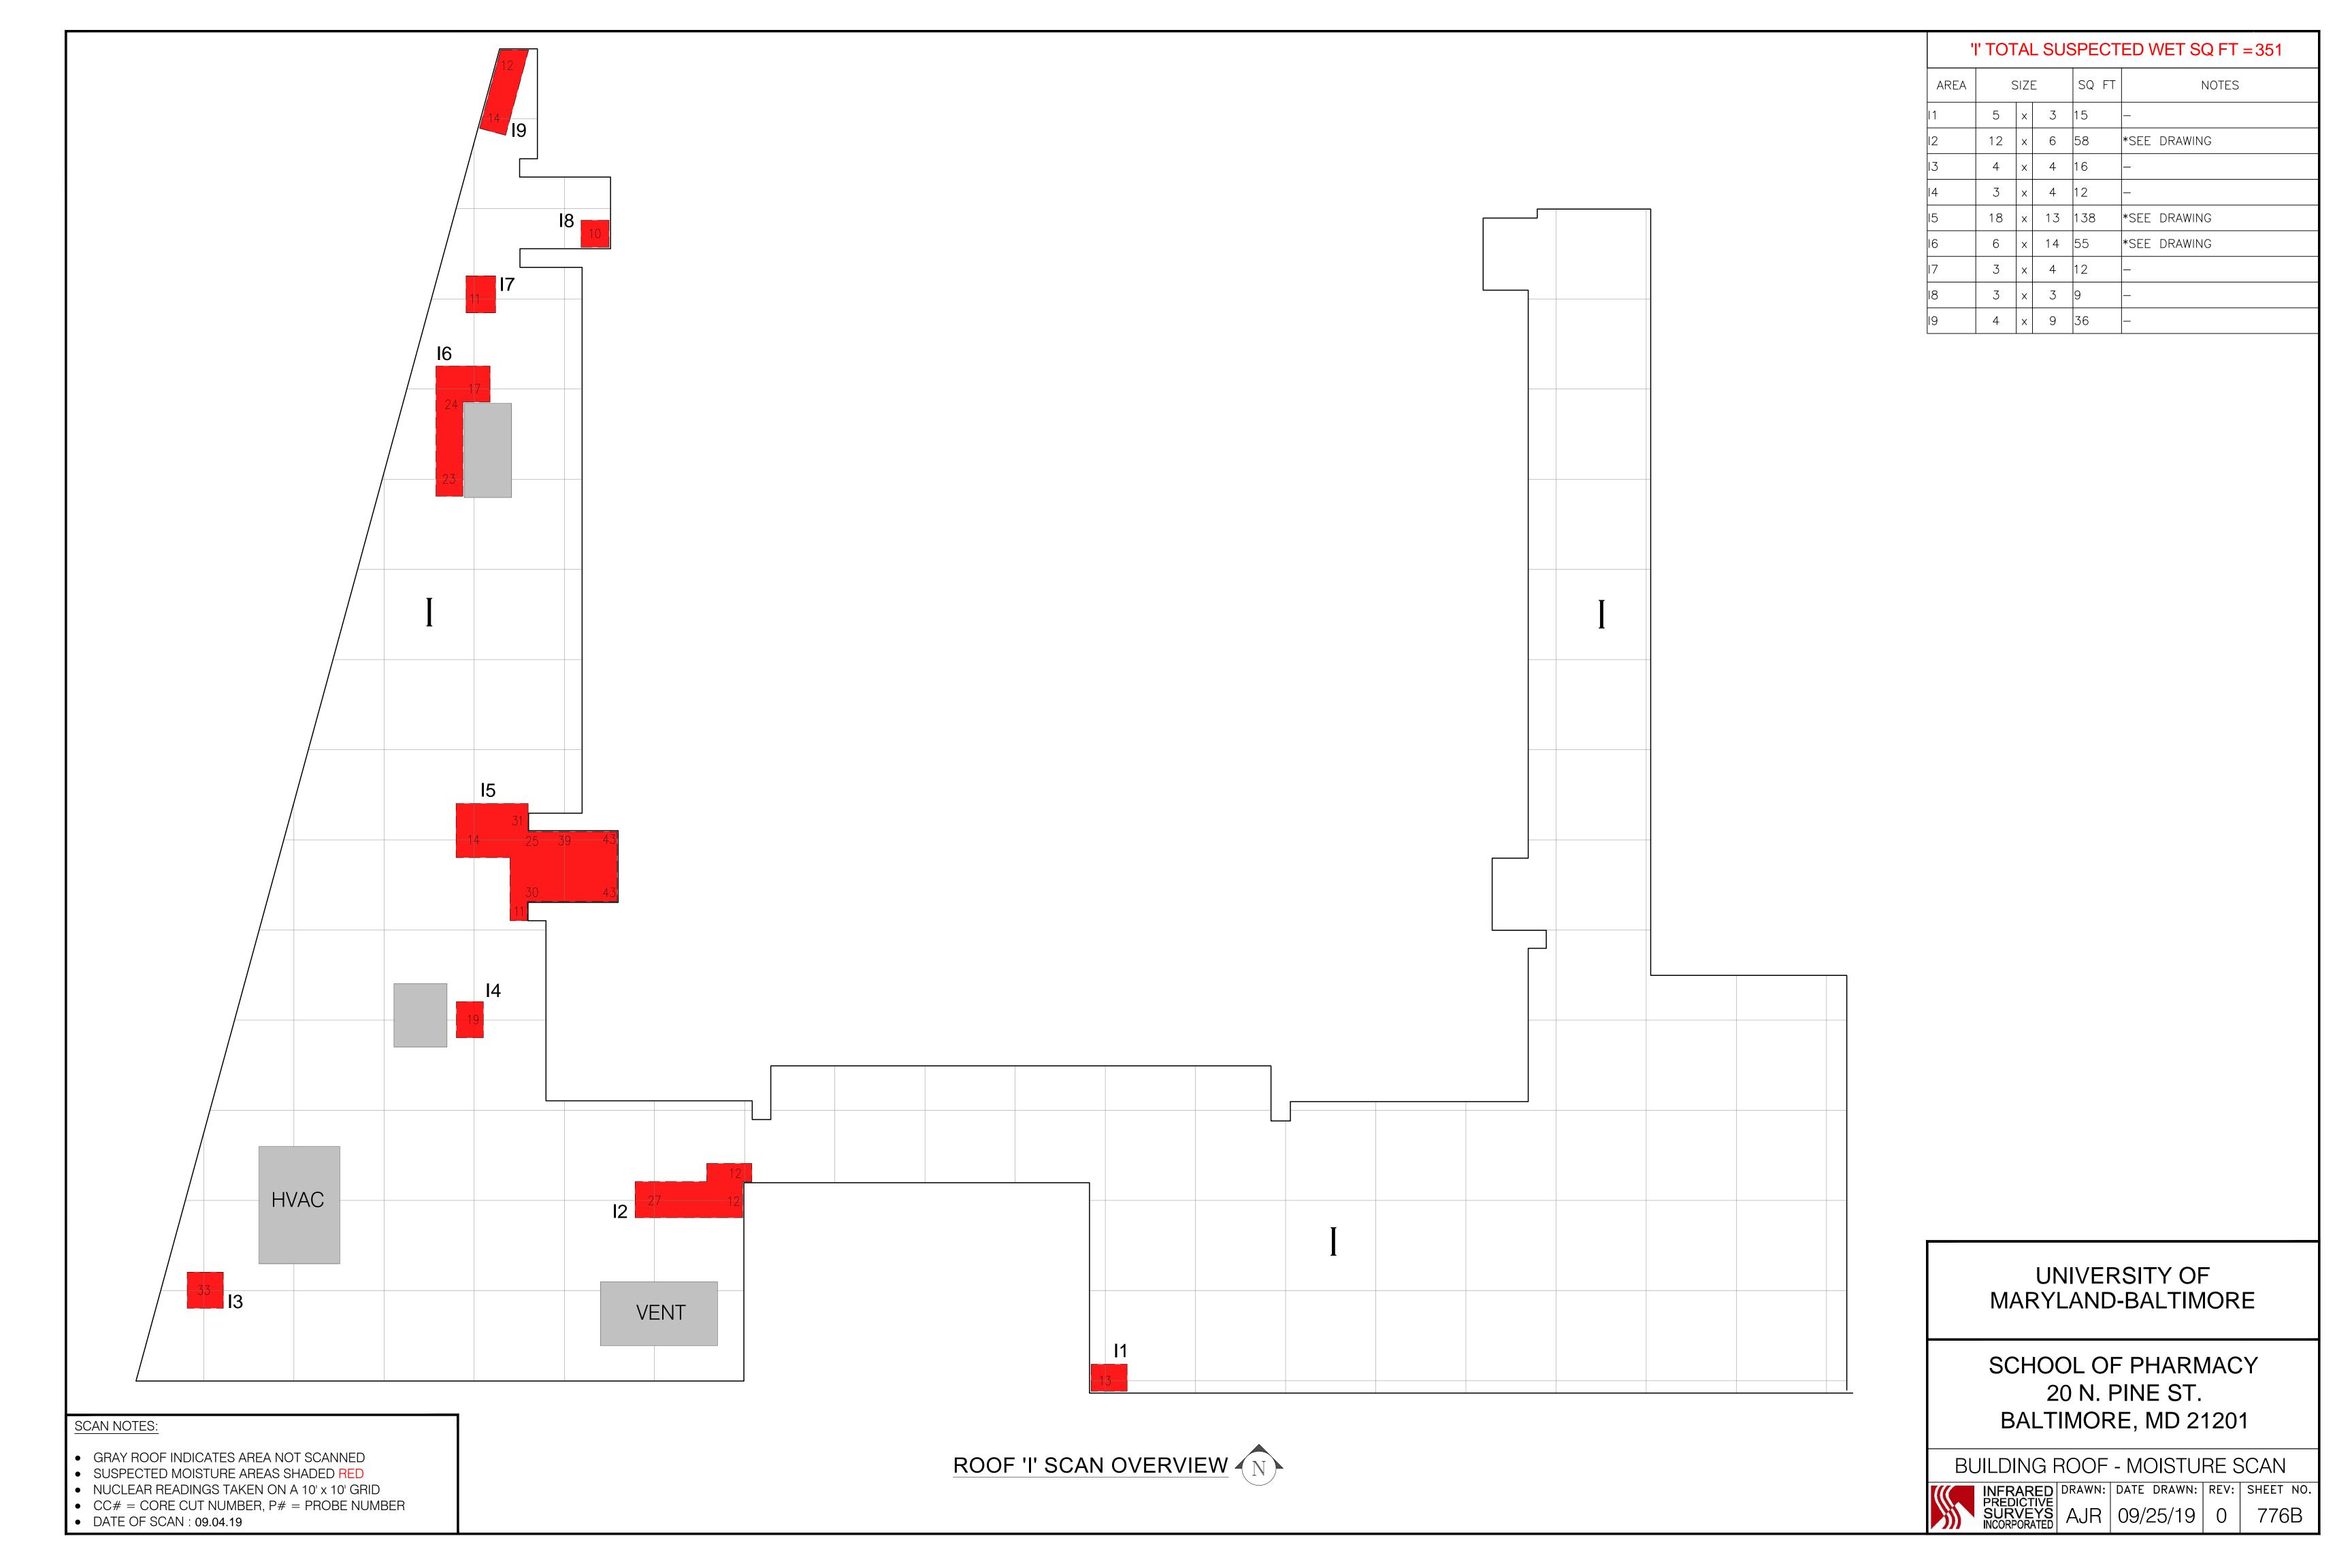
- GRAY ROOF INDICATES AREA NOT SCANNED
- SUSPECTED MOISTURE AREAS SHADED RED
- NUCLEAR READINGS TAKEN ON A 10' x 10' GRID
- CC# = CORE CUT NUMBER, P# = PROBE NUMBER
  DATE OF SCAN : 09.04.19

Core sampling was not allowed, but it is recommended to verify findings, especially near edges with high readings. These could be due to moisture, but can also be caused by a build-up of roofing materials in these areas.
